ECO INSPECTION CERTIFICATE

Order ID : 51682

121 Points Vehicle Inspection Certificate

Maruti Suzuki S-Cross ZETA 1.3, 2017

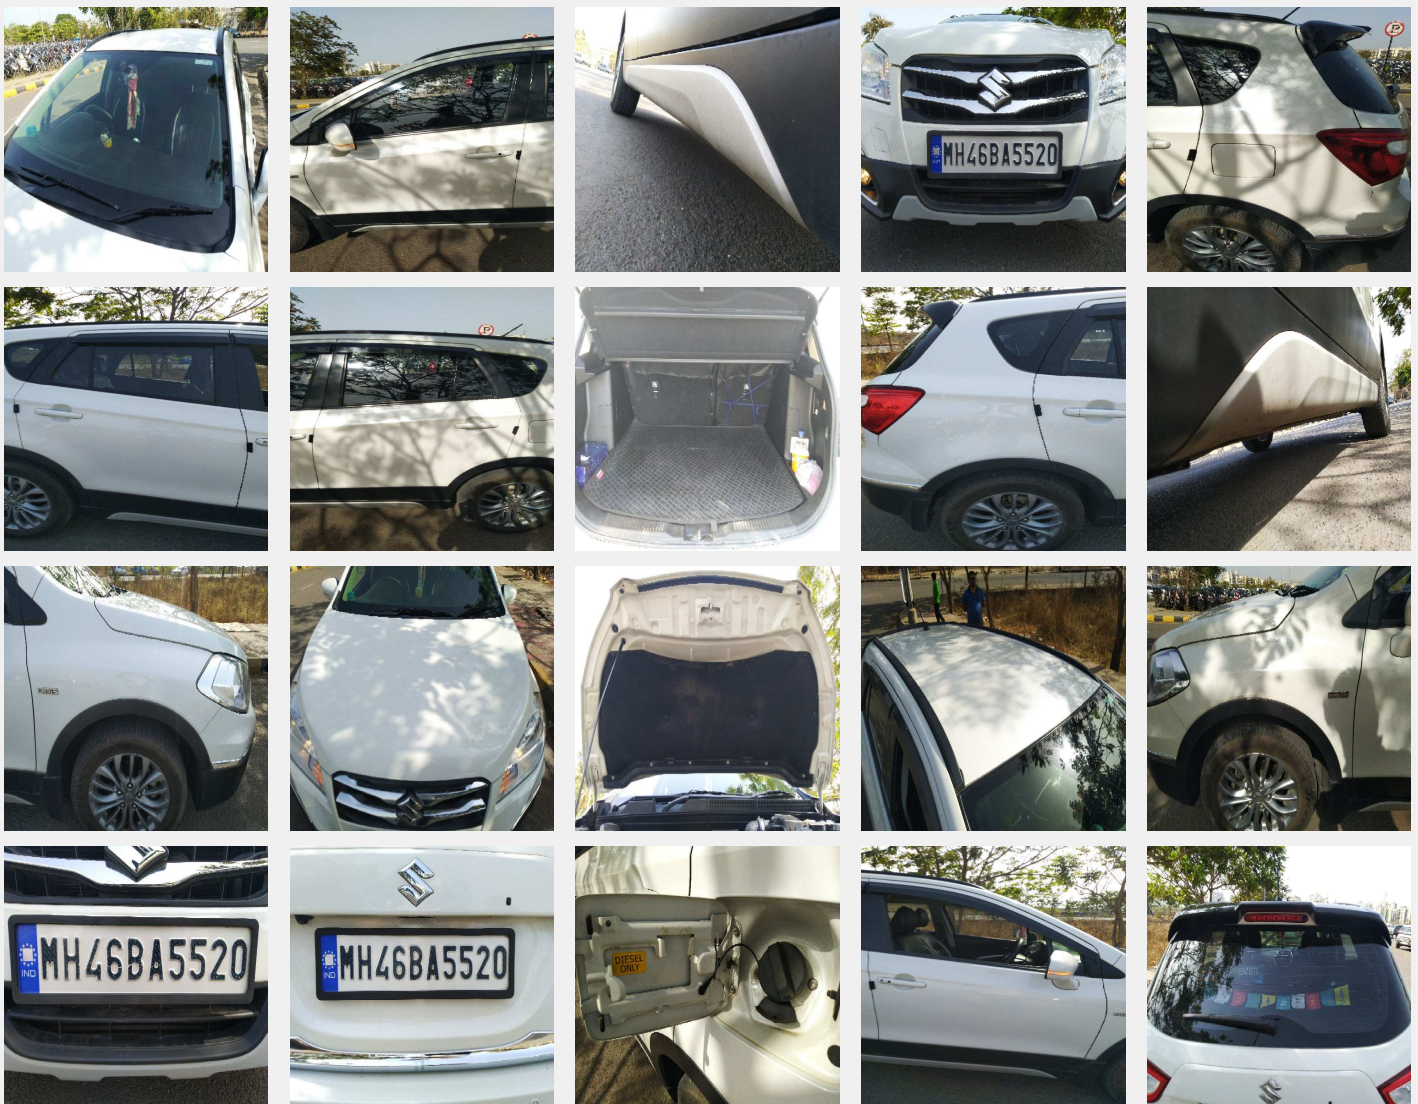
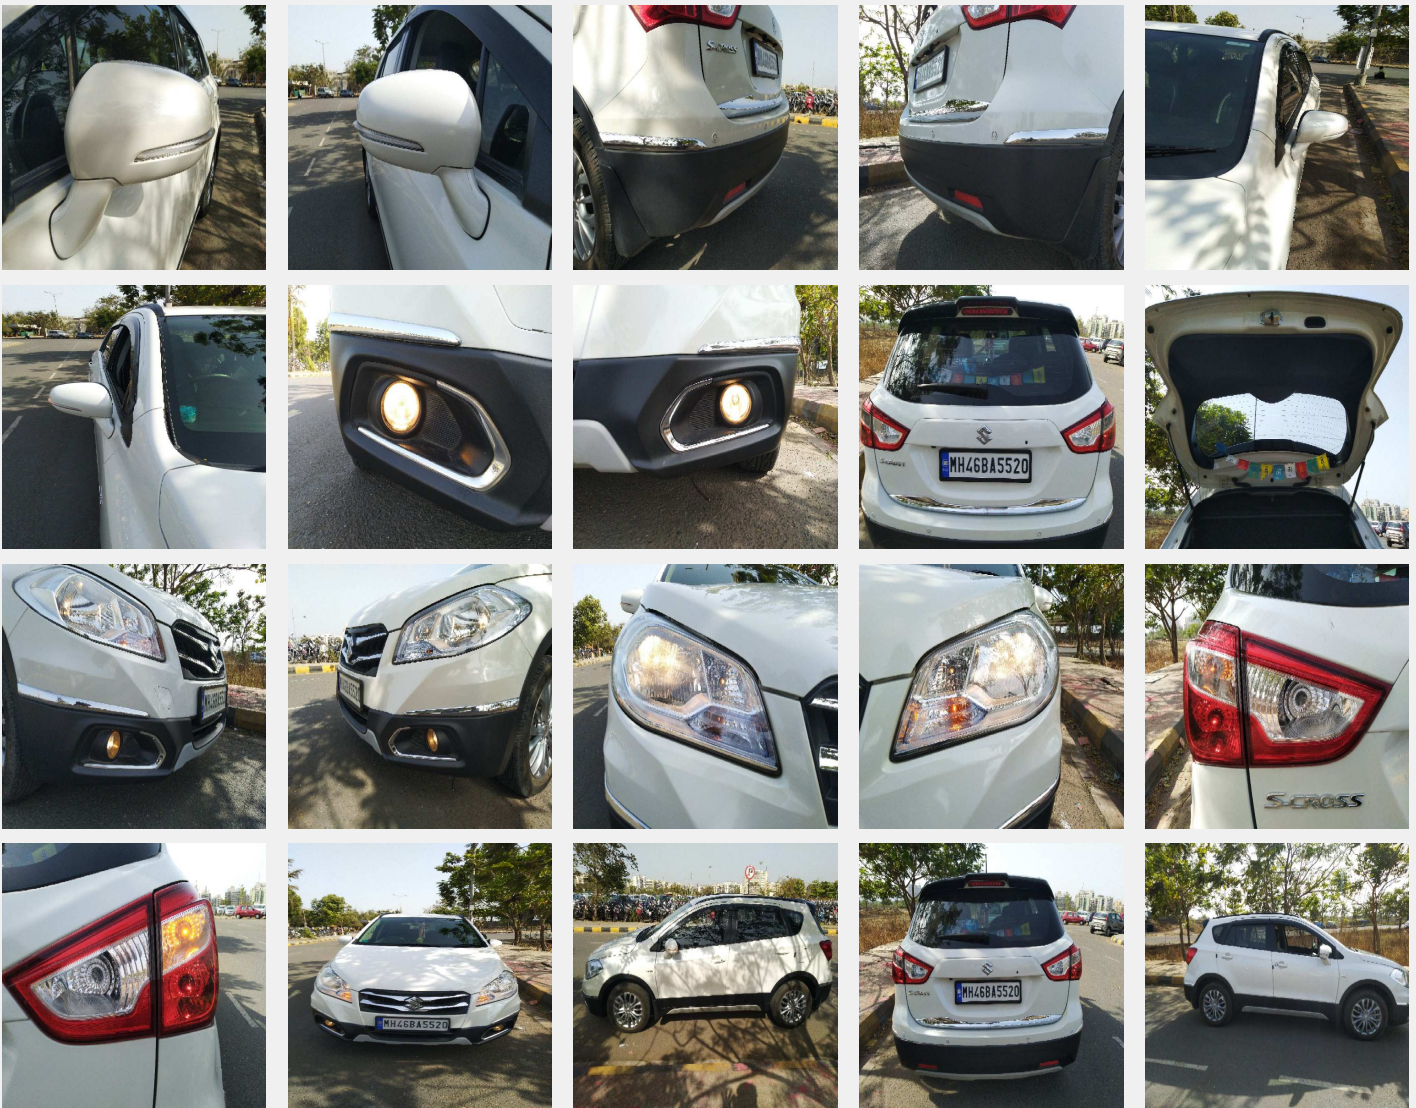
IMAGES

INSPECTION CHECKPOINTS	SCORE(X/10)	REMARKS/COMMENTS	OPTIONAL SPEND EST. (RS)
RH FRONT DOOR	8	VERY GOOD CONDITION	0
RH FENDER	8	VERY GOOD CONDITION	0
BODY RUST	8	NO RUST FOUND	0
ROOF (REGULAR)	8	VERY GOOD CONDITION	0
PAINT CONDITION	9	EXCELLENT CONDITION	0

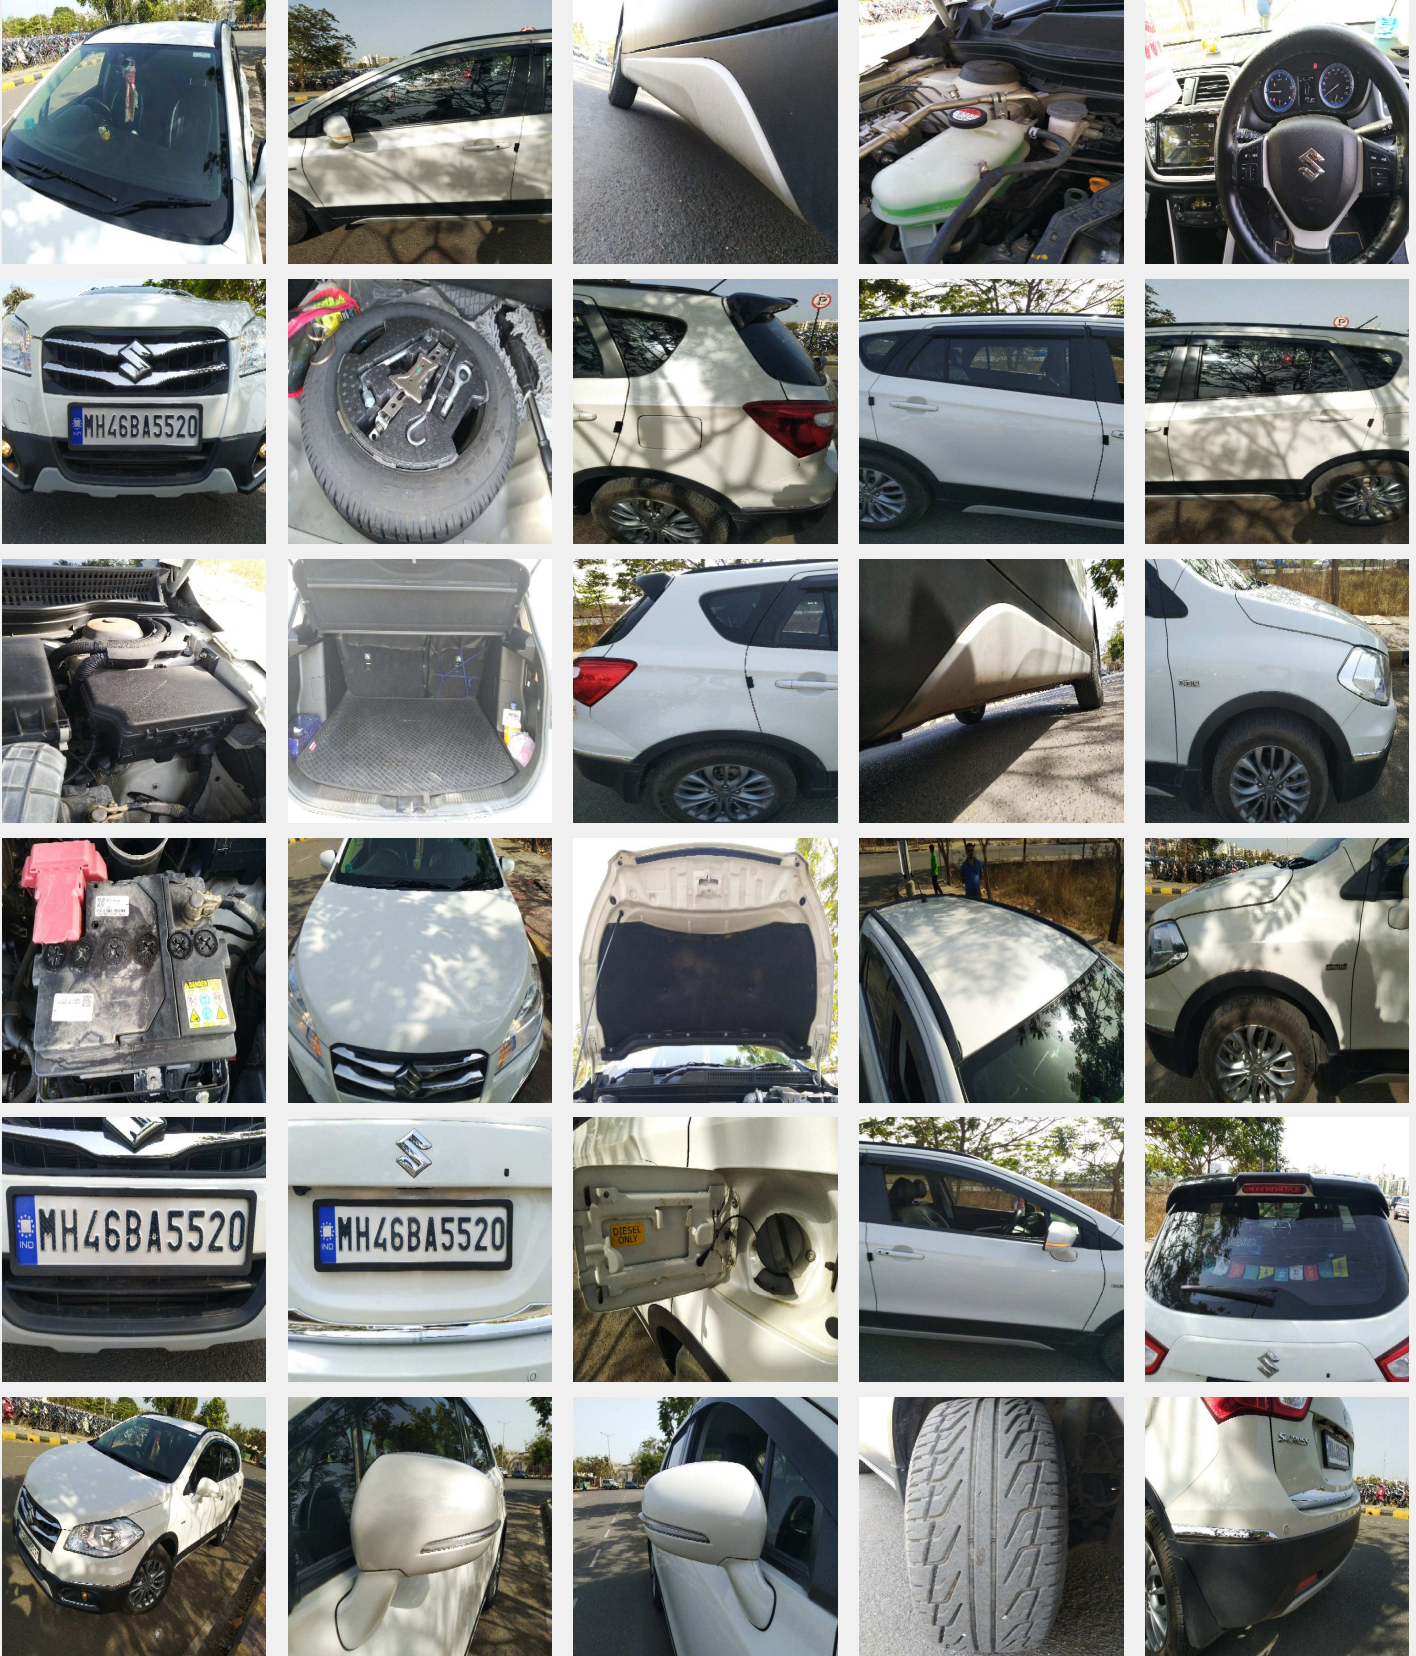
IMAGES

Excellent Condition Car
