ECO INSPECTION CERTIFICATE

Order ID : 51944

121 Points Vehicle Inspection Certificate

Maruti Suzuki Alto 800 LXI, 2017

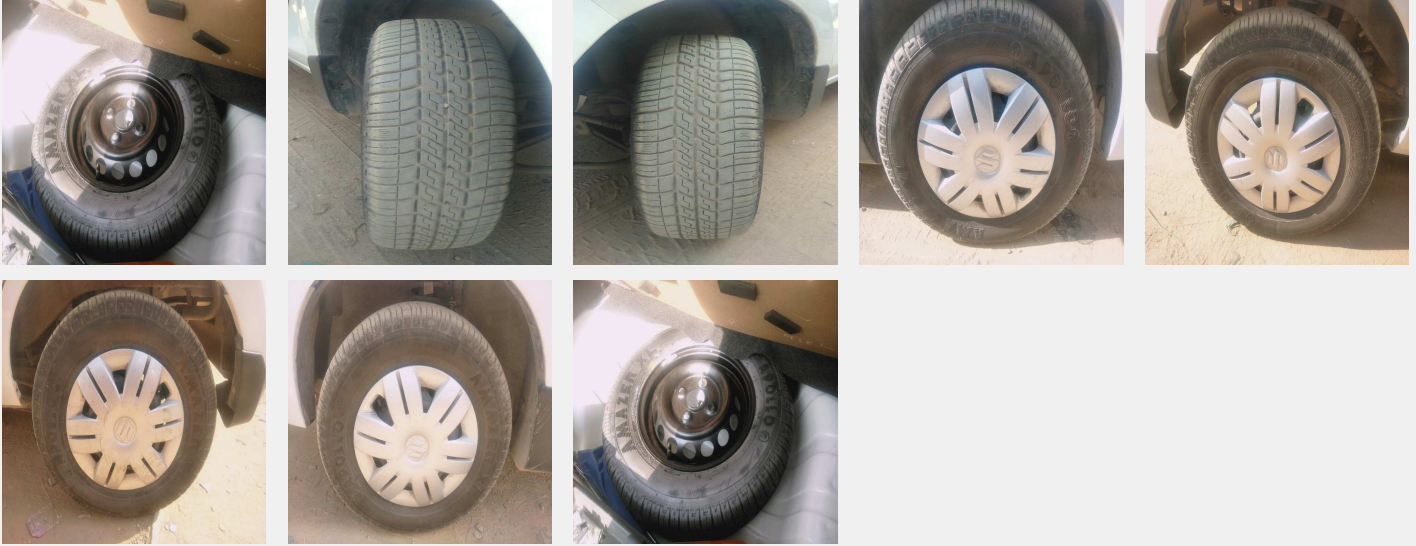
IMAGES

| INSPECTION CHECKPOINTS | SCORE(X/10) | REMARKS/COMMENTS | OPTIONAL SPEND EST. (RS) |
|---|---|---|---|
| TYRES | 8 | | 0 |
| SPARE TYRE (YES) | 9 | | 0 |
| WHEEL ASSEMBLY (STEEL RIM) | 9 | | 0 |

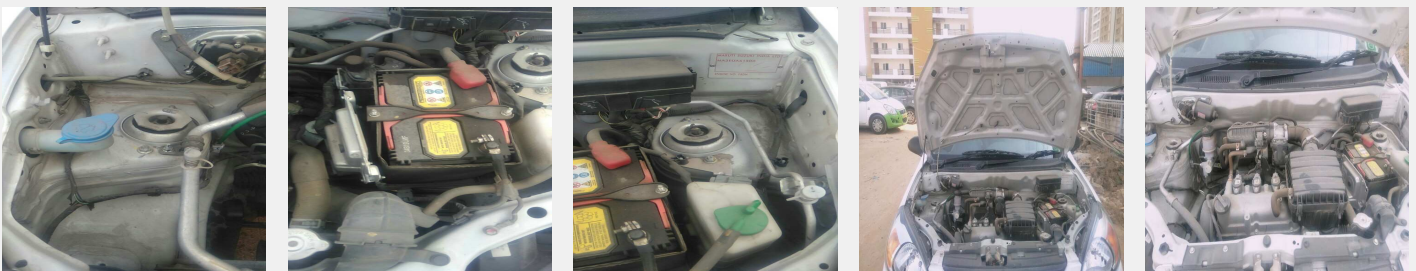
IMAGES

| INSPECTION CHECKPOINTS | SCORE(X/10) | REMARKS/COMMENTS | OPTIONAL SPEND EST. (RS) |
|---|---|---|---|
| LH APRON | 9 | | 0 |
| RH APRON | 9 | | 0 |
| RADIATOR | 8 | | 0 |
| WIRING | 8 | | 0 |
| BATTERY | 9 | | 0 |
| BRAKE FLUID LEVEL | 8 | | 0 |
| ENGINE OIL | 9 | | 0 |
| COOLANT LEVEL | 9 | | 0 |
| BRAKE & COOLANT HOSE PIPES | 8 | | 0 |
| UNDERCARRIAGE | 8 | | 0 |
| EXHAUST SYSTEM | 8 | | 0 |

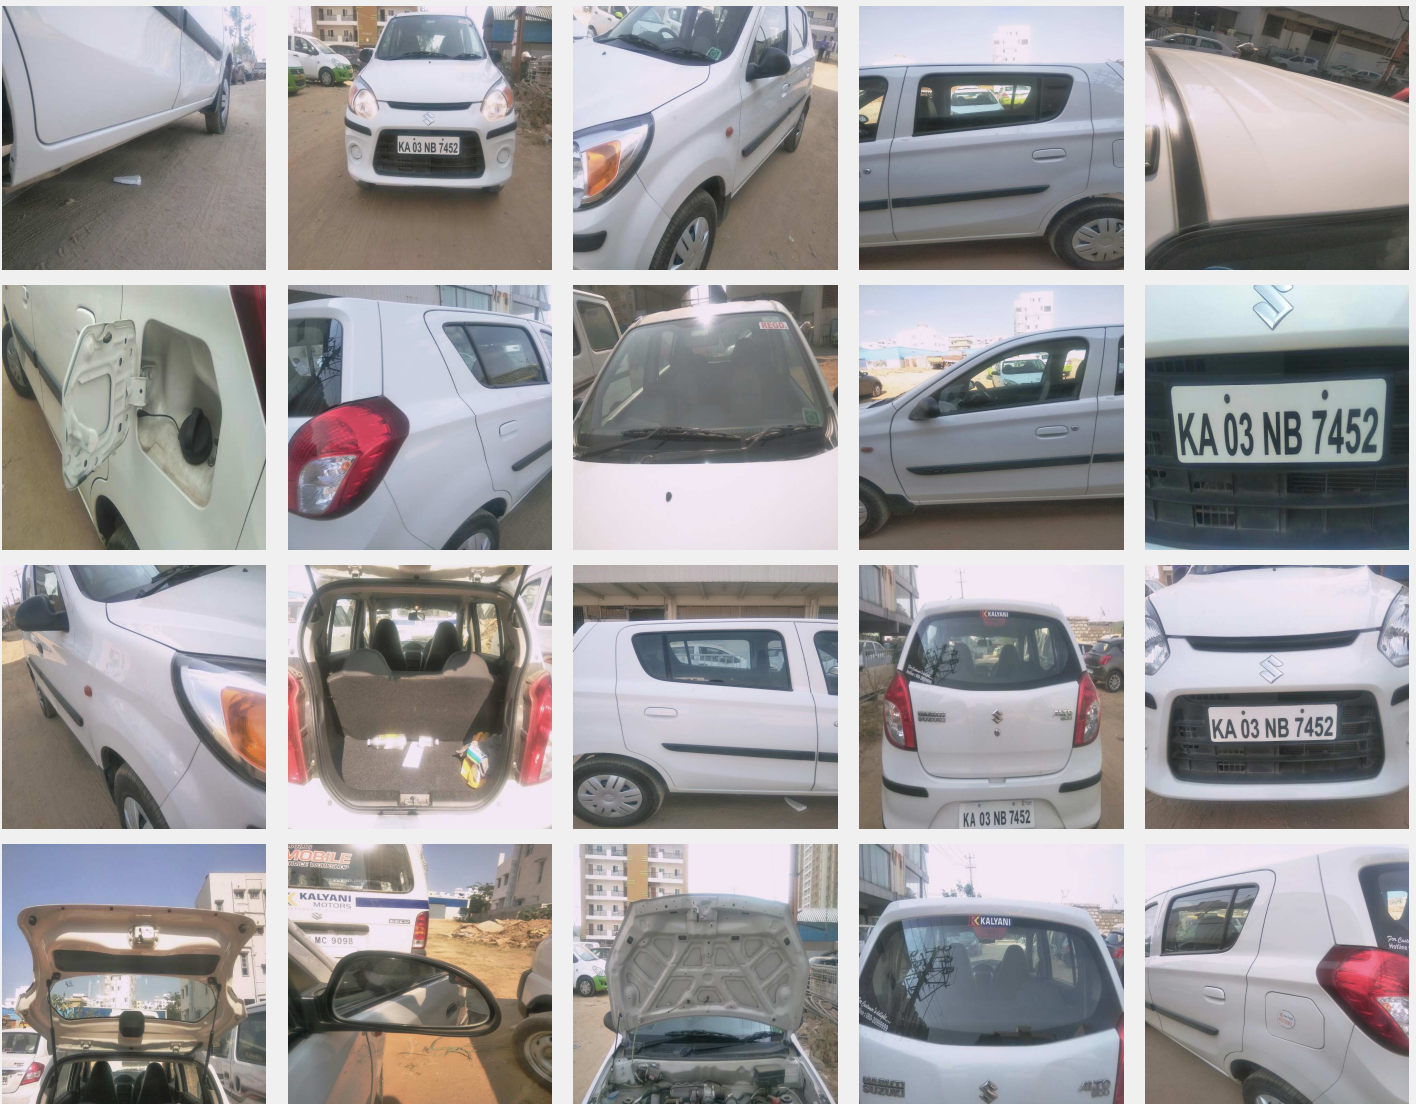
IMAGES

| INSPECTION CHECKPOINTS | SCORE(X/10) | REMARKS/COMMENTS | OPTIONAL SPEND EST. (RS) |
|---|---|---|---|
| FOG LAMPS | 0 | NO FOG LAMP | 0 |
| LH RUNNING BOARD | 5 | DENT AND SCRATCH | 0 |
