# ECO INSPECTION CERTIFICATE

121 Points Vehicle Inspection Certificate

Ordered By : Manoj Sharma	Inspection Date : 2019-03-22	Valid Till : 2019-06-22
------------------------------	---------------------------------	----------------------------

## Maruti Suzuki Swift VDI ABS BS IV, 2015

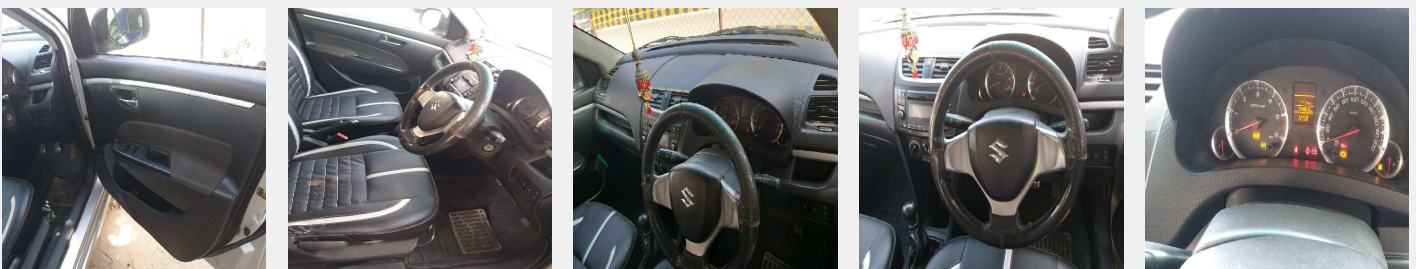
INSPECTION CHECKPOINTS	SCORE(X/10)	REMARKS/COMMENTS	OPTIONAL SPEND EST. (RS)
DOOR PANEL	7	GOOD CONDITION AND WORKING PROPERLY	0
DOOR HINGES	7	GOOD	0
CARPET & FLOOR MAT	7	GOOD	0
SEAT & SEAT BELT	7	GOOD CONDITION AND WORKING PROPERLY	0
DASHBOARD & INSTRUMENT PANEL	7	GOOD CONDITION AND WORKING PROPERLY	0
HORN	7	GOOD CONDITION AND WORKING PROPERLY	0
SPEAKERS & MUSIC SYSTEM	7	GOOD CONDITION AND WORKING PROPERLY	0
HANDBRAKE	7	GOOD CONDITION AND WORKING PROPERLY	0
PEDALS	7	GOOD CONDITION AND WORKING PROPERLY	0
CENTRAL LOCK	7	GOOD CONDITION AND WORKING PROPERLY	0
A/C VENTS & HEATER	7	GOOD	0
CUP HOLDERS	7	GOOD	0
NAVIGATION (NO)	10		0
ODOMETER	7	GOOD CONDITION AND WORKING PROPERLY	0
POWER WINDOWS (YES - FRONT ONLY)	7	GOOD CONDITION AND WORKING PROPERLY	0
HAZARD LIGHT	7	GOOD CONDITION AND WORKING PROPERLY	0
STEERING-MOUNTED CONTROLS	0	NOT AVAILABLE	0

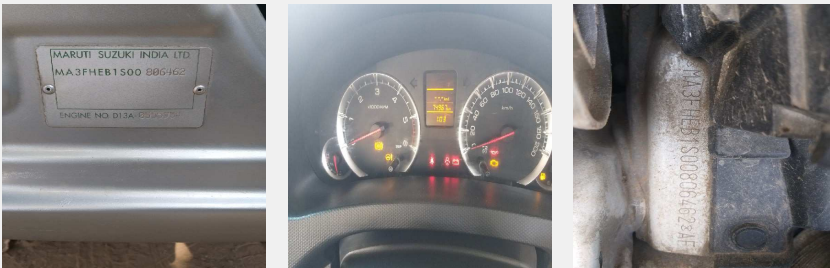
INSPECTION CHECKPOINTS	SCORE(X/10)	REMARKS/COMMENTS	OPTIONAL SPEND EST. (RS)
STEERING PERFORMANCE	7	GOOD CONDITION AND WORKING PROPERLY	0
BRAKE PERFORMANCE	7	GOOD CONDITION AND WORKING PROPERLY	0
CLUTCH PERFORMANCE	7	GOOD CONDITION AND WORKING PROPERLY	0
ENGINE NOISE	7	GOOD SOUND AND WORKING PROPERLY	0
IGNITION SYSTEM	7	GOOD CONDITION AND WORKING PROPERLY	0
SUSPENSION PERFORMANCE	7	GOOD CONDITION AND WORKING PROPERLY	0
SUSPENSION FRONT SHOCKS	7	GOOD CONDITION AND WORKING PROPERLY	0
SUSPENSION REAR SHOCKS	7	GOOD	0
TRANSMISSION ENGAGE	7	GOOD CONDITION AND WORKING PROPERLY	0
CRUISE CONTROL (NO)	10		0
REAR PARKING SENSORS (NO)	10		0
REAR VIEW CAMERA (NO)	10		0

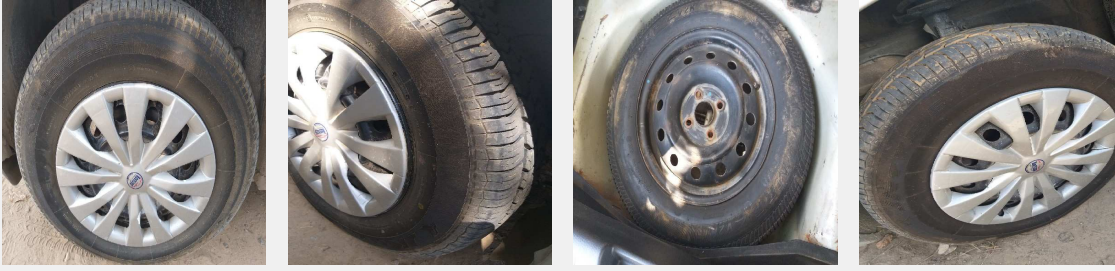
INSPECTION CHECKPOINTS	SCORE(X/10)	REMARKS/COMMENTS	OPTIONAL SPEND EST. (RS)
TYRES	7	GOOD CONDITION AND WORKING PROPERLY	0
SPARE TYRE (YES)	7	GOOD CONDITION AND WORKING PROPERLY	0
WHEEL ASSEMBLY (STEEL RIM)	7	GOOD	0

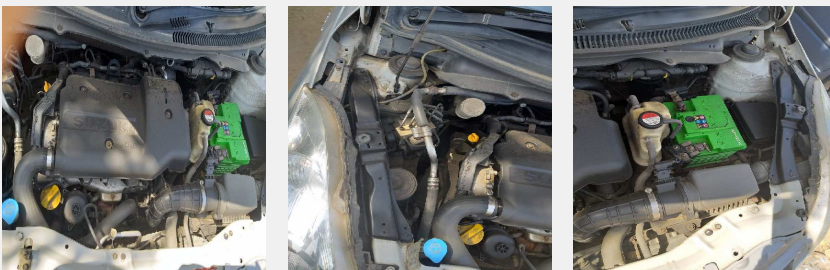
HOOD

INSPECTION CHECKPOINTS	SCORE(X/10)	REMARKS/COMMENTS	OPTIONAL SPEND EST. (RS)
LH APRON	7	GOOD	0
RH APRON	7	GOOD	0
RADIATOR	7	GOOD	0
WIRING	7	GOOD	0
BATTERY	7	GOOD	0
BRAKE FLUID LEVEL	7	MAXIMUM	0
ENGINE OIL	7	MAXIMUM	0
COOLANT LEVEL	7	MAXIMUM	0
BRAKE & COOLANT HOSE PIPES	7	GOOD	0
UNDERCARRIAGE	7	GOOD	0
EXHAUST SYSTEM	7	GOOD	0

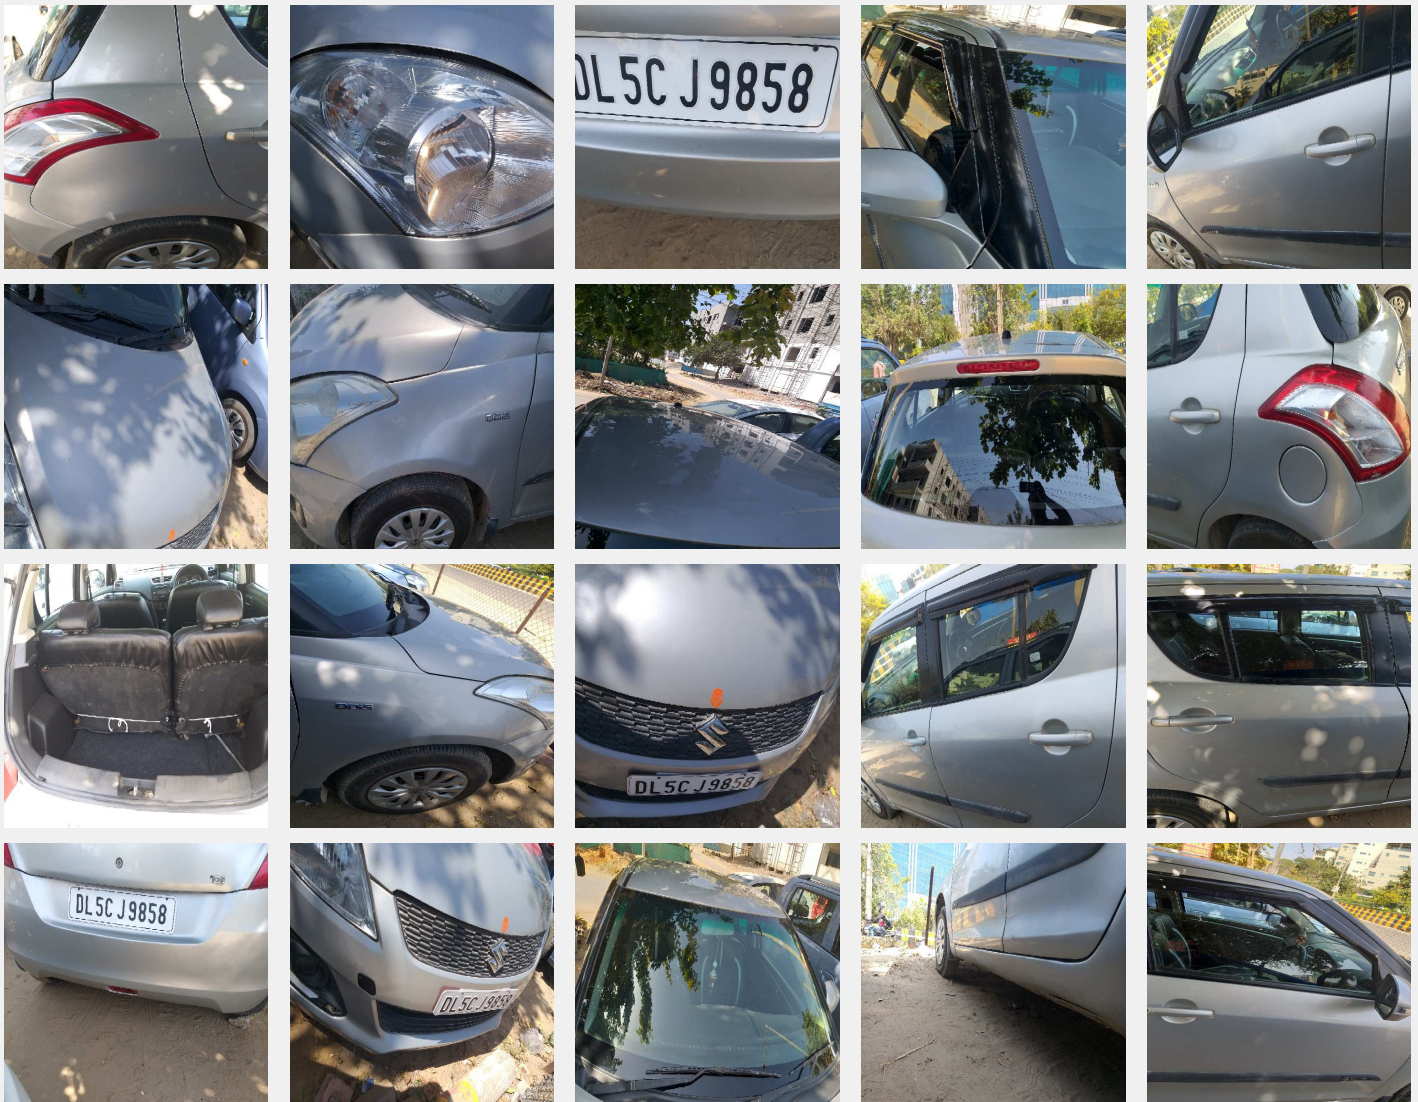
INSPECTION CHECKPOINTS	SCORE(X/10)	REMARKS/COMMENTS	OPTIONAL SPEND EST. (RS)
BODY RUST	7	GOOD	0
ROOF (REGULAR)	7	GOOD	0
PAINT CONDITION	7	GOOD	0
FOG LAMPS	0	NOT AVAILABLE	0
TAIL LIGHT	5	RIGHT SIDE TAIL LIGHT NEED TO BE CHANG	1800

**NEED ATTENTION**

minor scratches fully dent paint
