# ECO INSPECTION CERTIFICATE

121 Points Vehicle Inspection Certificate

## Ford Figo Duratorq Titanium 1.4, 2011

MAKE	FORD	TRANSMISSION TYPE	MANUAL
MODEL	FIGO	REGISTRATION NO.	UP80BX5796
YEAR	2011	VIN/CHASIS NUMBER	MAJ1XXMRJ1BY50847
TRIM	DURATORQ TITANIUM 1.4	KMS RUN	85360
COLOR	GREY	INSURANCE EXPIRY	2019-8-7
BODY TYPE	HATCHBACK	LOCATION	AGRA
FUEL TYPE	DIESEL	ENGINE SOUND LINK	<a href="#">LISTEN ENGINE SOUND</a>

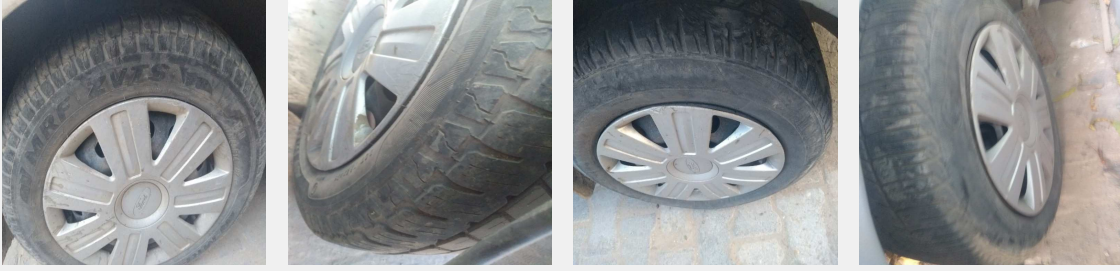
IMAGES

INSPECTION CHECKPOINTS	SCORE(X/10)	REMARKS/COMMENTS	OPTIONAL SPEND EST. (RS)
TYRES	7		0
SPARE TYRE (YES)	7		0
WHEEL ASSEMBLY (STEEL RIM)	7		0

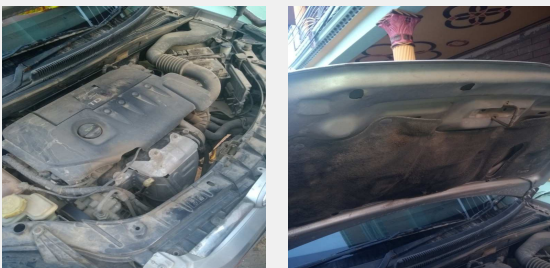
IMAGES

INSPECTION CHECKPOINTS	SCORE(X/10)	REMARKS/COMMENTS	OPTIONAL SPEND EST. (RS)
LH APRON	7		0
RH APRON	7		0
RADIATOR	7		0
WIRING	7		0
BATTERY	7		0
BRAKE FLUID LEVEL	7		0
ENGINE OIL	7		0
COOLANT LEVEL	7		0
BRAKE & COOLANT HOSE PIPES	7		0
UNDERCARRIAGE	7		0
EXHAUST SYSTEM	7		0
