ECO INSPECTION CERTIFICATE

Order ID : 51973

121 Points Vehicle Inspection Certificate

Fiat Punto Evo DYNAMIC MULTIJET 1.3, 2016

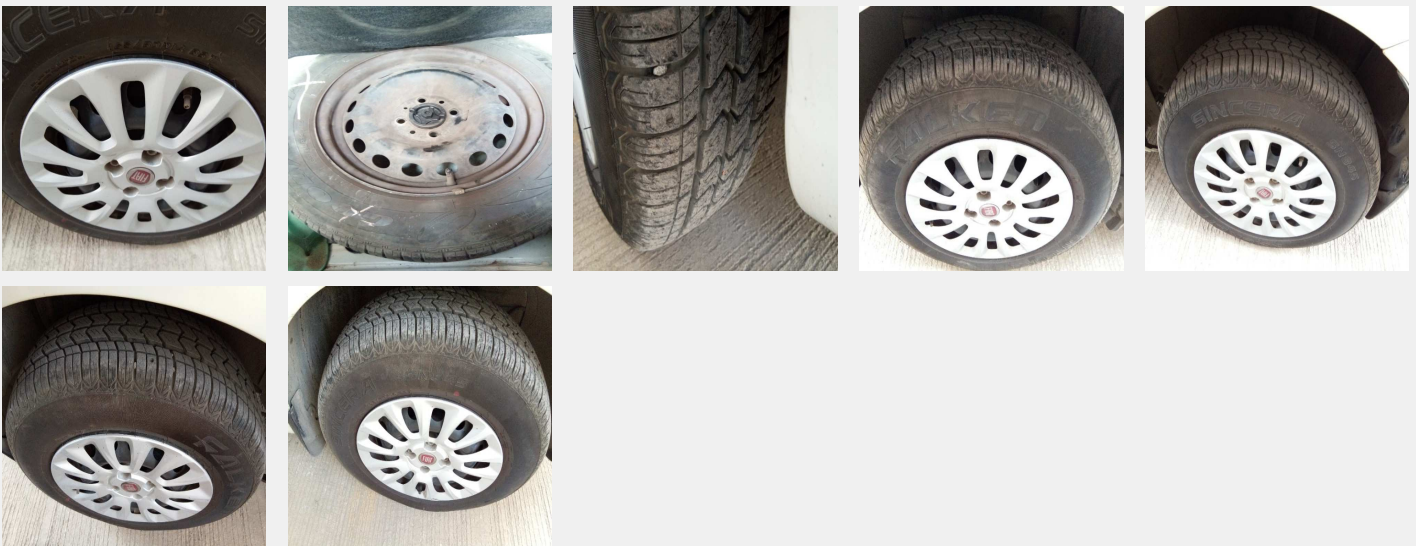
INSPECTION CHECKPOINTS	SCORE(X/10)	REMARKS/COMMENTS	OPTIONAL SPEND EST. (RS)
TYRES	8	GOOD	0
SPARE TYRE (YES)	8	GOOD	0
WHEEL ASSEMBLY (STEEL RIM)	8	GOOD	0

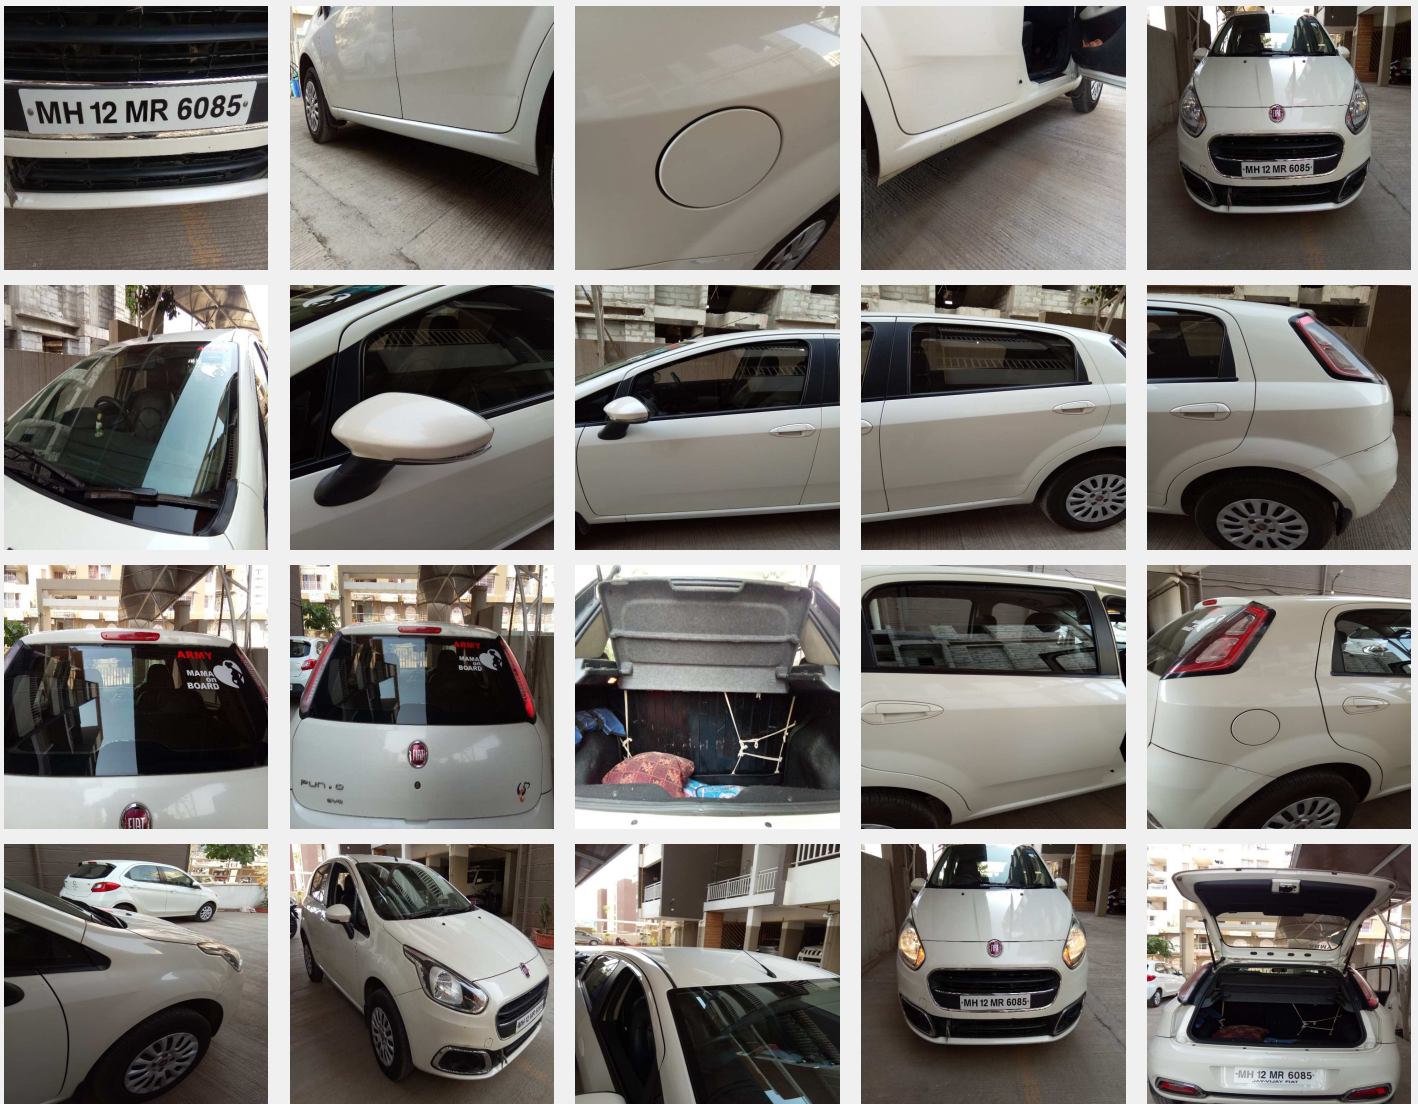
INSPECTION CHECKPOINTS	SCORE(X/10)	REMARKS/COMMENTS	OPTIONAL SPEND EST. (RS)
BODY RUST	8	GOOD	0
ROOF (REGULAR)	8	GOOD	0
PAINT CONDITION	8	GOOD	0
FOG LAMPS	3	NO	2000
REAR BUMPER	3	SCRATCHES	3000
