# ECO INSPECTION CERTIFICATE

121 Points Vehicle Inspection Certificate

Ordered By : Kiran	Inspection Date : 2019-03-26	Valid Till : 2019-06-26

## Maruti Suzuki Alto 800 LXI, 2016

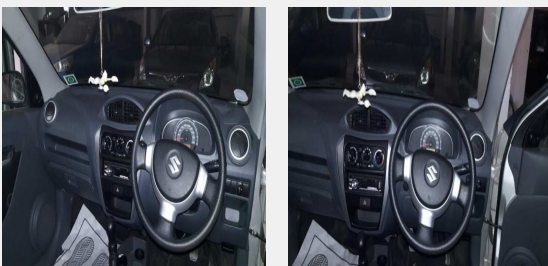
## IMAGES

INSPECTION CHECKPOINTS	SCORE(X/10)	REMARKS/COMMENTS	OPTIONAL SPEND EST. (RS)
DOOR PANEL	6		0
DOOR HINGES	6		0
CARPET & FLOOR MAT	6		0
SEAT & SEAT BELT	6		0
DASHBOARD & INSTRUMENT PANEL	6		0
HORN	6		0
SPEAKERS & MUSIC SYSTEM	6		0
HANDBRAKE	6		0
STEERING-MOUNTED CONTROLS	6		0
PEDALS	6		0
CENTRAL LOCK	6		0
A/C VENTS & HEATER	6		0
CUP HOLDERS	6		0
NAVIGATION (NO)	10		0
ODOMETER	6		0
POWER WINDOWS (YES - FRONT ONLY)	6		0
HAZARD LIGHT	6		0

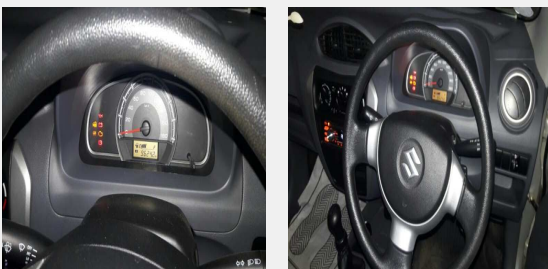
## IMAGES

INSPECTION CHECKPOINTS	SCORE(X/10)	REMARKS/COMMENTS	OPTIONAL SPEND EST. (RS)
STEERING PERFORMANCE	6		0
BRAKE PERFORMANCE	6		0
CLUTCH PERFORMANCE	6		0
ENGINE NOISE	6		0
IGNITION SYSTEM	6		0
SUSPENSION PERFORMANCE	6		0
SUSPENSION FRONT SHOCKS	6		0
SUSPENSION REAR SHOCKS	6		0
TRANSMISSION ENGAGE	6		0
CRUISE CONTROL (NO)	10		0
REAR PARKING SENSORS (NO)	10		0
REAR VIEW CAMERA (NO)	10		0

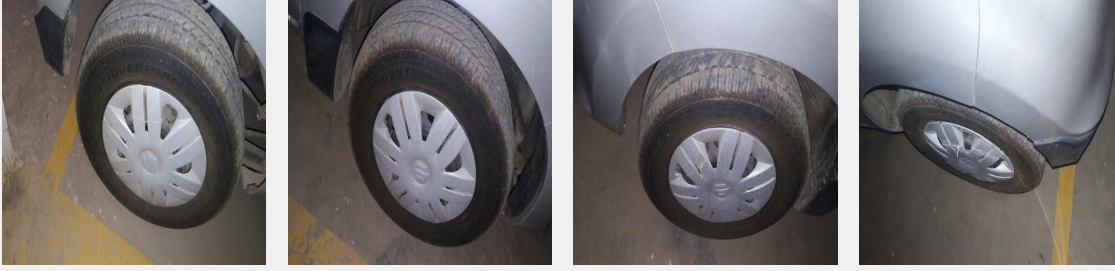
IMAGES

INSPECTION CHECKPOINTS	SCORE(X/10)	REMARKS/COMMENTS	OPTIONAL SPEND EST. (RS)
TYRES	6		0
SPARE TYRE (YES)	6		0
WHEEL ASSEMBLY (STEEL RIM)	6		0

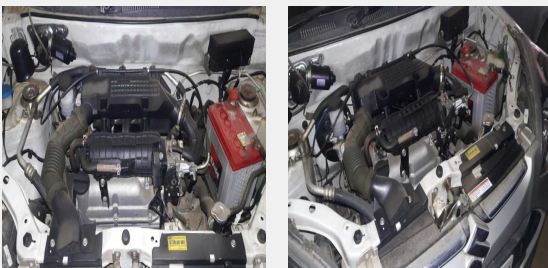
IMAGES

INSPECTION CHECKPOINTS	SCORE(X/10)	REMARKS/COMMENTS	OPTIONAL SPEND EST. (RS)
LH APRON	6		0
RH APRON	6		0
RADIATOR	6		0
WIRING	6		0
BATTERY	6		0
BRAKE FLUID LEVEL	6		0
ENGINE OIL	6		0
COOLANT LEVEL	6		0
BRAKE & COOLANT HOSE PIPES	6		0
UNDERCARRIAGE	6		0
EXHAUST SYSTEM	6		0
