ECO INSPECTION CERTIFICATE

Order ID : 53123

121 Points Vehicle Inspection Certificate

Mahindra Thar CRDE 4X4 AC, 2012

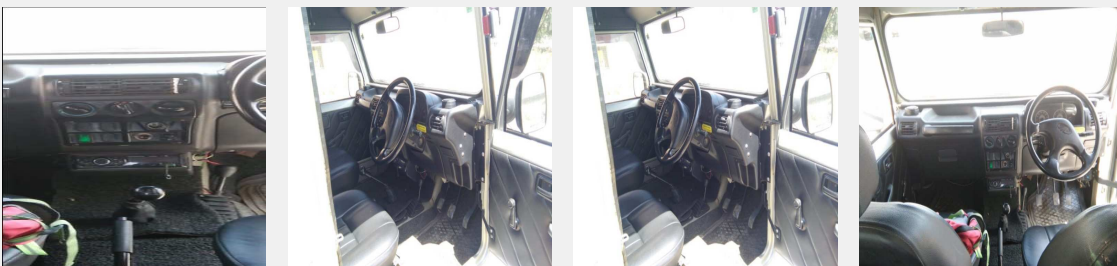
INTERIOR

INSPECTION CHECKPOINTS	SCORE(X/10)	REMARKS/COMMENTS	OPTIONAL SPEND EST. (RS)
DOOR PANEL	8	OK	0
DOOR HINGES	7	OK	0
CARPET & FLOOR MAT	8	OK	0
SEAT & SEAT BELT	7	OK	0
DASHBOARD & INSTRUMENT PANEL	8	OK	0
HORN	9	OK	0
SPEAKERS & MUSIC SYSTEM	7	OK	0
HANDBRAKE	8	OK	0
STEERING-MOUNTED CONTROLS	7	OK	0
PEDALS	8	OK	0
CENTRAL LOCK	7	OK	0
A/C VENTS & HEATER	7	OK	0
CUP HOLDERS	7	OK	0
NAVIGATION (NO)	10		0
ODOMETER	8	OK	0
POWER WINDOWS (YES - FRONT ONLY)	6	OK	0
HAZARD LIGHT	8	OK	0

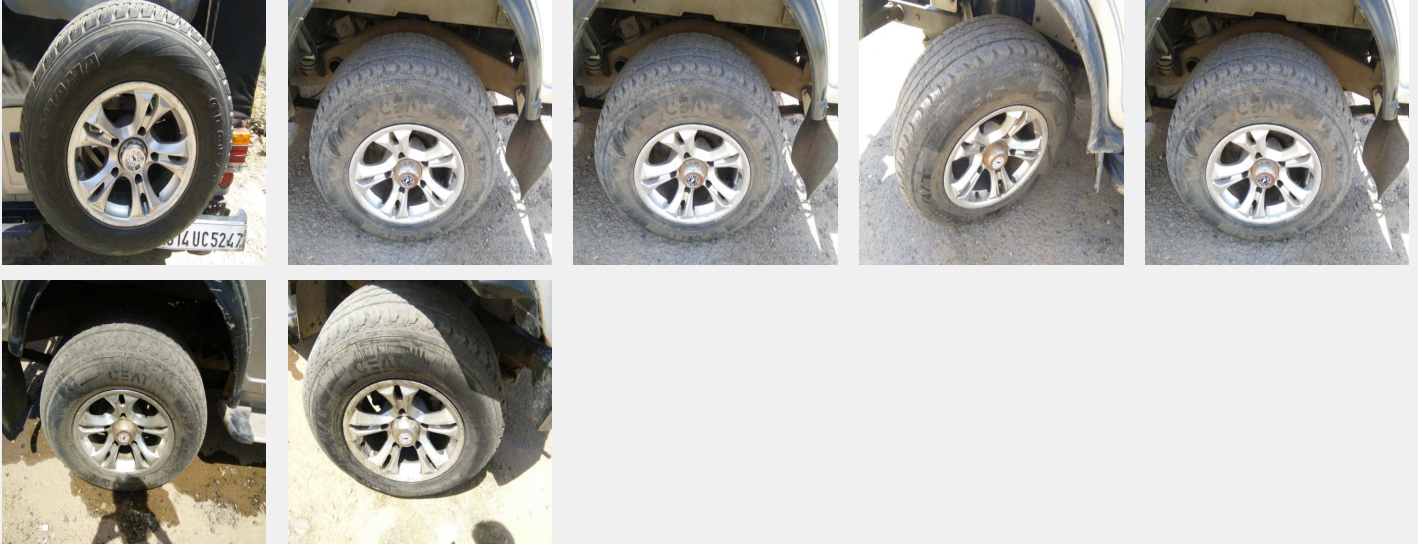
INSPECTION CHECKPOINTS	SCORE(X/10)	REMARKS/COMMENTS	OPTIONAL SPEND EST. (RS)
TYRES	7	OK	0
SPARE TYRE (YES)	8	OK	0
WHEEL ASSEMBLY (ALLOY RIM)	7	OK	0

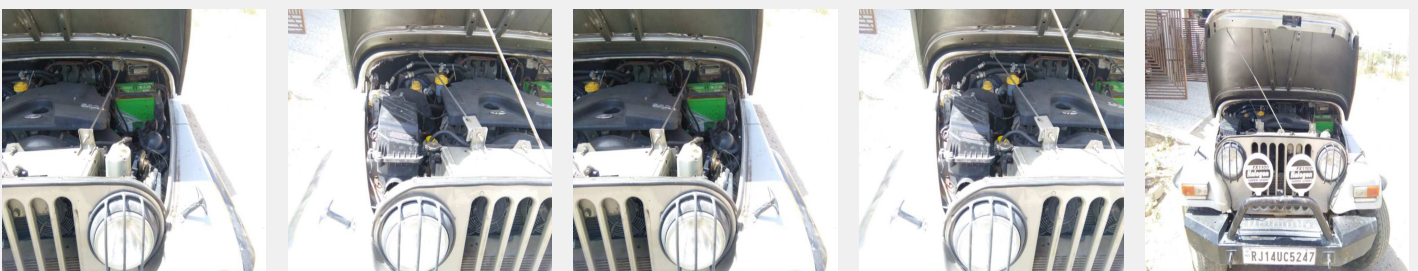
HOOD

INSPECTION CHECKPOINTS	SCORE(X/10)	REMARKS/COMMENTS	OPTIONAL SPEND EST. (RS)
LH APRON	7	OK	0
RH APRON	8	OK	0
RADIATOR	6	OK	0
WIRING	8	OK	0
BATTERY	7	OK	0
BRAKE FLUID LEVEL	8	OK	0
ENGINE OIL	7	OK	0
COOLANT LEVEL	8	OK	0
BRAKE & COOLANT HOSE PIPES	7	OK	0
UNDERCARRIAGE	6	OK	0
EXHAUST SYSTEM	8	OK	0

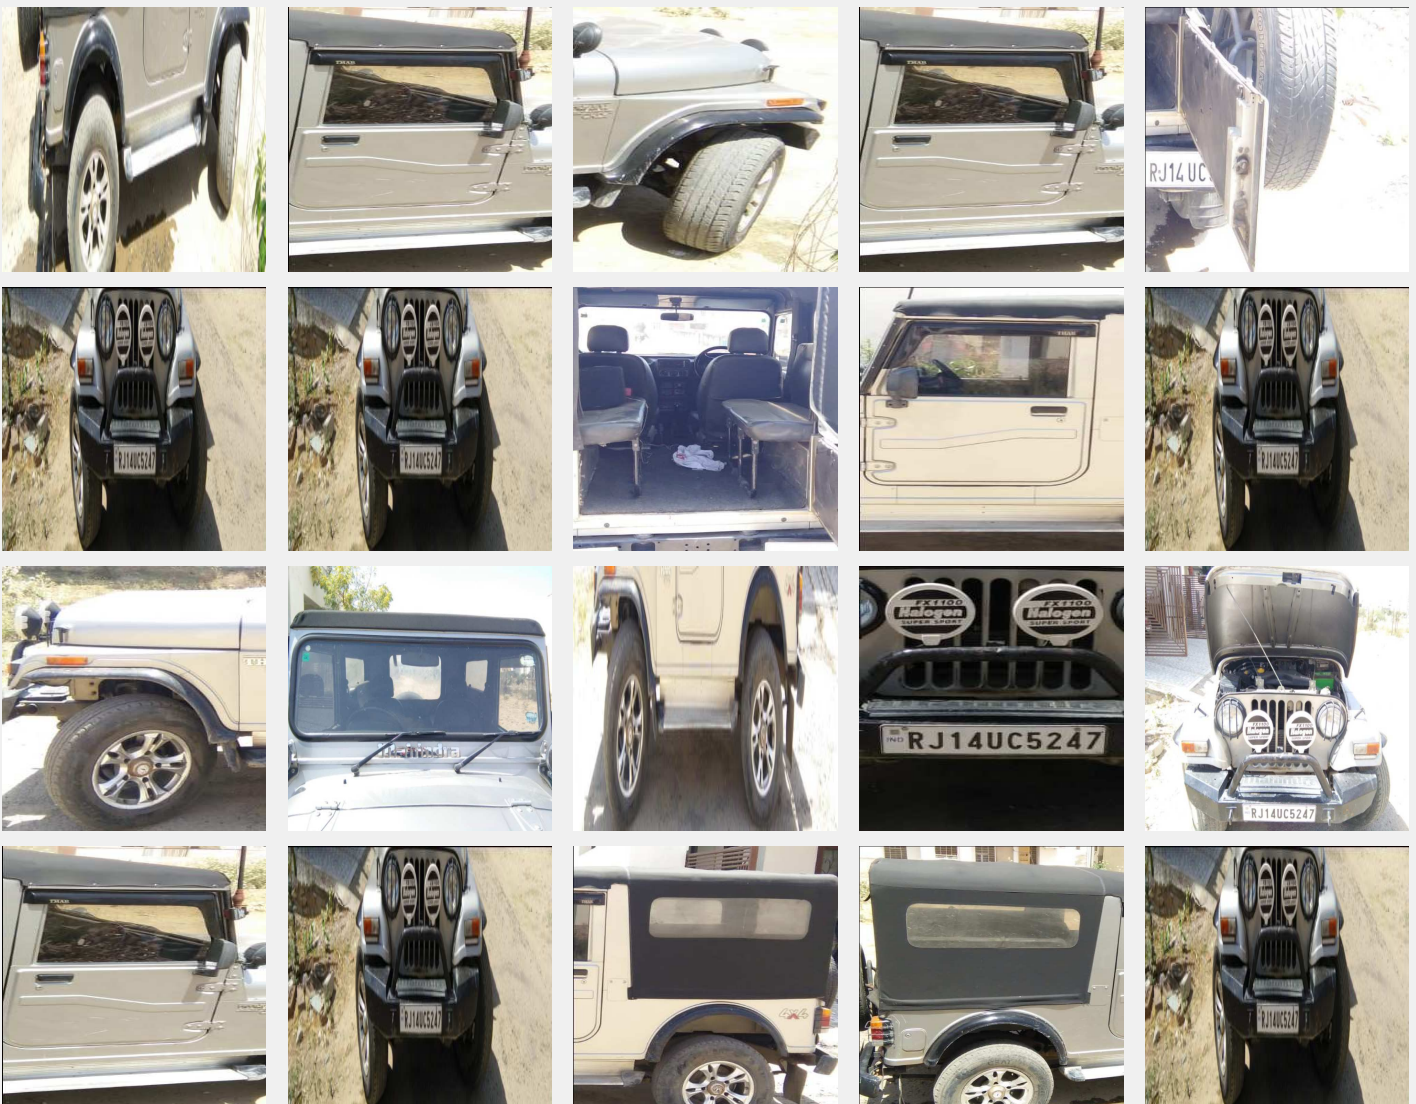
EXTERIOR (CONTINUED)

INSPECTION CHECKPOINTS	SCORE(X/10)	REMARKS/COMMENTS	OPTIONAL SPEND EST. (RS)
LH REAR DOOR	0	NOT IN MODEL	0
REAR WINDSHIELD	0	NOT IN MODEL	0
REAR BUMPER	5	FAIR	1000
RH REAR DOOR	0	NOT IN MODEL	0
BODY RUST	5	OK	2000
