ECO INSPECTION CERTIFICATE

Order ID : 44678

121 Points Vehicle Inspection Certificate

Nissan X-Trail SLX AT, 2011

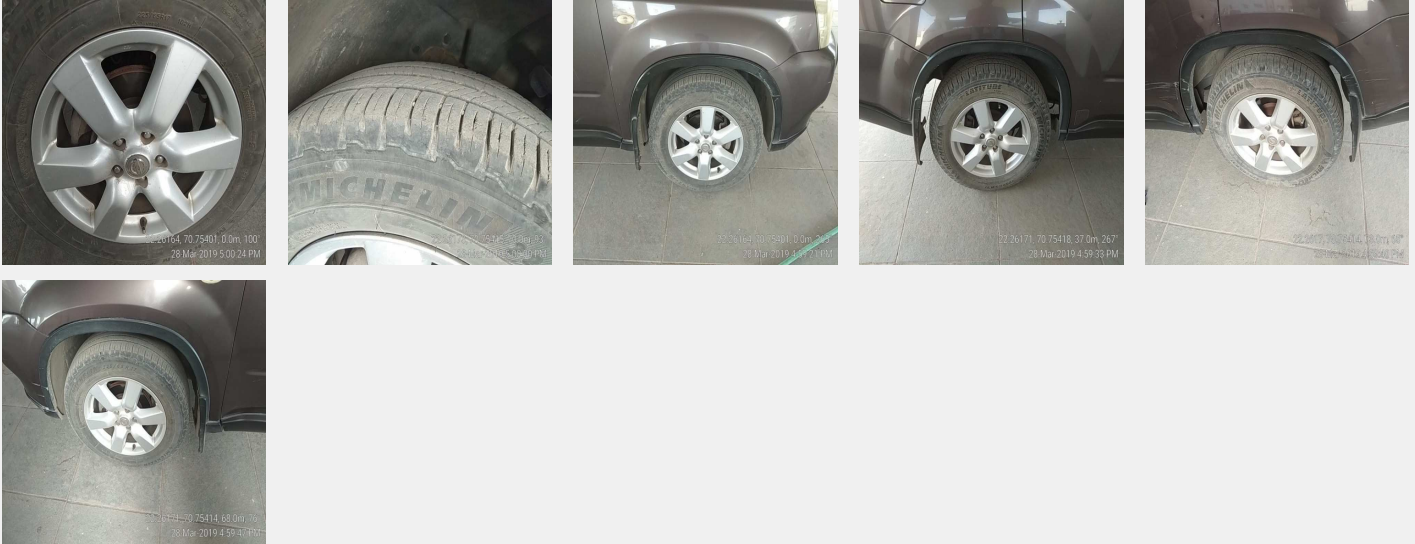
IMAGES

INSPECTION CHECKPOINTS	SCORE(X/10)	REMARKS/COMMENTS	OPTIONAL SPEND EST. (RS)
TYRES	6		0
SPARE TYRE (YES)	6		0
WHEEL ASSEMBLY (STEEL RIM)	6		0

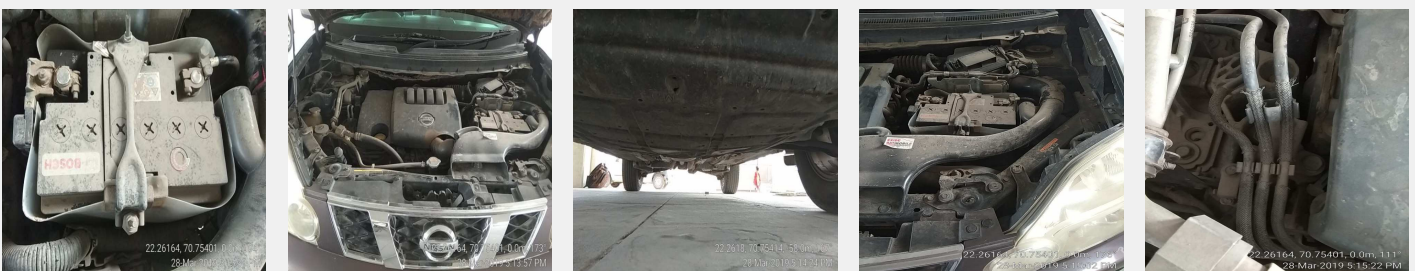
IMAGES

INSPECTION CHECKPOINTS	SCORE(X/10)	REMARKS/COMMENTS	OPTIONAL SPEND EST. (RS)
LH APRON	6		0
RH APRON	6		0
RADIATOR	6		0
WIRING	6		0
BATTERY	6		0
BRAKE FLUID LEVEL	6		0
ENGINE OIL	6		0
COOLANT LEVEL	6		0
BRAKE & COOLANT HOSE PIPES	6		0
UNDERCARRIAGE	6		0
EXHAUST SYSTEM	6		0

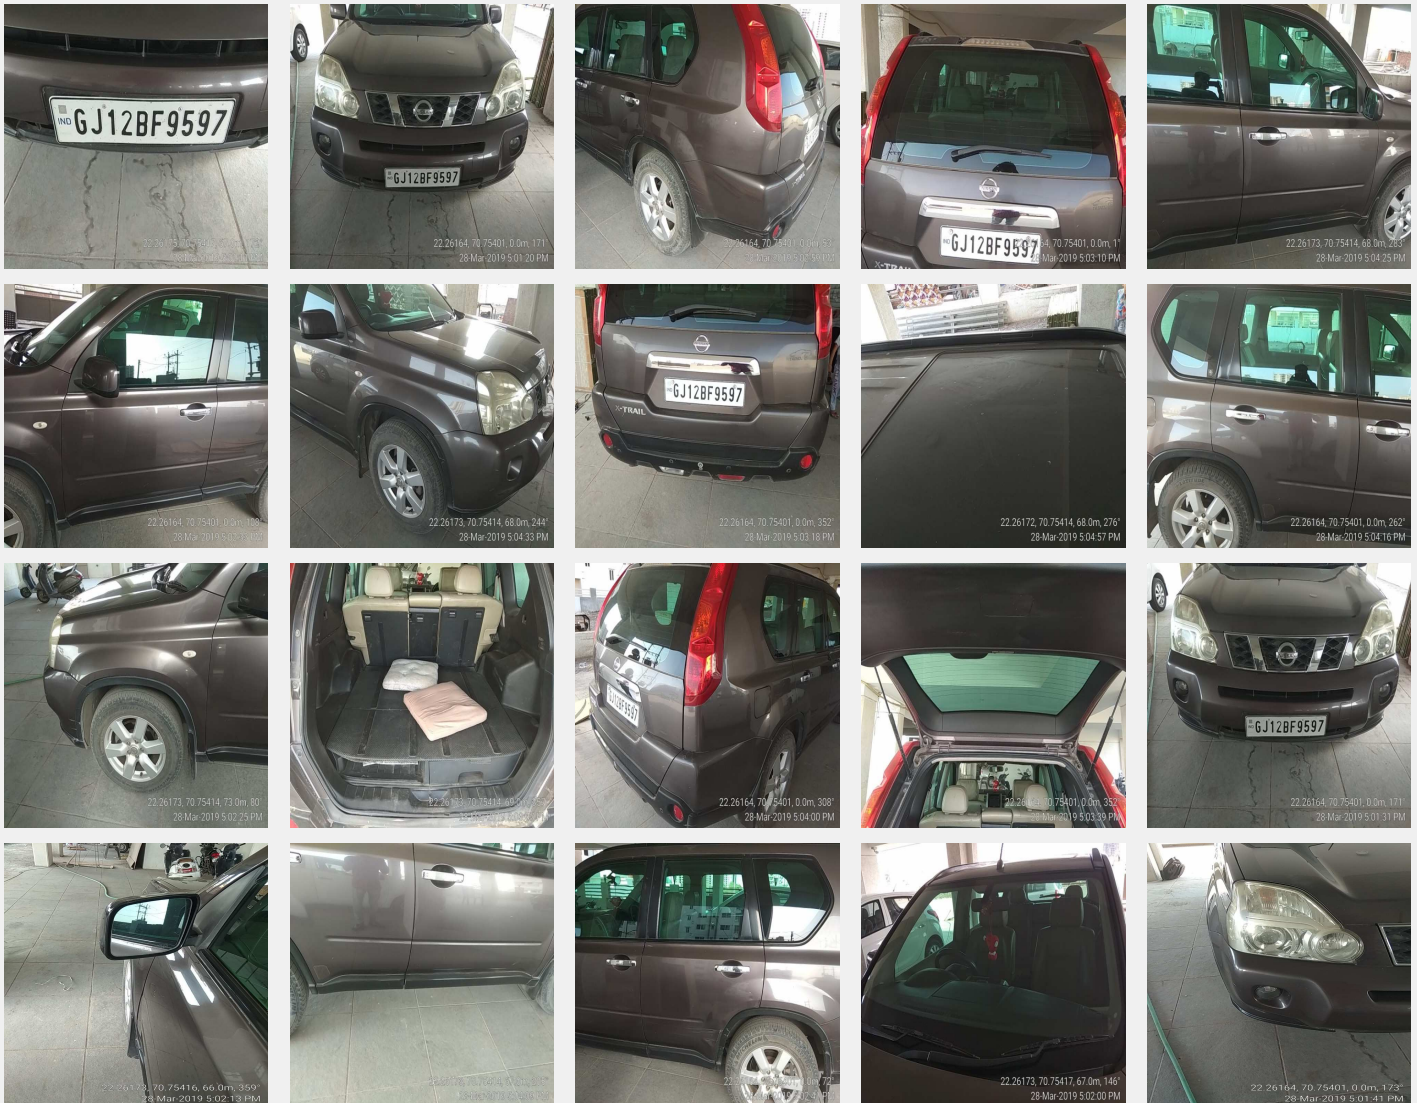
IMAGES

INSPECTION CHECKPOINTS	SCORE(X/10)	REMARKS/COMMENTS	OPTIONAL SPEND EST. (RS)
RH FRONT DOOR	6		0
RH FENDER	6		0
BODY RUST	6		0
ROOF (SUN ROOF)	6		0
PAINT CONDITION	6		0
