ECO INSPECTION CERTIFICATE

Order ID : 51078

121 Points Vehicle Inspection Certificate

Maruti Suzuki Swift VDI, 2016

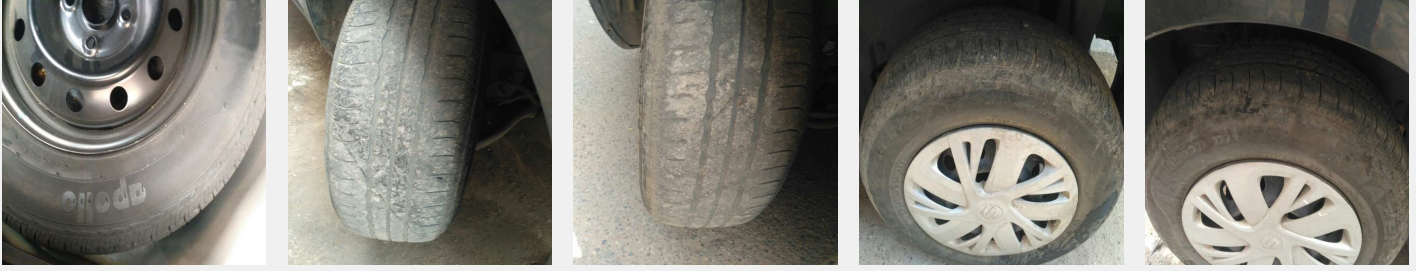
INSPECTION CHECKPOINTS	SCORE(X/10)	REMARKS/COMMENTS	OPTIONAL SPEND EST. (RS)
TYRES	6	AVERAGE CONDITION	0
SPARE TYRE (YES)	9	VERY GOOD CONDITION	0
WHEEL ASSEMBLY (STEEL RIM)	7	GOOD CONDITION	0

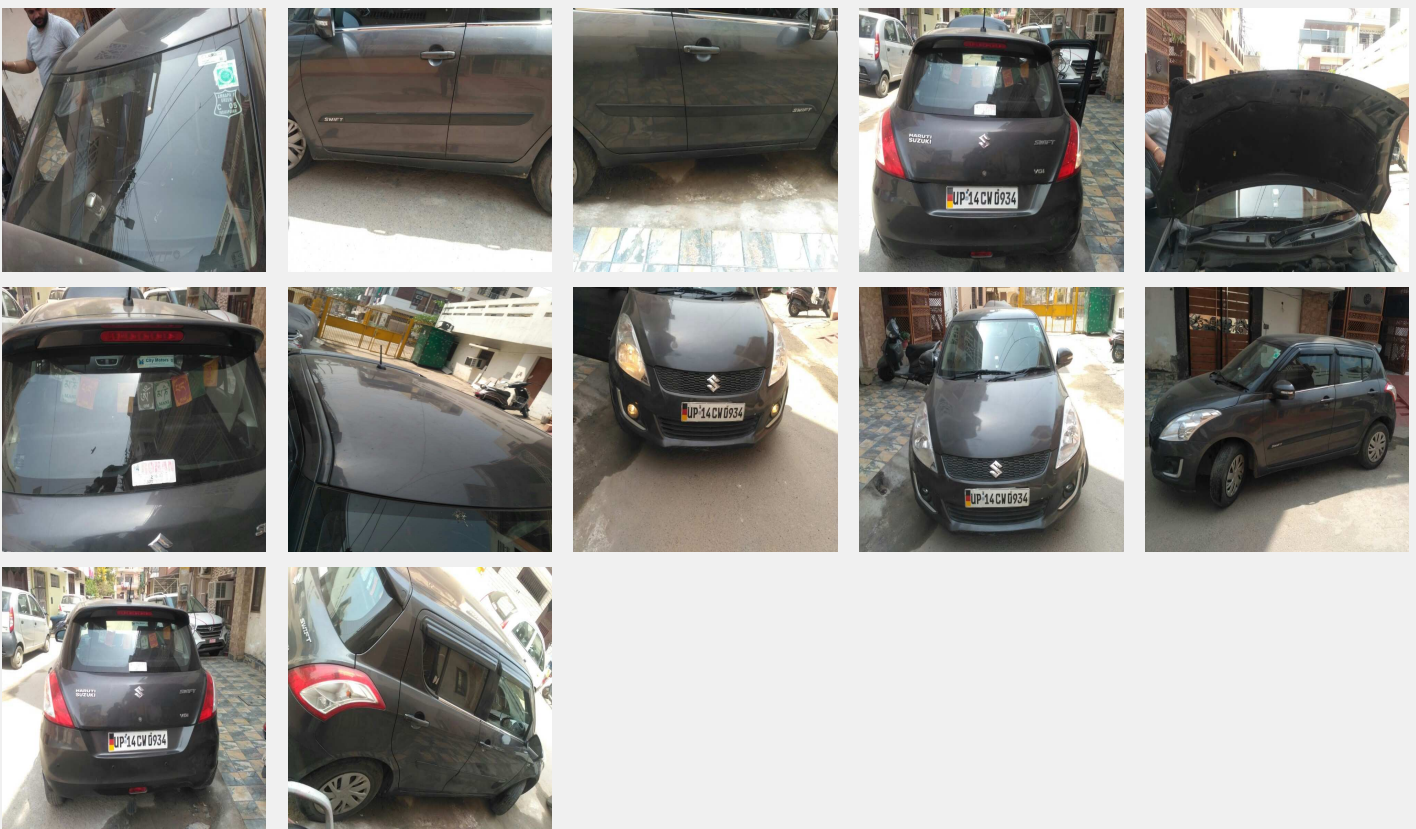
INSPECTION CHECKPOINTS	SCORE(X/10)	REMARKS/COMMENTS	OPTIONAL SPEND EST. (RS)
BODY RUST	7	GOOD CONDITION	0
ROOF (REGULAR)	7	GOOD CONDITION	0
PAINT CONDITION	7	GOOD CONDITION	0
FRONT BUMPER	5	FRONT BUMPER BROKEN NEED TO BE REPAIR	2000
HEAD LIGHTS	5	RIGHT HEAD LAMP BROKEN NEED TO CHANGE	1200

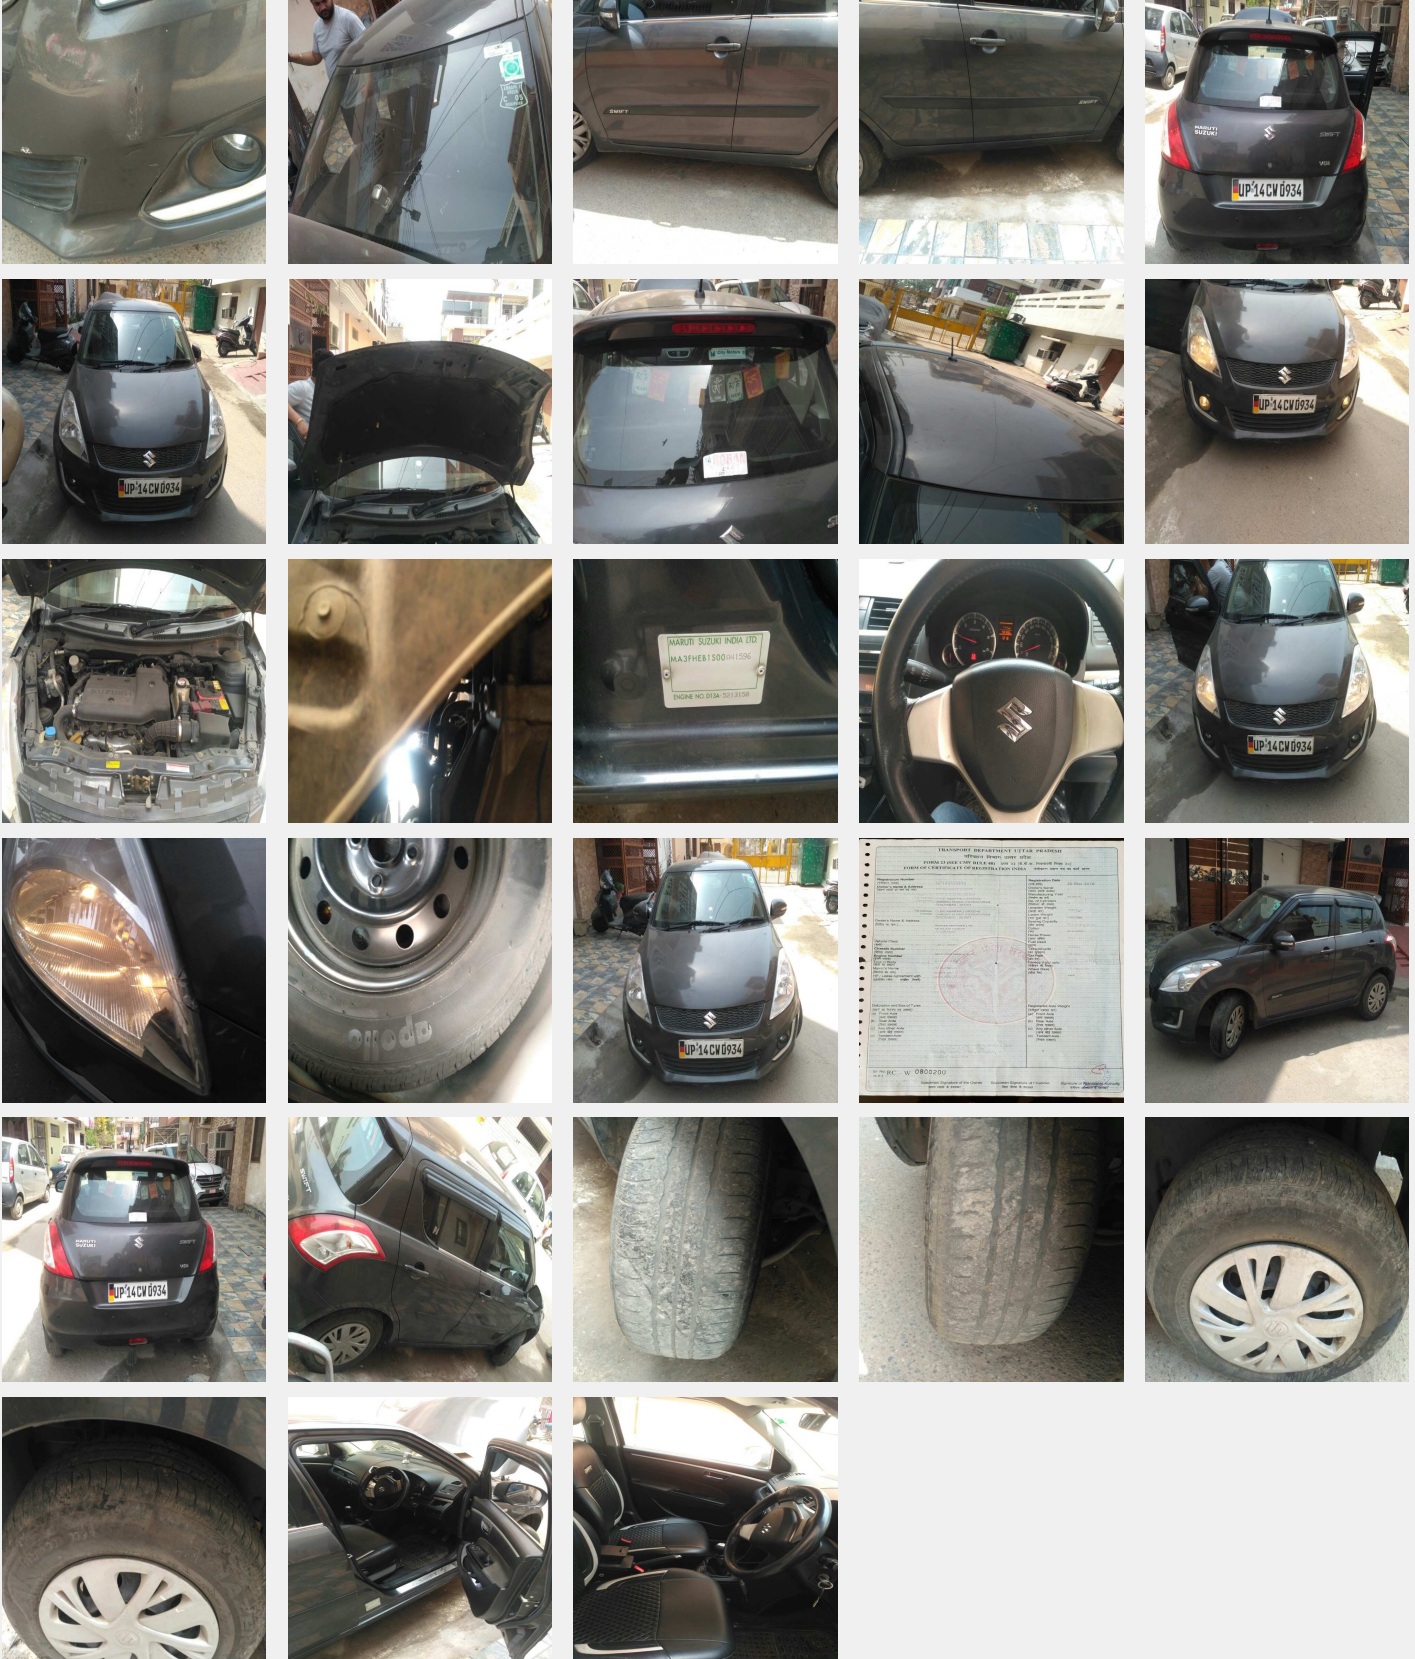
All body minor scratches and tyres warn out
