ECO INSPECTION CERTIFICATE

121 Points Vehicle Inspection Certificate

Maruti Suzuki Swift LDI, 2012

MAKE	MARUTI SUZUKI	TRANSMISSION TYPE	MANUAL
MODEL	SWIFT	REGISTRATION NO.	GJ01KP5716
YEAR	2012	VIN/CHASIS NUMBER	MA3FHEB1S0019644
TRIM	LDI	KMS RUN	82390
COLOR	RED	INSURANCE EXPIRY	2019-3-30
BODY TYPE	HATCHBACK	LOCATION	AHMEDABAD
FUEL TYPE	DIESEL	ENGINE SOUND LINK	LISTEN ENGINE SOUND

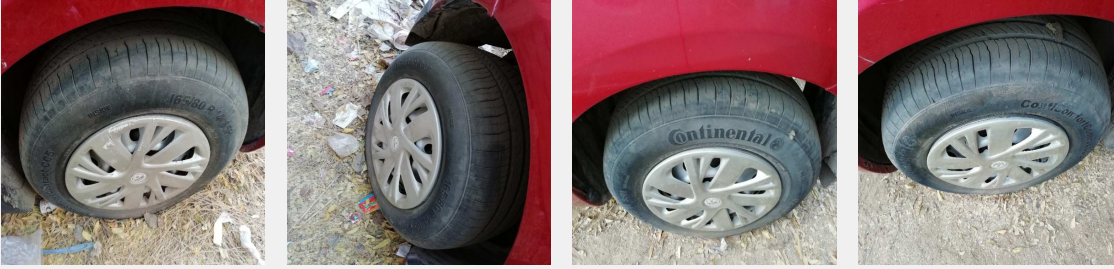
IMAGES

INSPECTION CHECKPOINTS	SCORE(X/10)	REMARKS/COMMENTS	OPTIONAL SPEND EST. (RS)
TYRES	6	NEUTRAL CONDITION	0
SPARE TYRE (YES)	7	GOOD CONDITION	0
WHEEL ASSEMBLY (STEEL RIM)	8	GOOD CONDITION	0

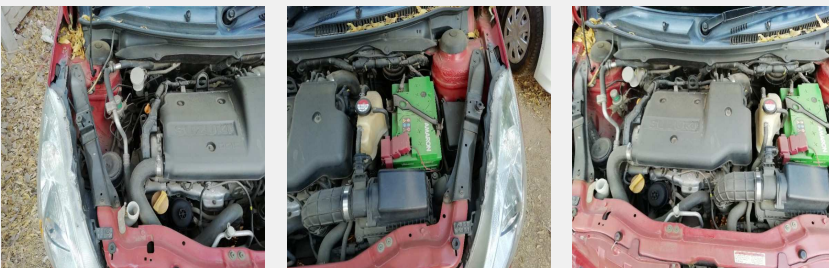
IMAGES

INSPECTION CHECKPOINTS	SCORE(X/10)	REMARKS/COMMENTS	OPTIONAL SPEND EST. (RS)
LH APRON	7	GOOD CONDITION	0
RH APRON	7	GOOD CONDITION	0
RADIATOR	7	GOOD CONDITION	0
WIRING	7	GOOD CONDITION	0
BATTERY	7	GOOD CONDITION	0
BRAKE FLUID LEVEL	7	GOOD CONDITION	0
ENGINE OIL	7	GOOD CONDITION	0
COOLANT LEVEL	7	GOOD CONDITION	0
BRAKE & COOLANT HOSE PIPES	7	GOOD CONDITION	0
UNDERCARRIAGE	7	GOOD CONDITION	0
EXHAUST SYSTEM	7	GOOD CONDITION	0
