# ECO INSPECTION CERTIFICATE

Order ID : 53368

121 Points Vehicle Inspection Certificate

## Maruti Suzuki Swift LDI, 2012

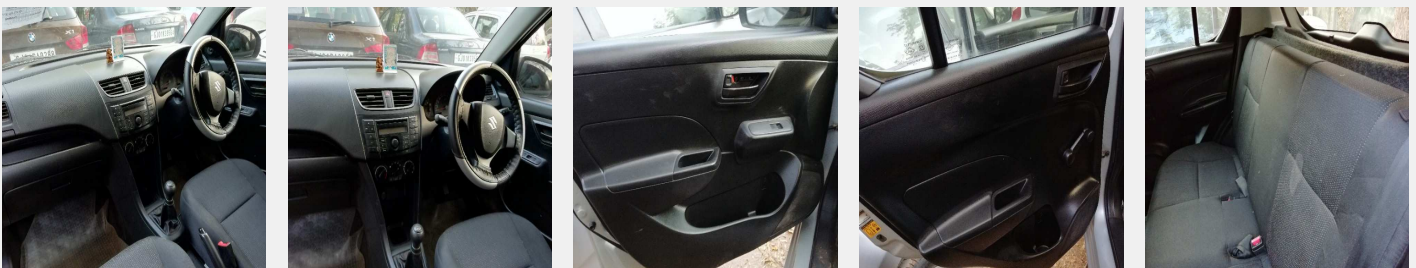
## IMAGES

INSPECTION CHECKPOINTS	SCORE(X/10)	REMARKS/COMMENTS	OPTIONAL SPEND EST. (RS)
DOOR PANEL	8	GOOD CONDITION	0
DOOR HINGES	8	GOOD CONDITION	0
CARPET & FLOOR MAT	8	GOOD CONDITION	0
SEAT & SEAT BELT	8	GOOD CONDITION	0
DASHBOARD & INSTRUMENT PANEL	8	GOOD CONDITION	0
HORN	8	GOOD CONDITION	0
SPEAKERS & MUSIC SYSTEM	8	GOOD CONDITION	0
HANDBRAKE	8	GOOD CONDITION	0
STEERING-MOUNTED CONTROLS	8	GOOD CONDITION	0
PEDALS	8	GOOD CONDITION	0
CENTRAL LOCK	8	GOOD CONDITION	0
A/C VENTS & HEATER	8	GOOD CONDITION	0
CUP HOLDERS	8	GOOD CONDITION	0
NAVIGATION (NO)	10		0
ODOMETER	8	GOOD CONDITION	0
POWER WINDOWS (YES - FRONT ONLY)	8	GOOD CONDITION	0
HAZARD LIGHT	8	GOOD CONDITION	0

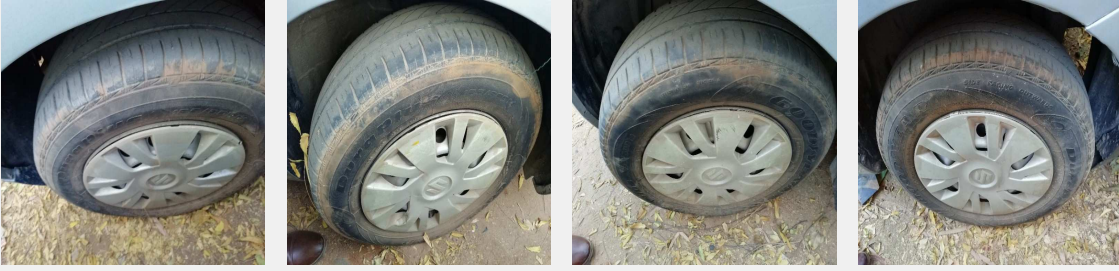
IMAGES

INSPECTION CHECKPOINTS	SCORE(X/10)	REMARKS/COMMENTS	OPTIONAL SPEND EST. (RS)
TYRES	6	NEUTRAL CONDITION	0
SPARE TYRE (YES)	7	GOOD CONDITION	0
WHEEL ASSEMBLY (STEEL RIM)	7	GOOD CONDITION	0

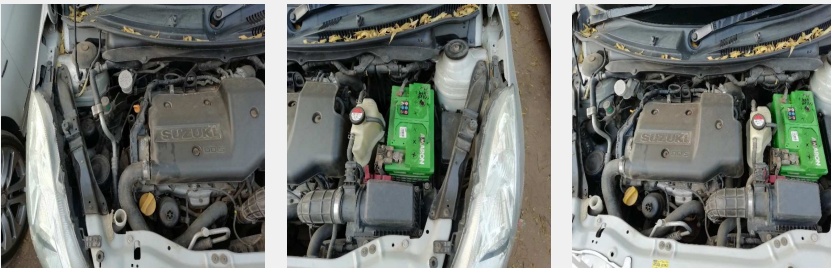
IMAGES

INSPECTION CHECKPOINTS	SCORE(X/10)	REMARKS/COMMENTS	OPTIONAL SPEND EST. (RS)
LH APRON	8	GOOD CONDITION	0
RH APRON	8	GOOD CONDITION	0
RADIATOR	7	GOOD CONDITION	0
WIRING	7	GOOD CONDITION	0
BATTERY	7	GOOD CONDITION	0
BRAKE FLUID LEVEL	7	GOOD CONDITION	0
ENGINE OIL	7	GOOD CONDITION	0
COOLANT LEVEL	7	GOOD CONDITION	0
BRAKE & COOLANT HOSE PIPES	7	GOOD CONDITION	0
UNDERCARRIAGE	7	GOOD CONDITION	0
EXHAUST SYSTEM	7	GOOD CONDITION	0
