# ECO INSPECTION CERTIFICATE

121 Points Vehicle Inspection Certificate

## Hyundai I10 ERA, 2013

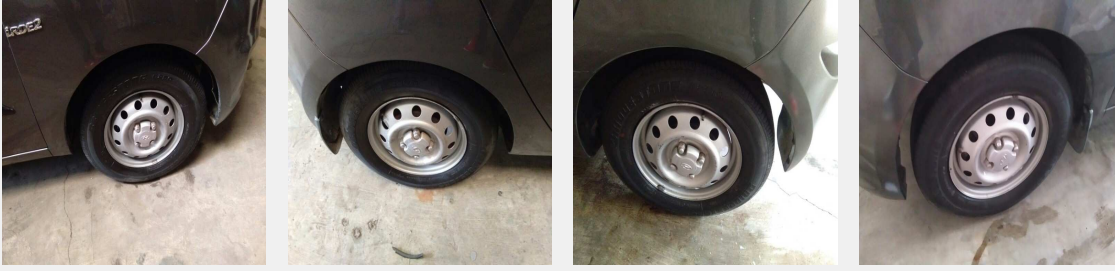
INSPECTION CHECKPOINTS	SCORE(X/10)	REMARKS/COMMENTS	OPTIONAL SPEND EST. (RS)
TYRES	6		0
WHEEL ASSEMBLY (STEEL RIM)	6		0
SPARE TYRE (YES)	3	DAMEGE	3000

**NEED ATTENTION** ⚠️
