ECO INSPECTION CERTIFICATE

Order ID : 57860

121 Points Vehicle Inspection Certificate

Maruti Suzuki Sx4 VDI, 2014

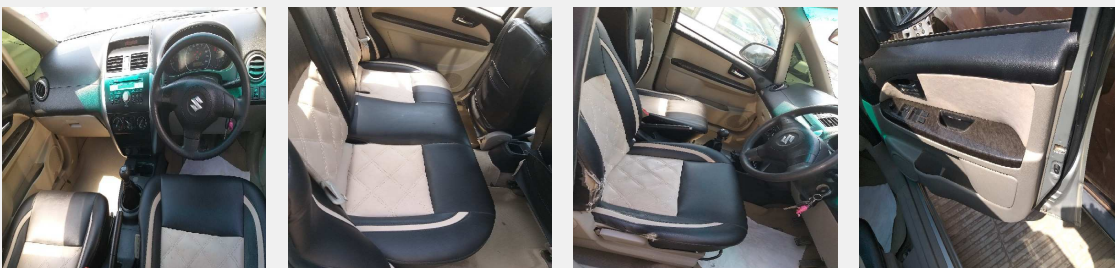
IMAGES

INSPECTION CHECKPOINTS	SCORE(X/10)	REMARKS/COMMENTS	OPTIONAL SPEND EST. (RS)
DOOR PANEL	6	FAIR	0
DOOR HINGES	6	FAIR	0
CARPET & FLOOR MAT	6	FAIR	0
SEAT & SEAT BELT	6	DRIVER SIDE SEAT COVER MAJOR CUT	2500
DASHBOARD & INSTRUMENT PANEL	6	FAIR	0
HORN	6	FAIR	0
SPEAKERS & MUSIC SYSTEM	6	FAIR	0
HANDBRAKE	6	FAIR	0
STEERING-MOUNTED CONTROLS	6	FAIR	0
PEDALS	6	FAIR	0
CENTRAL LOCK	6	FAIR	0
A/C VENTS & HEATER	6	FAIR	0
CUP HOLDERS	6	FAIR	0
NAVIGATION (NO)	10		0
ODOMETER	6	FAIR	0
POWER WINDOWS (YES)	6	FAIR	0
HAZARD LIGHT	6	FAIR	0

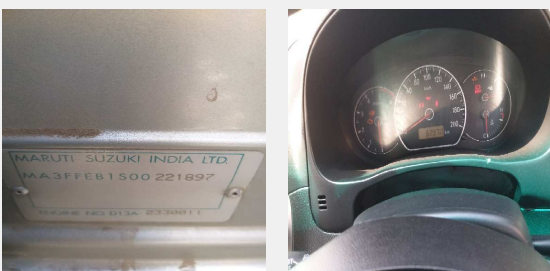
IMAGES

INSPECTION CHECKPOINTS	SCORE(X/10)	REMARKS/COMMENTS	OPTIONAL SPEND EST. (RS)
STEERING PERFORMANCE	6	FAIR	0
BRAKE PERFORMANCE	6	FAIR	0
CLUTCH PERFORMANCE	6	FAIR	0
ENGINE NOISE	6	FAIR	0
IGNITION SYSTEM	6	FAIR	0
SUSPENSION PERFORMANCE	6	FAIR	0
SUSPENSION FRONT SHOCKS	6	FAIR	0
SUSPENSION REAR SHOCKS	6	FAIR	0
TRANSMISSION ENGAGE	6	FAIR	0
CRUISE CONTROL (NO)	10		0
REAR PARKING SENSORS (NO)	10		0
REAR VIEW CAMERA (NO)	10		0

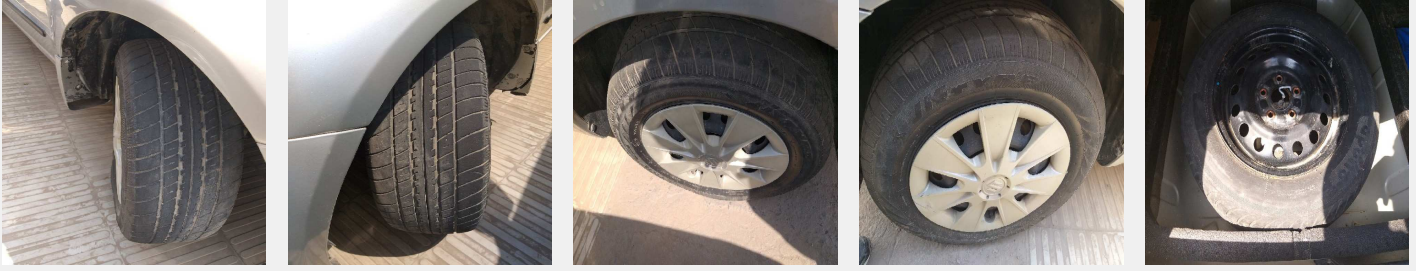
IMAGES

INSPECTION CHECKPOINTS	SCORE(X/10)	REMARKS/COMMENTS	OPTIONAL SPEND EST. (RS)
TYRES	6	FAIR	0
SPARE TYRE (YES)	6	FAIR	0
WHEEL ASSEMBLY (STEEL RIM)	6	FAIR	0

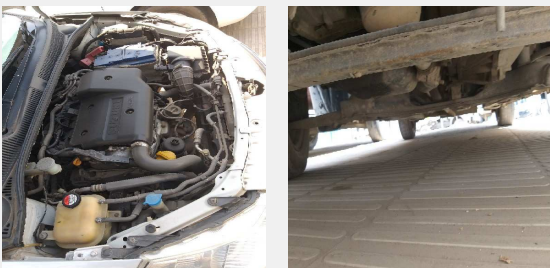
IMAGES

INSPECTION CHECKPOINTS	SCORE(X/10)	REMARKS/COMMENTS	OPTIONAL SPEND EST. (RS)
LH APRON	6	FAIR	0
RH APRON	6	FAIR	0
RADIATOR	6	FAIR	0
WIRING	6	FAIR	0
BATTERY	6	FAIR	0
BRAKE FLUID LEVEL	6	FAIR	0
ENGINE OIL	6	FAIR	0
COOLANT LEVEL	6	FAIR	0
BRAKE & COOLANT HOSE PIPES	6	FAIR	0
UNDERCARRIAGE	6	FAIR	0
EXHAUST SYSTEM	6	FAIR	0

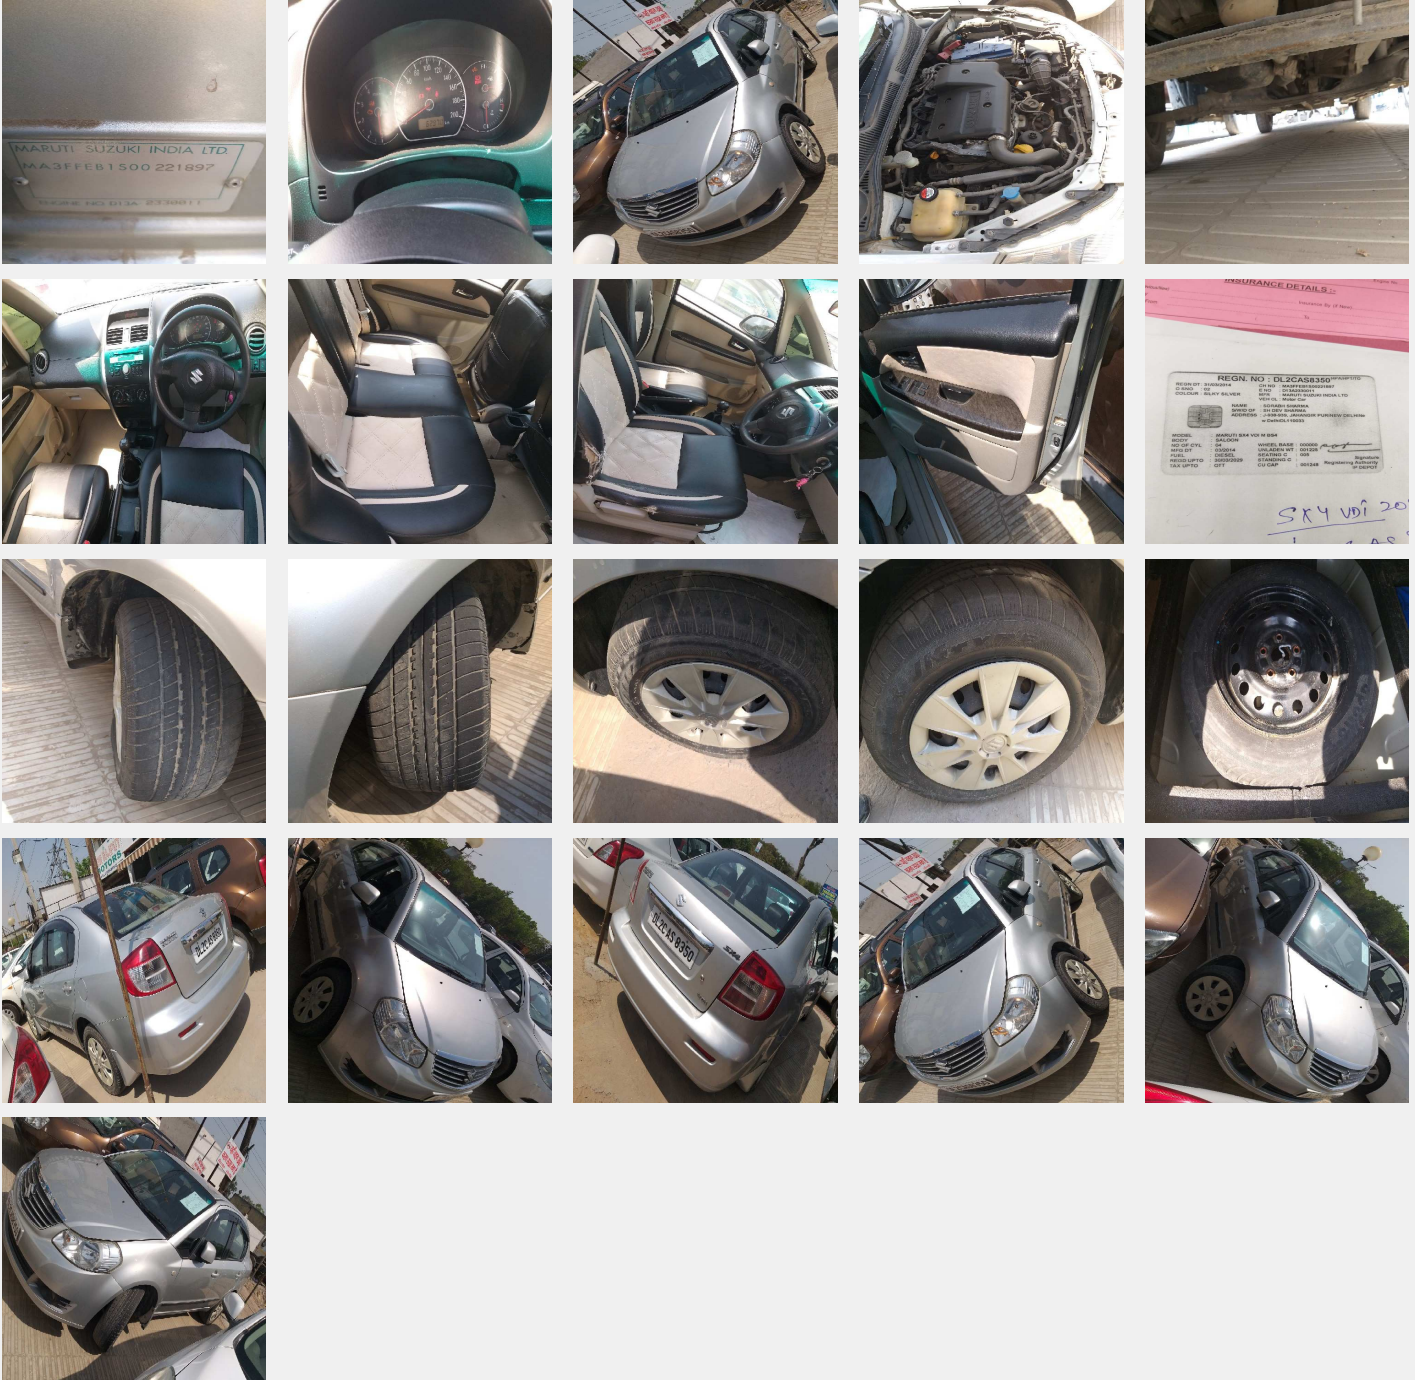
IMAGES

INSPECTION CHECKPOINTS	SCORE(X/10)	REMARKS/COMMENTS	OPTIONAL SPEND EST. (RS)
LICENSE PLATE	6	FAIR	0
FRONT BUMPER	6	PAINTED	0
HEAD LIGHTS	6	FAIR	0
GRILLE	6	FAIR	0
TURN SIGNAL	6	FAIR	0
FOG LAMPS	6	FAIR	0
HOOD	6	PAINTED	0
PILLAR	6	FAIR	0
FRONT WINDSHIELD	6	FAIR	0
SIDE VIEW MIRRORS	6	FAIR	0
LH FENDER	6	PAINTED	0
LH FRONT DOOR	6	PAINTED.	0
LH REAR DOOR	6	PAINTED	0
LH RUNNING BOARD	6	PAINTED	0
LH QUARTER PANEL	6	PAINTED	0
FUEL LID	6	FAIR	0
REAR WINDSHIELD	6	FAIR	0
REAR BUMPER	6	PAINTED	0
TAIL LIGHT	6	PAINTED	0
TRUNK LID/TAIL GATE	6	FAIR	0
LUGGAGE COMPARTMENT LIGHT	6	FAIR	0
RH QUARTER PANEL	6	PAINTED	0
RH RUNNING BOARD	6	SCRATCH	0
RH REAR DOOR	6	PAINTED	0

INSPECTION CHECKPOINTS	SCORE(X/10)	REMARKS/COMMENTS	OPTIONAL SPEND EST. (RS)
RH FRONT DOOR	6	PAINTED.	0
RH FENDER	6	PAINTED	0
BODY RUST	6	MINOR	0
ROOF (REGULAR)	6	FAIR	0
PAINT CONDITION	6	FAIR	0

fair condition ,, minor scratch,, interior and exterior major dirty
