ECO INSPECTION CERTIFICATE

121 Points Vehicle Inspection Certificate

Mitsubishi Lancer LXI 1.5, 2004

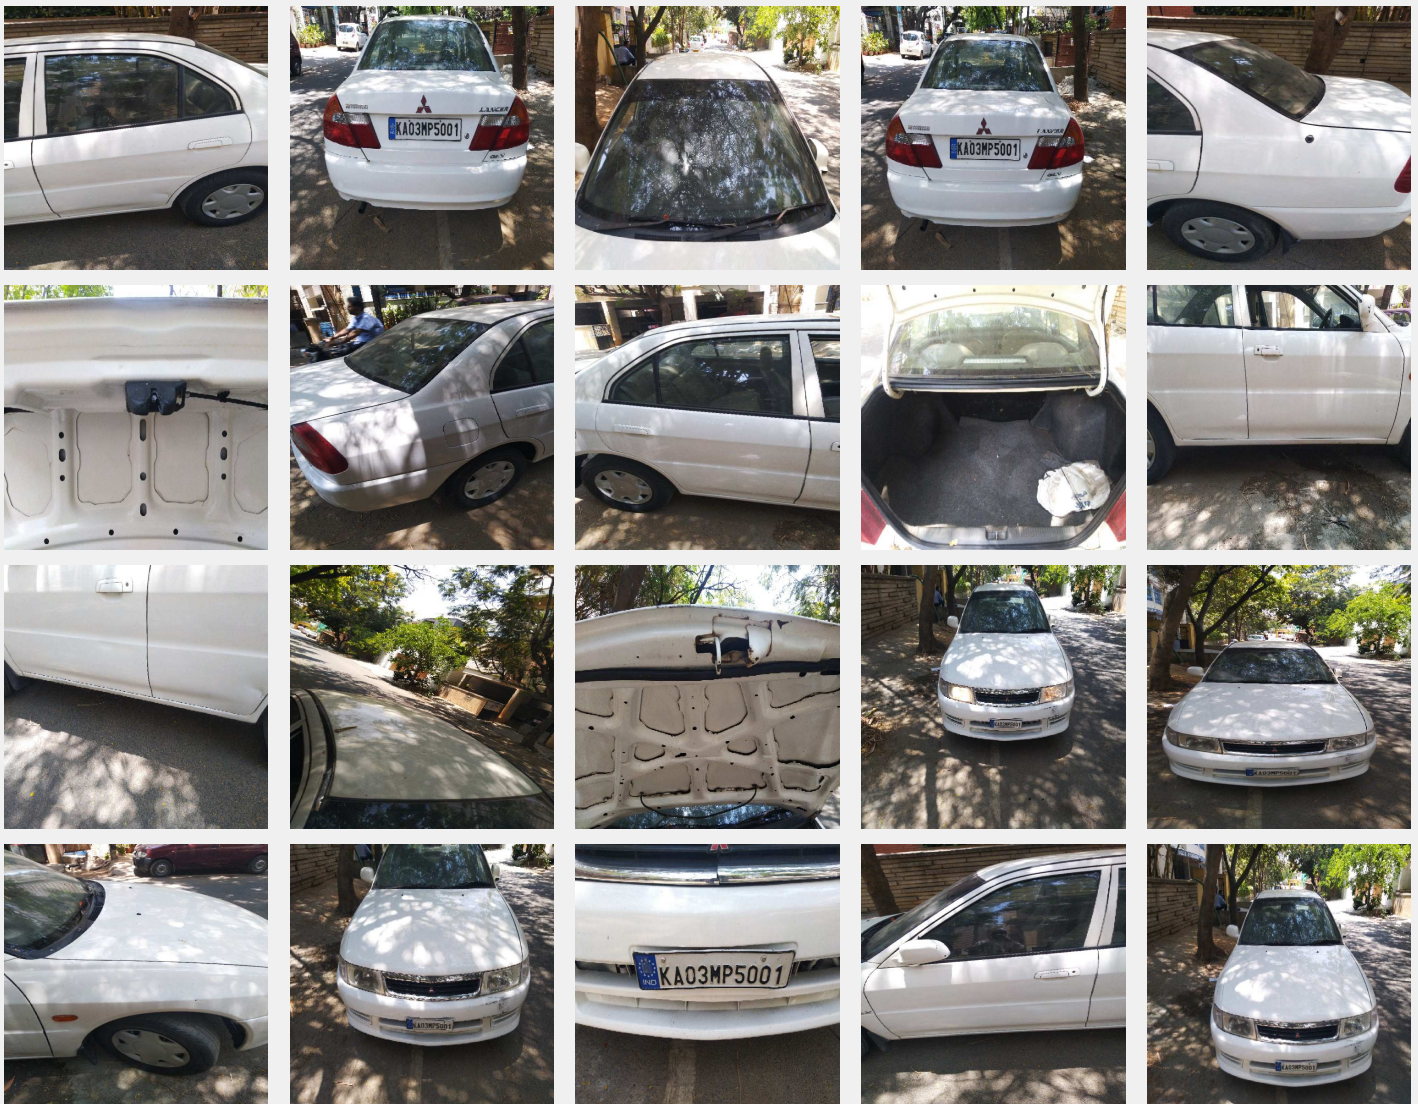
IMAGES

INSPECTION CHECKPOINTS	SCORE(X/10)	REMARKS/COMMENTS	OPTIONAL SPEND EST. (RS)
BODY RUST	6		0
ROOF (REGULAR)	6		0
PAINT CONDITION	6		0
GRILLE	2	BROKEN	1200
FOG LAMPS	0	NO FOG LAMPS	2500

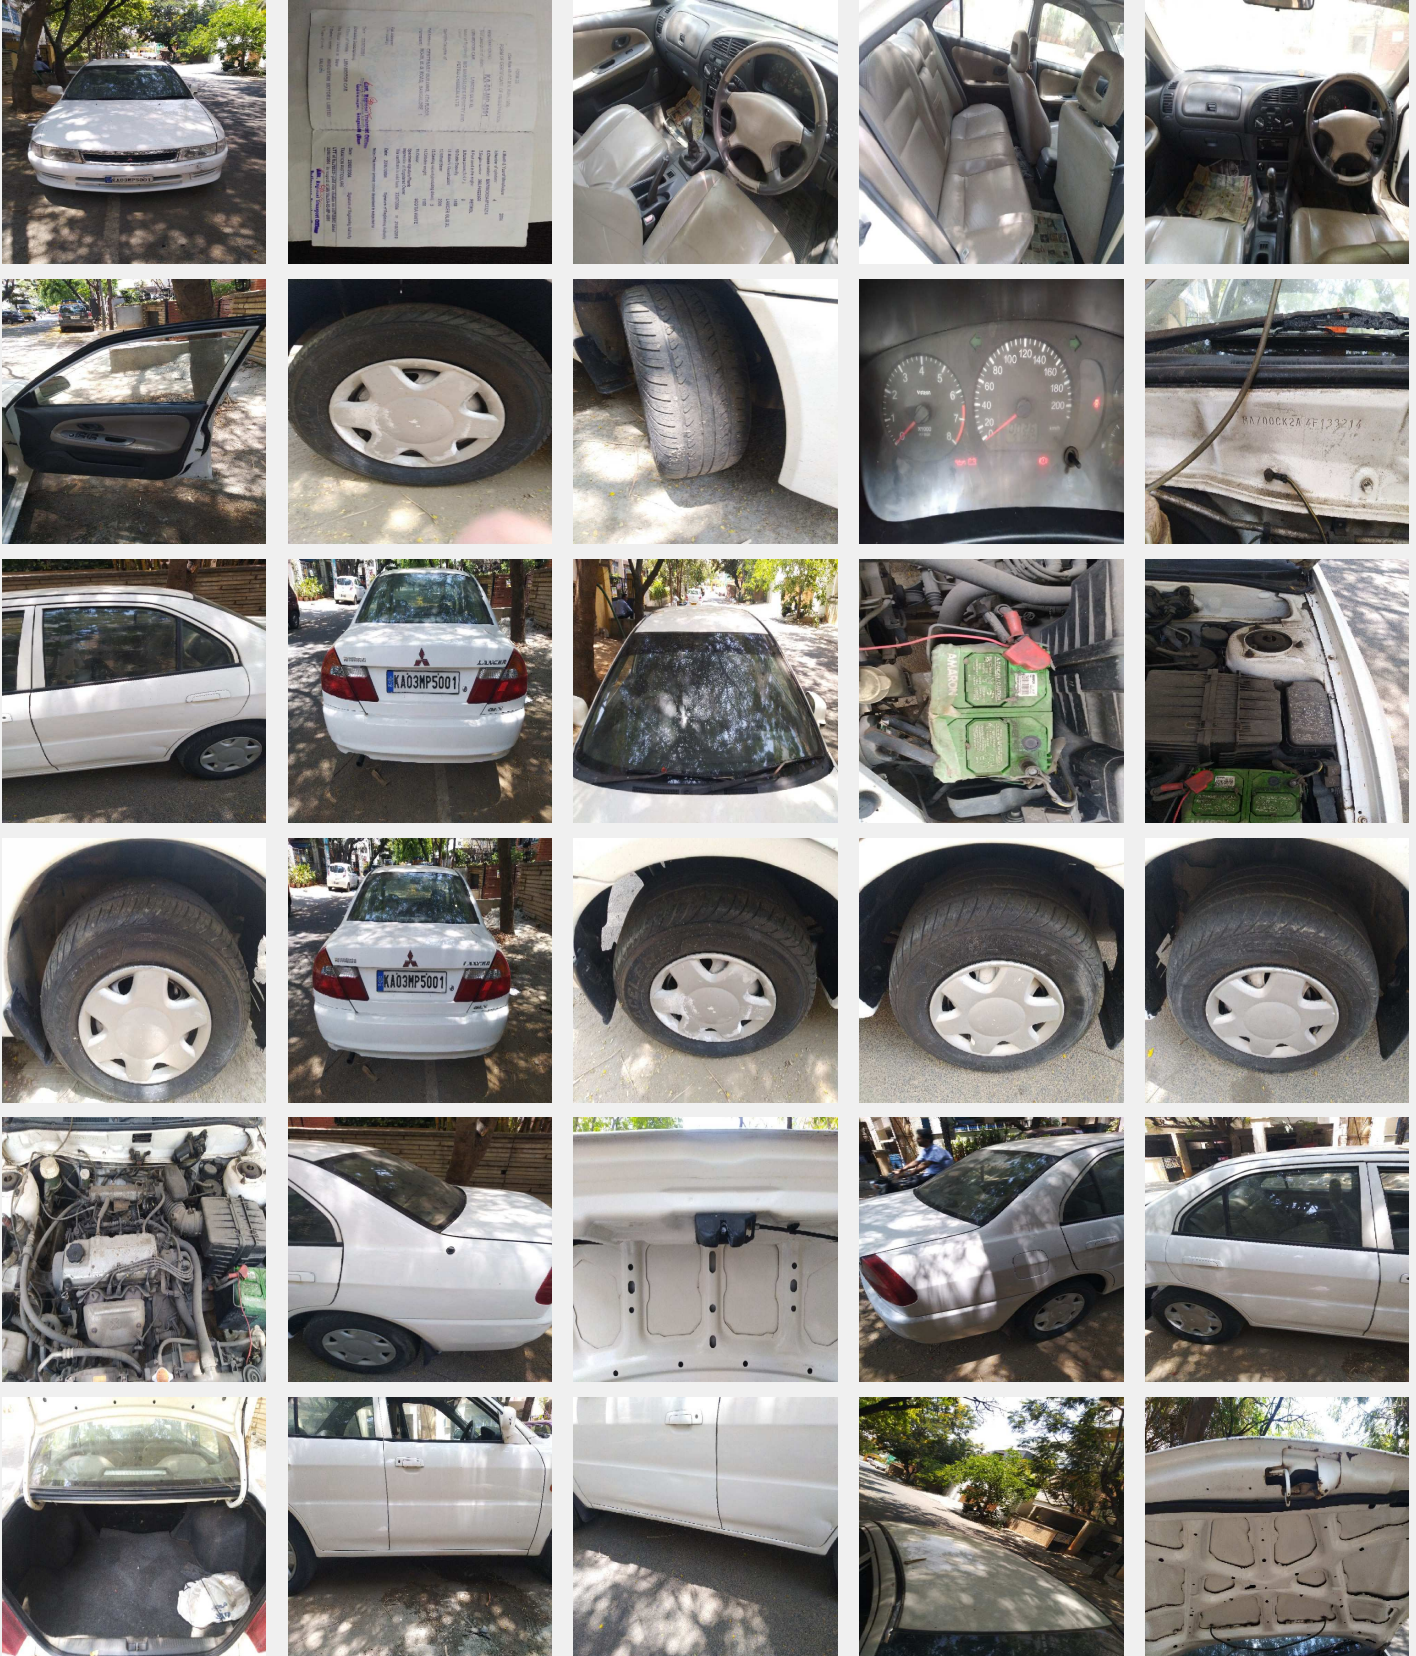
vehicle is good condition silencer leakage and tires week small small scratches
