# ECO INSPECTION CERTIFICATE

Order ID : 58820

121 Points Vehicle Inspection Certificate

## Yamaha Fz25 250CC, 2017

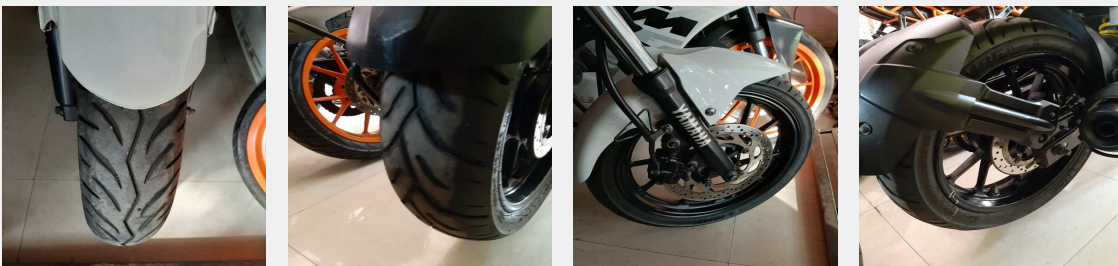
## TYRE

INSPECTION CHECKPOINTS	SCORE(X/10)	REMARKS/COMMENTS	OPTIONAL SPEND EST. (RS)
FRONT TYRE CONDITION & AIR PRESSURE	7	GOOD TREAD & PROPER	0
REAR TYRE CONDITION & AIR PRESSURE	7	GOOD TREAD & PROPER	0
WHEEL SPOKES FRONT	7	GOOD	0
WHEEL SPOKES REAR	7	GOOD	0
WHEEL RIM FRONT	7	NO WEAR & TEAR	0
WHEEL RIM REAR	7	NO WEAR & TEAR	0
WHEEL BEARINGS FRONT	7	WORKING	0
WHEEL BEARINGS REAR	7	WORKING	0
WHEEL SEALS FRONT	7	PROPER	0
WHEEL SEALS REAR	7	PROPER	0
BRAKE FUNCTION FRONT	7	GOOD BRAKE	0
BRAKE FUNCTION REAR	7	GOOD BRAKE	0
BRAKES CONDITION FRONT	7	GOOD	0
BRAKES CONDITION REAR	7	GOOD	0

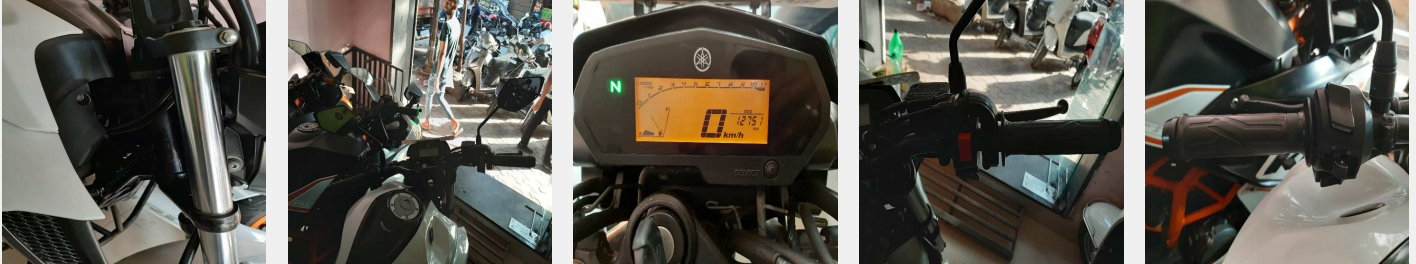
## CONTROL

INSPECTION CHECKPOINTS	SCORE(X/10)	REMARKS/COMMENTS	OPTIONAL SPEND EST. (RS)
HANDLEBARS CONDITION	7	GOOD CONDITION	0
LEVERS & PEDAL CONDITION	7	GOOD	0
PIVOTS	7	WORKING	0
CABLES CONDITION	7	GOOD	0
CABLES ROUTING	7	PROPER	0
HOSES CONDITION	7	GOOD	0
HOSES ROUTING	7	PROPER	0
THROTTLE OPERATION	7	NORMAL	0

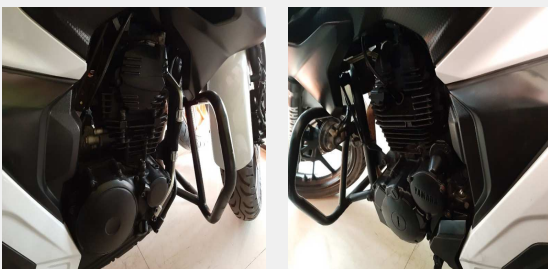
## OIL

INSPECTION CHECKPOINTS	SCORE(X/10)	REMARKS/COMMENTS	OPTIONAL SPEND EST. (RS)
LEVELS - ENGINE OIL	6	MORE THEN MINIMUM LEVEL	0
LEVELS - GEAR OIL/SHAFT DRIVE (YES)	6	MORE THEN MINIMUM LEVEL	0
LEVELS - HYDRAULIC FLUID (YES)	7	MAX LEVEL	0
LEVELS - COOLANT (NO)	10		0
LEVELS - FUEL	6	MORE THEN MINIMUM LEVEL	0
LEAKS - ENGINE OIL	7	NO LEAKAGE	0
LEAKS - GEAR OIL	7	NO LEAKAGE	0
LEAKS - HYDRAULIC FLUID	7	NO LEAKAGE	0
LEAKS - FUEL	7	NO LEAKAGE	0
LEAKS - COOLANT	5	NA	0

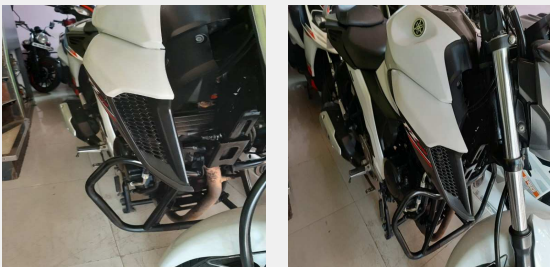
## CHASSIS

INSPECTION CHECKPOINTS	SCORE(X/10)	REMARKS/COMMENTS	OPTIONAL SPEND EST. (RS)
FRAME CONDITION	7	GOOD CONDITION	0
FRAME STEERING-HEAD BEARINGS	7	NO DAMAGE	0
FRAME SWINGARM BUSHINGS	7	NO DAMAGE	0
SUSPENSION FRONT FORKS LEFT	7	WORKING	0
SUSPENSION FRONT FORKS RIGHT	7	WORKING	0
SUSPENSION REAR SHOCKS LEFT	7	WORKING	0
SUSPENSION REAR SHOCKS RIGHT	7	WORKING	0
CHAIN/BELT TENSION	7	CHAIN TENSION	0
CHAIN/BELT LUBRICATION	7	GOOD LUBRICATION	0
CHAIN/BELT SPROCKETS	7	CHAIN SPROCKET	0
FASTENERS THREADED	7	GOOD THREADED	0
FASTENERS CLIPS & COTTER PINS	7	PROPER FIX	0
ENGINE	7	MINIMUM NOISE	0
TRANSMISSION	7	SMOOTH GEAR SHIFTING	0
