ECO INSPECTION CERTIFICATE

Order ID : 59065

121 Points Vehicle Inspection Certificate

Skoda Rapid 1.6 Tdi Mt Active, 2014

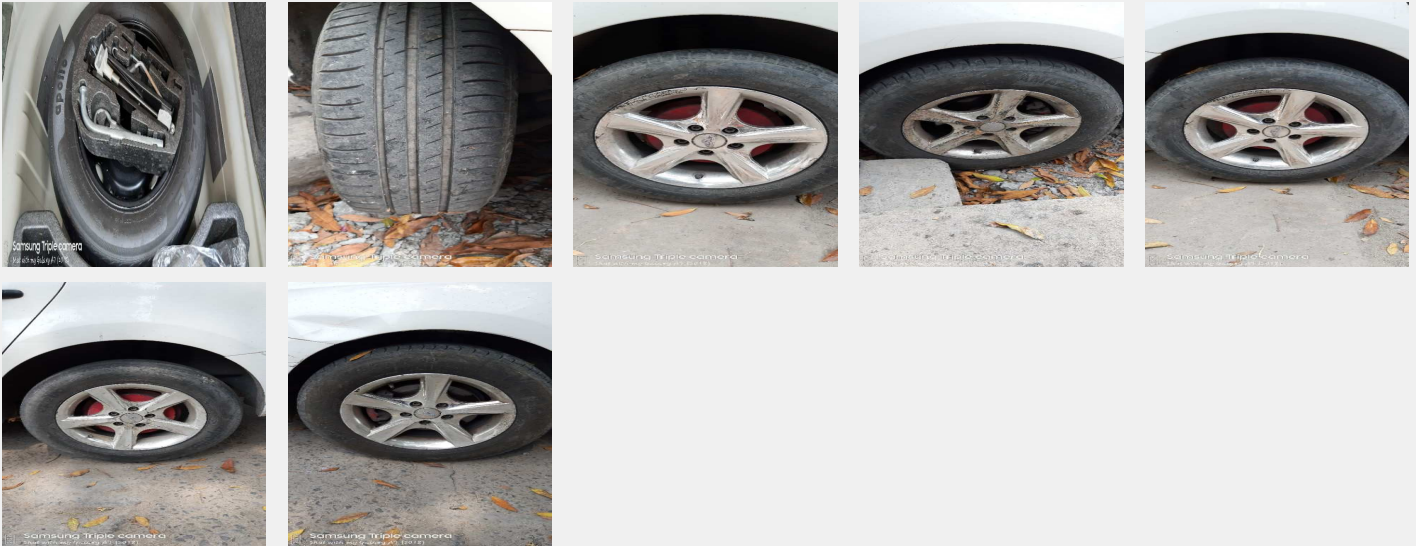
INSPECTION CHECKPOINTS	SCORE(X/10)	REMARKS/COMMENTS	OPTIONAL SPEND EST. (RS)
TYRES	7	GOOD	0
SPARE TYRE (YES)	7	GOO	0
WHEEL ASSEMBLY (ALLOY RIM)	7	GOOD	0

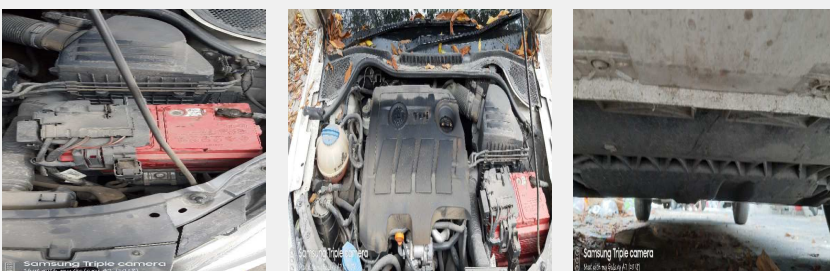
INSPECTION CHECKPOINTS	SCORE(X/10)	REMARKS/COMMENTS	OPTIONAL SPEND EST. (RS)
LH APRON	7	GOOD	0
RH APRON	7	GOOD	0
RADIATOR	7	GOOD	0
WIRING	7	GOOD	0
BATTERY	7	GOOD	0
BRAKE FLUID LEVEL	7	GOOD	0
ENGINE OIL	7	GOOD	0
COOLANT LEVEL	7	GOOD	0
BRAKE & COOLANT HOSE PIPES	7	GOOD	0
UNDERCARRIAGE	7	GOOD	0
EXHAUST SYSTEM	7	GOOD	0

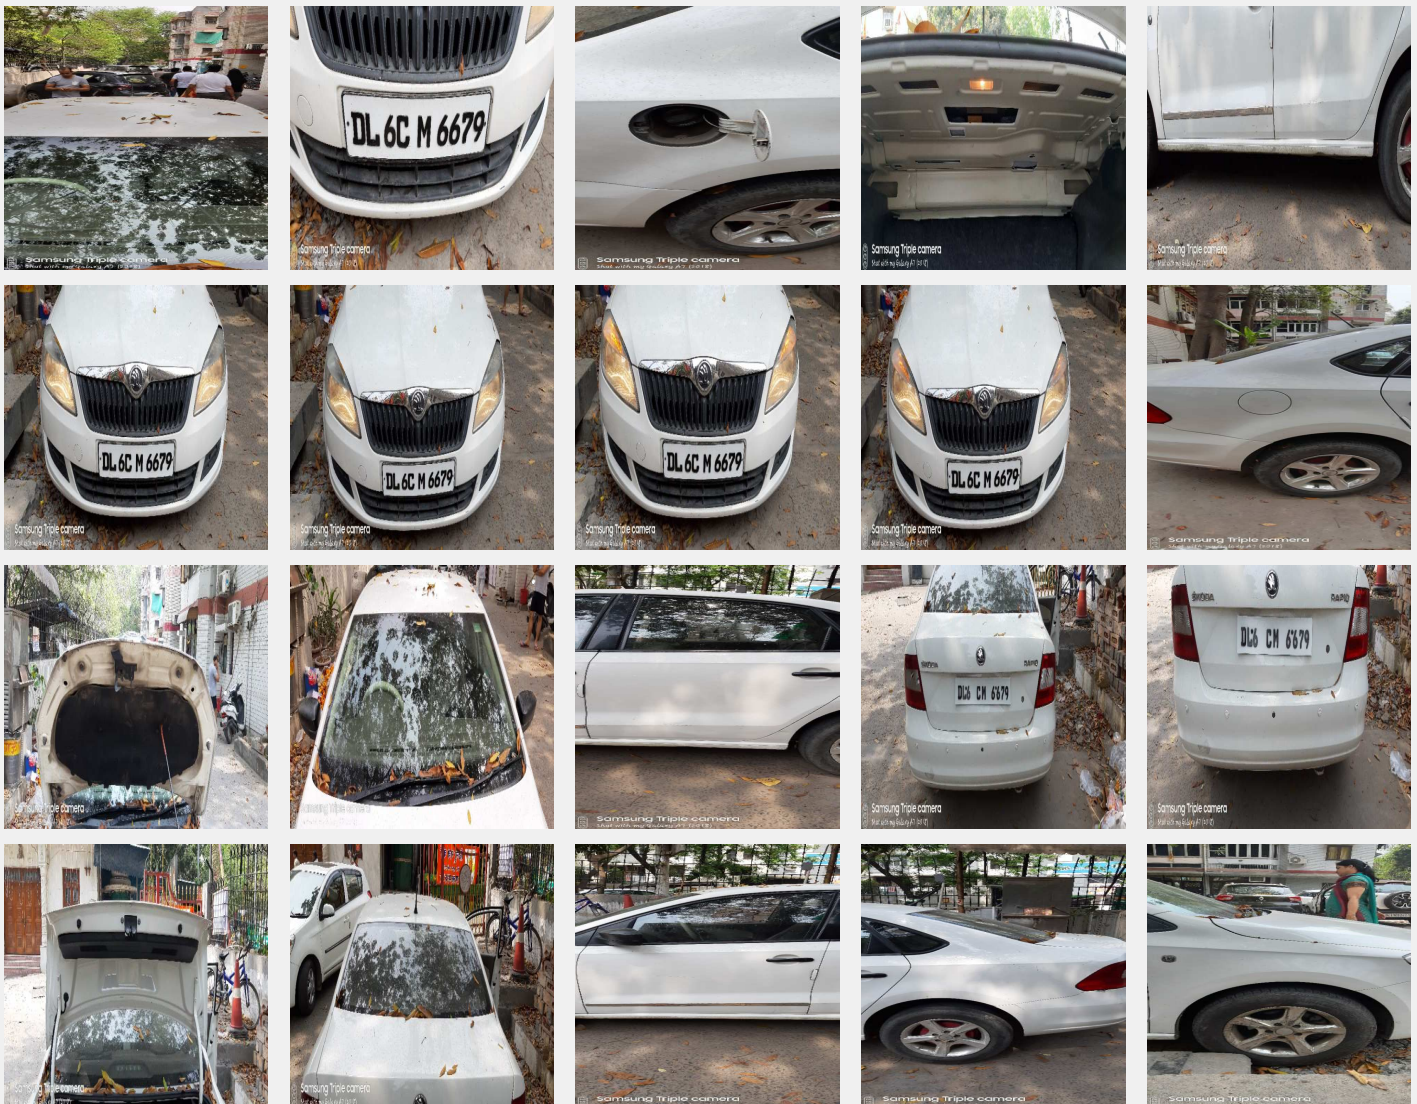
INSPECTION CHECKPOINTS	SCORE(X/10)	REMARKS/COMMENTS	OPTIONAL SPEND EST. (RS)
BODY RUST	7	GOOD	0
ROOF (REGULAR)	7	GOOD	0
PAINT CONDITION	7	GOOD	0
FOG LAMPS	0	NA	0
LH FENDER	3	DENT NEED TO REPAIR	4000

left hand fender dent minor scratches in body minor scratches in doors
