ECO INSPECTION CERTIFICATE

Order ID : 61793

121 Points Vehicle Inspection Certificate

Yamaha Yzf-R15 2.0 150CC, 2013

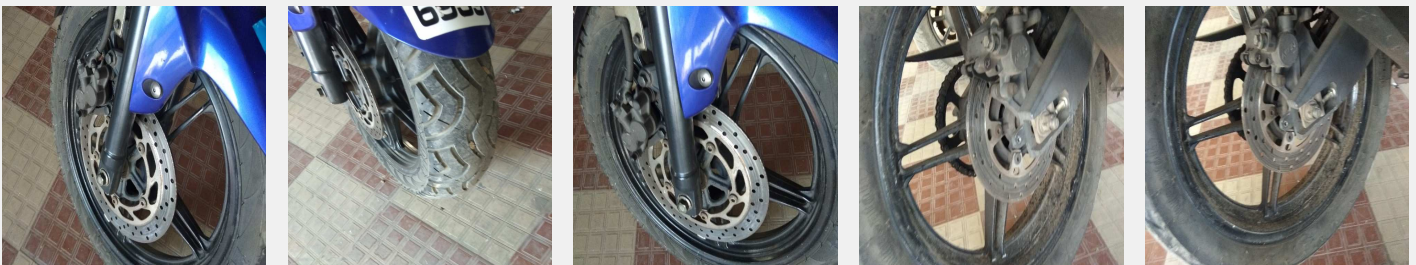
INSPECTION CHECKPOINTS	SCORE(X/10)	REMARKS/COMMENTS	OPTIONAL SPEND EST. (RS)
FRONT TYRE CONDITION & AIR PRESSURE	6	OK	0
WHEEL SPOKES FRONT	6	OK	0
WHEEL SPOKES REAR	6	OK	0
WHEEL RIM FRONT	6	OK	0
WHEEL RIM REAR	6	OK	0
WHEEL BEARINGS FRONT	6	OK	0
WHEEL BEARINGS REAR	6	OK	0
WHEEL SEALS FRONT	6	OK	0
WHEEL SEALS REAR	6	OK	0
BRAKE FUNCTION FRONT	6	OK	0
BRAKE FUNCTION REAR	6	OK	0
BRAKES CONDITION FRONT	6	OK	0
BRAKES CONDITION REAR	7	OK	0
REAR TYRE CONDITION & AIR PRESSURE	5	OK	0

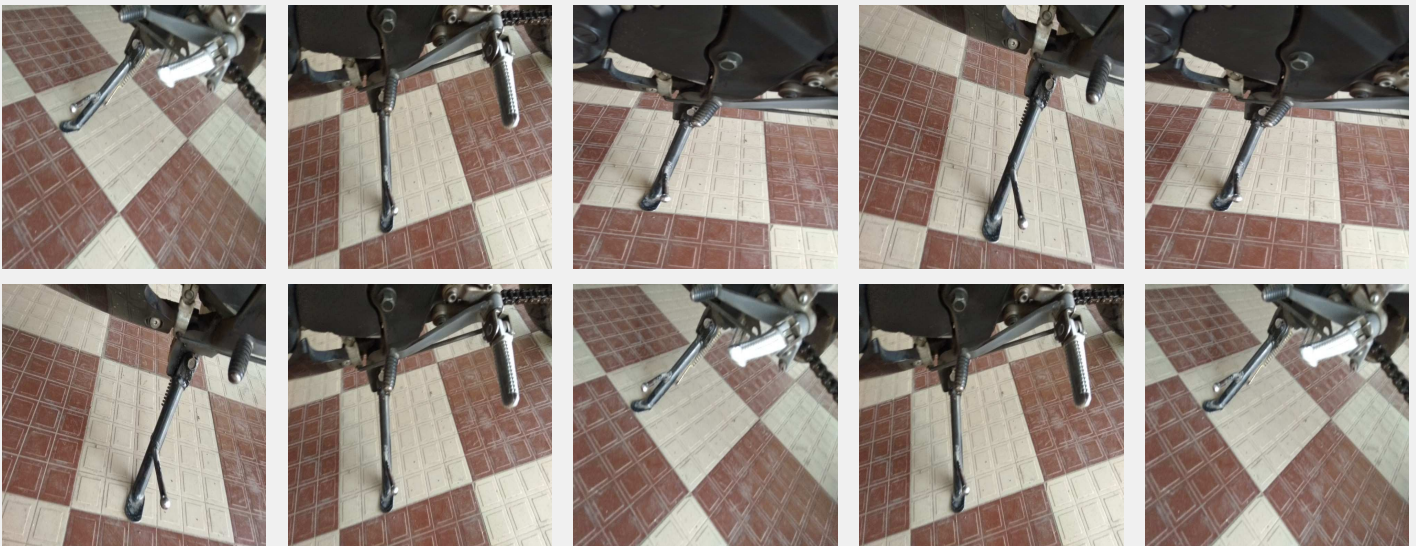
INSPECTION CHECKPOINTS	SCORE(X/10)	REMARKS/COMMENTS	OPTIONAL SPEND EST. (RS)
CENTRE STAND CONDITION	6	OK	0
CENTRE STAND RETENTION	6	OK	0
SIDE STAND CONDITION	6	GOOD	0
SIDE STAND RETENTION	7	OK	0

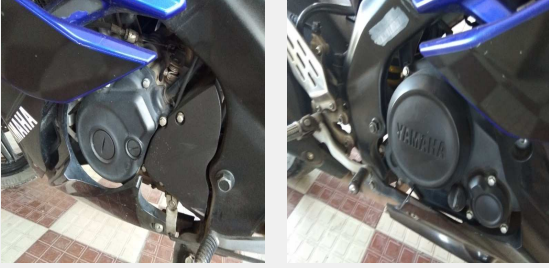
INSPECTION CHECKPOINTS	SCORE(X/10)	REMARKS/COMMENTS	OPTIONAL SPEND EST. (RS)
LEVELS - ENGINE OIL	7	OK	0
LEVELS - GEAR OIL/SHAFT DRIVE (NO)	10		0
LEVELS - HYDRAULIC FLUID (NO)	10		0
LEVELS - COOLANT (NO)	10		0
LEVELS - FUEL	7	GOOD	0
LEAKS - ENGINE OIL	7	NO LEAK	0
LEAKS - GEAR OIL	6	OK	0

LEAKS - HYDRAULIC FLUID	7	OK	0
LEAKS - COOLANT	7	OK	0
LEAKS - FUEL	6	NO LEAK OK	0

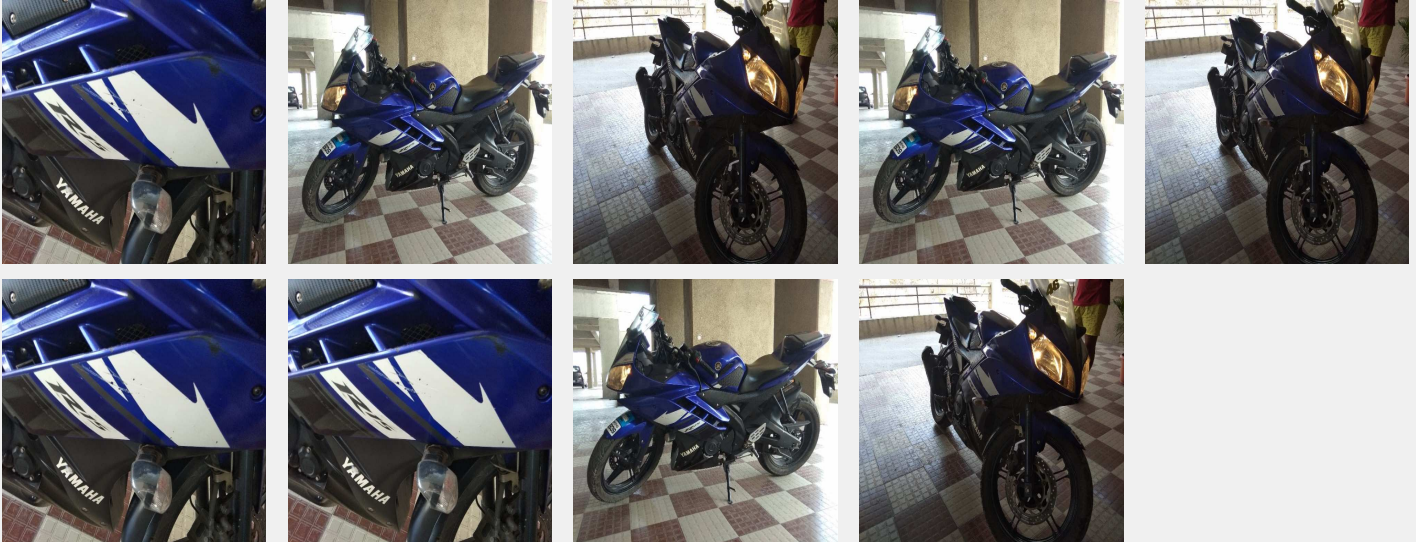
**CHASSIS**

INSPECTION CHECKPOINTS	SCORE(X/10)	REMARKS/COMMENTS	OPTIONAL SPEND EST. (RS)
FRAME CONDITION	6	SCRATCH	0
FRAME STEERING-HEAD BEARINGS	6	OK	0
FRAME SWINGARM BUSHINGS	6	OK	0
SUSPENSION FRONT FORKS LEFT	6	OK	0
SUSPENSION FRONT FORKS RIGHT	6	GOOD	0
SUSPENSION REAR SHOCKS LEFT	6	OK	0
SUSPENSION REAR SHOCKS RIGHT	7	GOOD	0
CHAIN/BELT TENSION	7	GOOD	0
CHAIN/BELT LUBRICATION	7	OK	0
CHAIN/BELT SPROCKETS	6	OK	0
FASTENERS THREADED	7	OK	0
FASTENERS CLIPS & COTTER PINS	6	OK	0
ENGINE	6	OK	0
TRANSMISSION	6	OK	0

regular use. running ok. little small scatch
