# ECO INSPECTION CERTIFICATE

121 Points Vehicle Inspection Certificate

Ordered By : Monika Sharma	Inspection Date : 2019-04-09	Valid Till : 2019-07-12
-------------------------------	---------------------------------	----------------------------

## Volkswagen Polo 1.2 TDI HIGHLINE, 2012

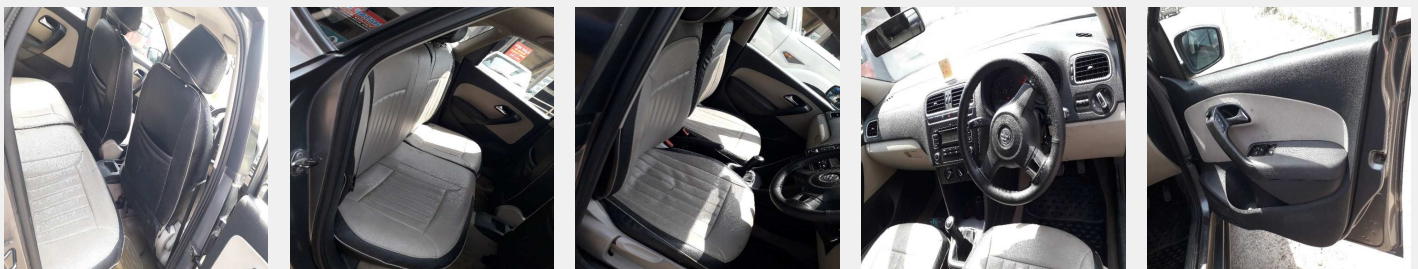
## INTERIOR

INSPECTION CHECKPOINTS	SCORE(X/10)	REMARKS/COMMENTS	OPTIONAL SPEND EST. (RS)
DOOR PANEL	7	GOOD	0
DOOR HINGES	7	GOOD	0
SEAT & SEAT BELT	7	GOOD	0
DASHBOARD & INSTRUMENT PANEL	7	GOOD	0
HORN	7	GOOD	0
SPEAKERS & MUSIC SYSTEM	7	GOOD	0
HANDBRAKE	6	FAIR	0
STEERING-MOUNTED CONTROLS	7	GOOD	0
PEDALS	7	GOOD	0
CENTRAL LOCK	7	GOOD	0
A/C VENTS & HEATER	6	FAIR	0
CUP HOLDERS	7	GOOD	0
NAVIGATION (NO)	10		0
ODOMETER	7	GOOD	0
POWER WINDOWS (YES)	7	GOOD	0
HAZARD LIGHT	7	GOOD	0
CARPET & FLOOR MAT	5	NEED DRYCLINIG	2500

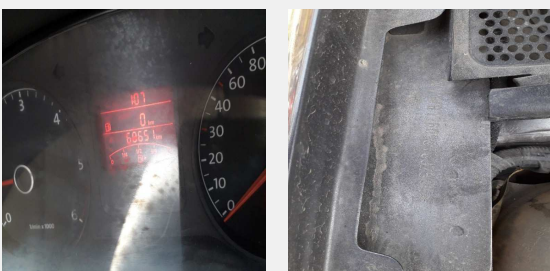
## TEST DRIVE

INSPECTION CHECKPOINTS	SCORE(X/10)	REMARKS/COMMENTS	OPTIONAL SPEND EST. (RS)
STEERING PERFORMANCE	7	GOOD	0
BRAKE PERFORMANCE	7	GOOD	0
CLUTCH PERFORMANCE	6	FAIR	0
ENGINE NOISE	6	FAIR	0
IGNITION SYSTEM	7	GOOD	0
SUSPENSION PERFORMANCE	7	GOOD	0
SUSPENSION FRONT SHOCKS	7	GOOD	0
SUSPENSION REAR SHOCKS	7	GOOD	0
TRANSMISSION ENGAGE	7	GOOD	0
CRUISE CONTROL (NO)	10		0
REAR PARKING SENSORS (YES)	7	GOOD	0
REAR VIEW CAMERA (NO)	10		0

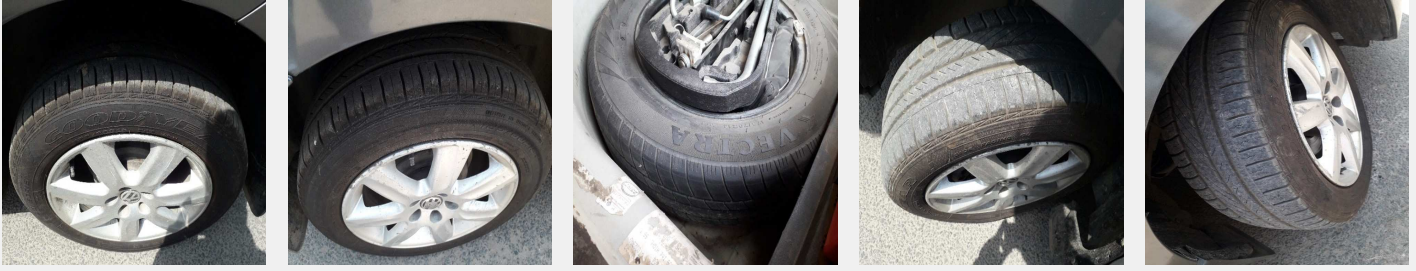
## WHEEL

INSPECTION CHECKPOINTS	SCORE(X/10)	REMARKS/COMMENTS	OPTIONAL SPEND EST. (RS)
TYRES	8	GOOD	0
SPARE TYRE (YES)	7	GOOD	0
WHEEL ASSEMBLY (ALLOY RIM)	7	GOOD	0

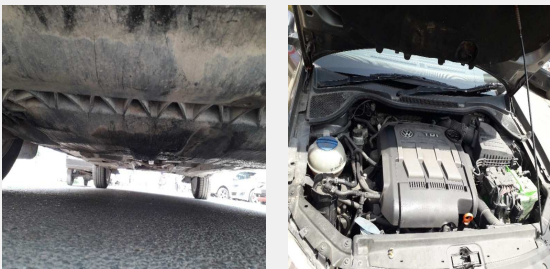
HOOD

INSPECTION CHECKPOINTS	SCORE(X/10)	REMARKS/COMMENTS	OPTIONAL SPEND EST. (RS)
LH APRON	7	GOOD	0
RH APRON	7	GOOD	0
RADIATOR	6	FAIR	0
WIRING	7	GOOD	0
BATTERY	6	FAIR	0
BRAKE FLUID LEVEL	6	FAIR	0
BRAKE & COOLANT HOSE PIPES	7	GOOD	0
UNDERCARRIAGE	7	GOOD	0
EXHAUST SYSTEM	6	FAIR	0
ENGINE OIL	4	POOR	3000
COOLANT LEVEL	4	POOR	750

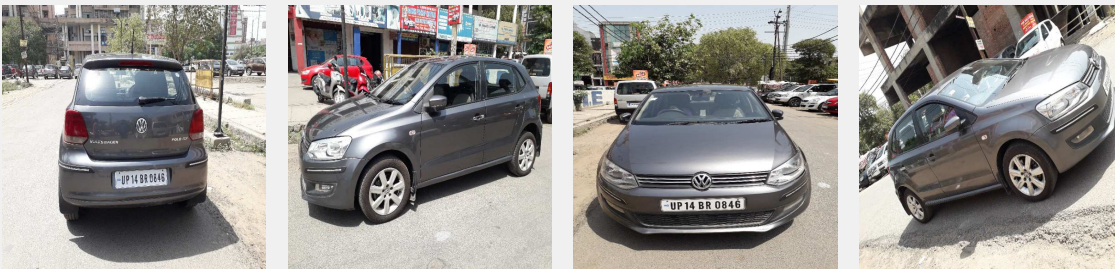
**EXTERIOR (CONTINUED)**

INSPECTION CHECKPOINTS	SCORE(X/10)	REMARKS/COMMENTS	OPTIONAL SPEND EST. (RS)
BODY RUST	7	GOOD	0
ROOF (REGULAR)	7	GOOD	0
PAINT CONDITION	6	FULL CAR IS PAINTED WITHOUT ROOF	0
FOG LAMPS	4	POOR	2000
REAR WINDSHIELD	4	SCRATCH	5500
