# ECO INSPECTION CERTIFICATE

121 Points Vehicle Inspection Certificate

## Um Renegade Sports S 280CC, 2017

Ordered by: Hemant Kumar | Inspected date: 2019-04-13

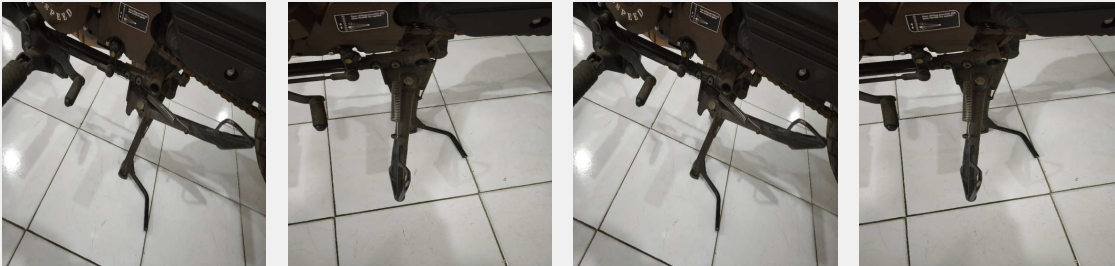
## IMAGES

INSPECTION CHECKPOINTS	SCORE(X/10)	REMARKS/COMMENTS	OPTIONAL SPEND EST. (RS)
CENTRE STAND CONDITION	7		0
CENTRE STAND RETENTION	7		0
SIDE STAND CONDITION	7		0
SIDE STAND RETENTION	7		0

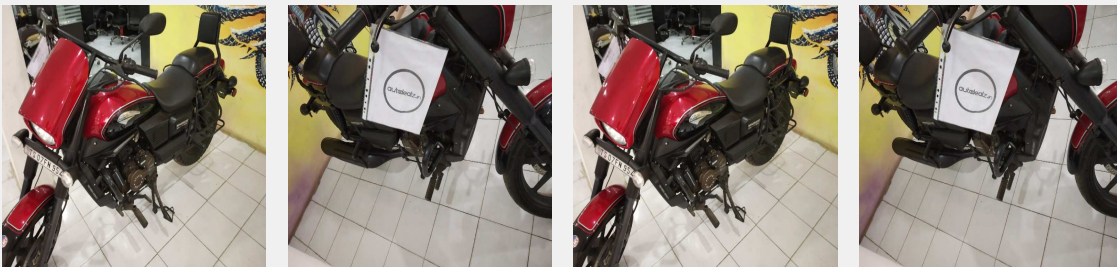
## IMAGES

INSPECTION CHECKPOINTS	SCORE(X/10)	REMARKS/COMMENTS	OPTIONAL SPEND EST. (RS)
FRAME CONDITION	7		0
FRAME STEERING-HEAD BEARINGS	7		0
FRAME SWINGARM BUSHINGS	7		0
SUSPENSION FRONT FORKS LEFT	7		0
SUSPENSION FRONT FORKS RIGHT	7		0
SUSPENSION REAR SHOCKS LEFT	7		0
SUSPENSION REAR SHOCKS RIGHT	7		0
CHAIN/BELT TENSION	7		0
CHAIN/BELT LUBRICATION	7		0
CHAIN/BELT SPROCKETS	7		0
FASTENERS THREADED	7		0
FASTENERS CLIPS & COTTER PINS	7		0
ENGINE	7		0
TRANSMISSION	7		0
