# ECO INSPECTION CERTIFICATE

121 Points Vehicle Inspection Certificate

<b>Ordered By :</b> Sanjeev Kumar Juneja	<b>Inspection Date :</b> 2019-04-16	<b>Location :</b> DELHI
---	--	----------------------------

## Hyundai I10 SPORTZ 1.2 AT, 2011

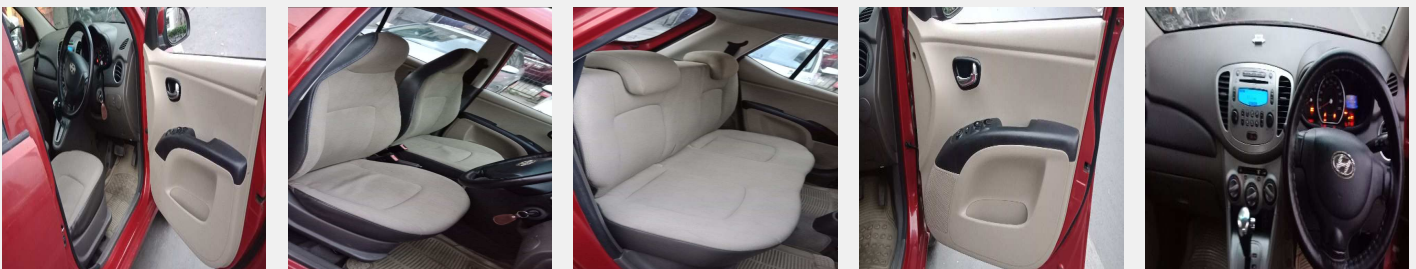
## IMAGES

INSPECTION CHECKPOINTS	SCORE(X/10)	REMARKS/COMMENTS	OPTIONAL SPEND EST. (RS)
DOOR PANEL	7		0
DOOR HINGES	7		0
CARPET & FLOOR MAT	7		0
SEAT & SEAT BELT	7		0
DASHBOARD & INSTRUMENT PANEL	7		0
HORN	7		0
SPEAKERS & MUSIC SYSTEM	7		0
HANDBRAKE	7		0
PEDALS	7		0
CENTRAL LOCK	7		0
A/C VENTS & HEATER	7		0
CUP HOLDERS	7		0
NAVIGATION (NO)	10		0
ODOMETER	7		0
POWER WINDOWS (YES)	7		0
HAZARD LIGHT	7		0
STEERING-MOUNTED CONTROLS	0	NOT AVAILABLE	0

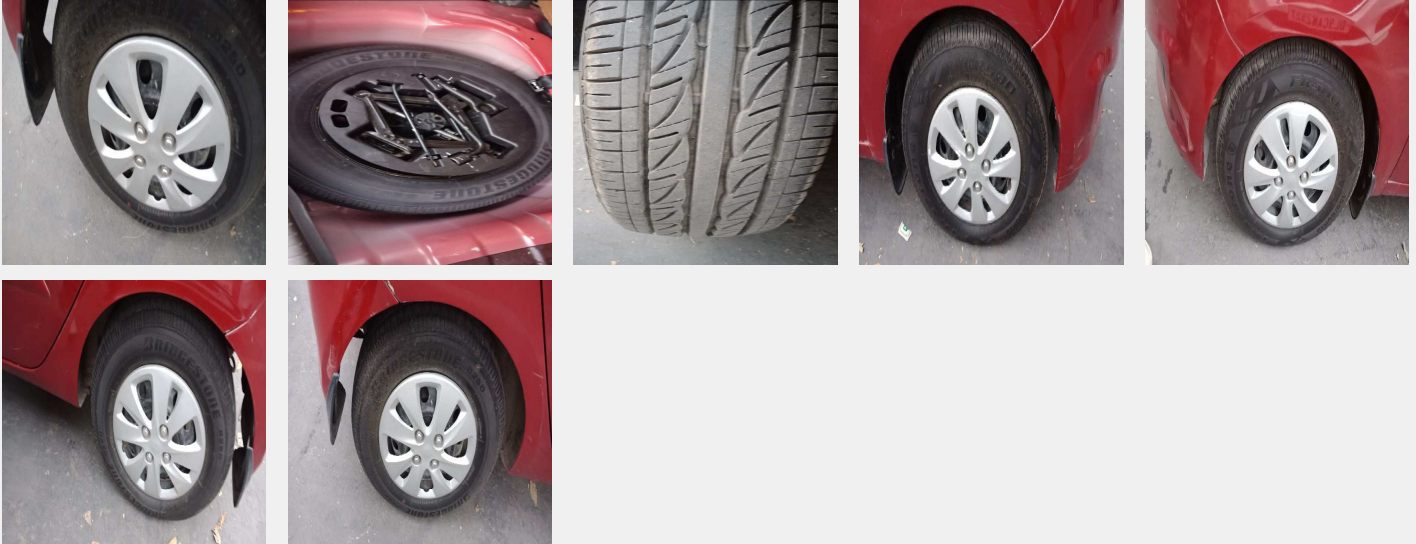
IMAGES

INSPECTION CHECKPOINTS	SCORE(X/10)	REMARKS/COMMENTS	OPTIONAL SPEND EST. (RS)
TYRES	8		0
SPARE TYRE (YES)	8		0
WHEEL ASSEMBLY (STEEL RIM)	7		0

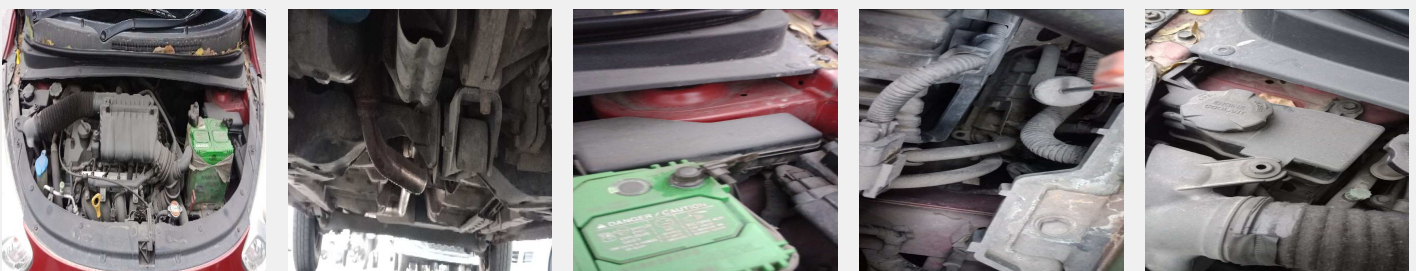
IMAGES

INSPECTION CHECKPOINTS	SCORE(X/10)	REMARKS/COMMENTS	OPTIONAL SPEND EST. (RS)
LH APRON	7		0
RH APRON	7		0
RADIATOR	7		0
WIRING	7		0
BATTERY	7		0
BRAKE FLUID LEVEL	7		0
ENGINE OIL	7		0
COOLANT LEVEL	7		0
BRAKE & COOLANT HOSE PIPES	7		0
UNDERCARRIAGE	7		0
EXHAUST SYSTEM	7		0

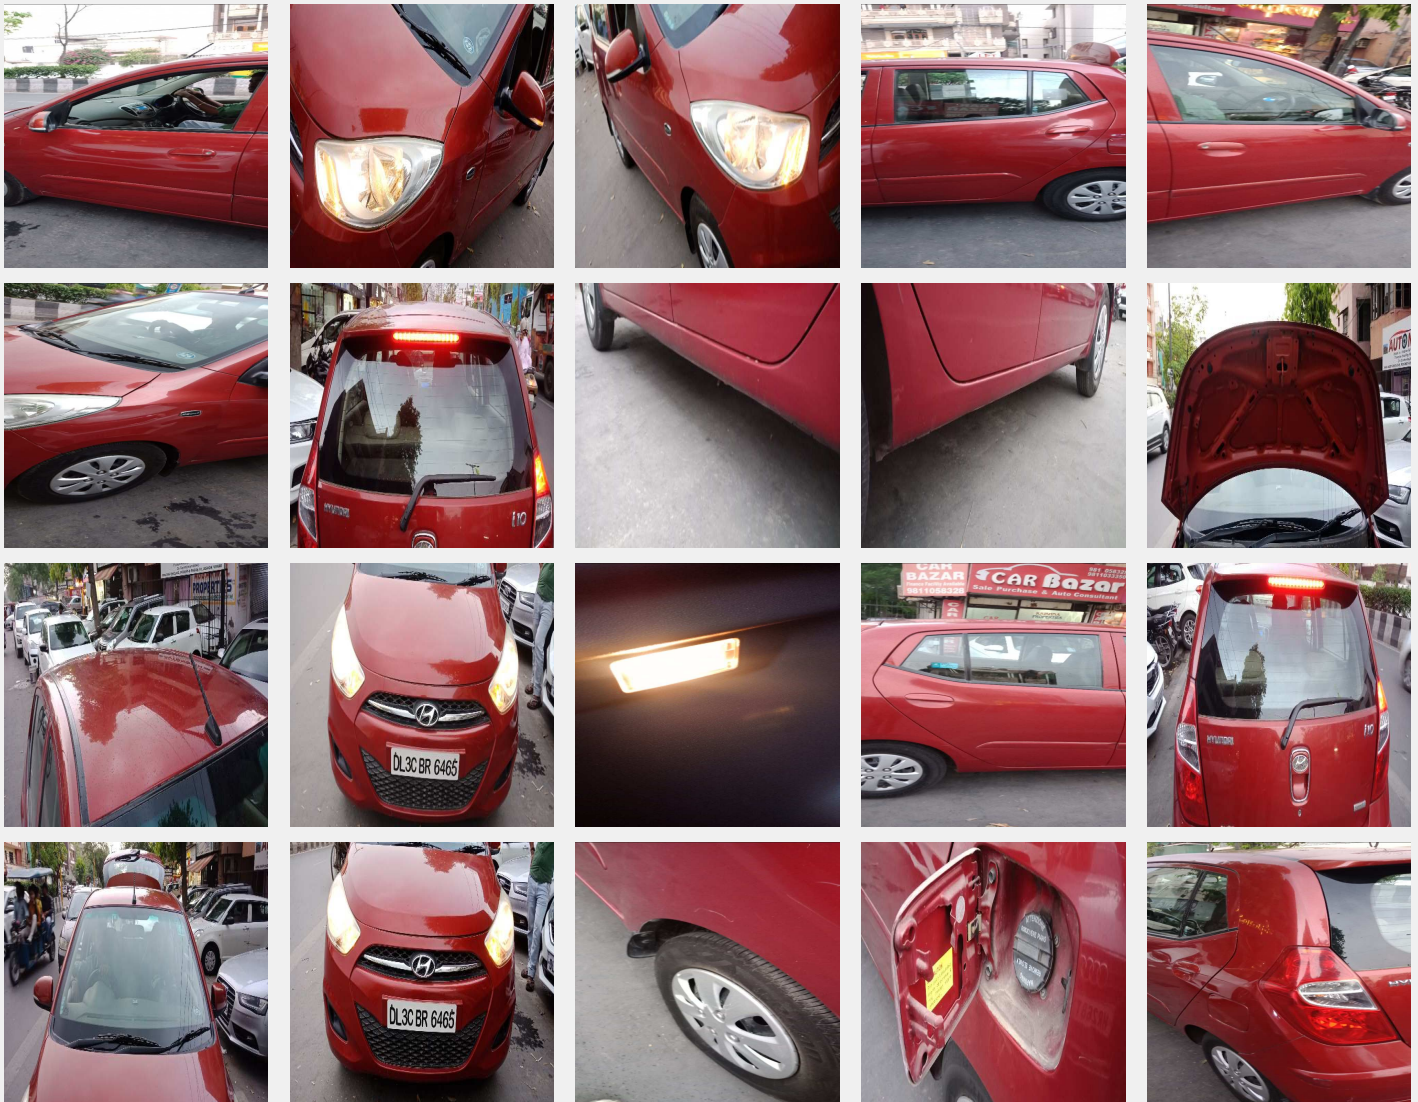
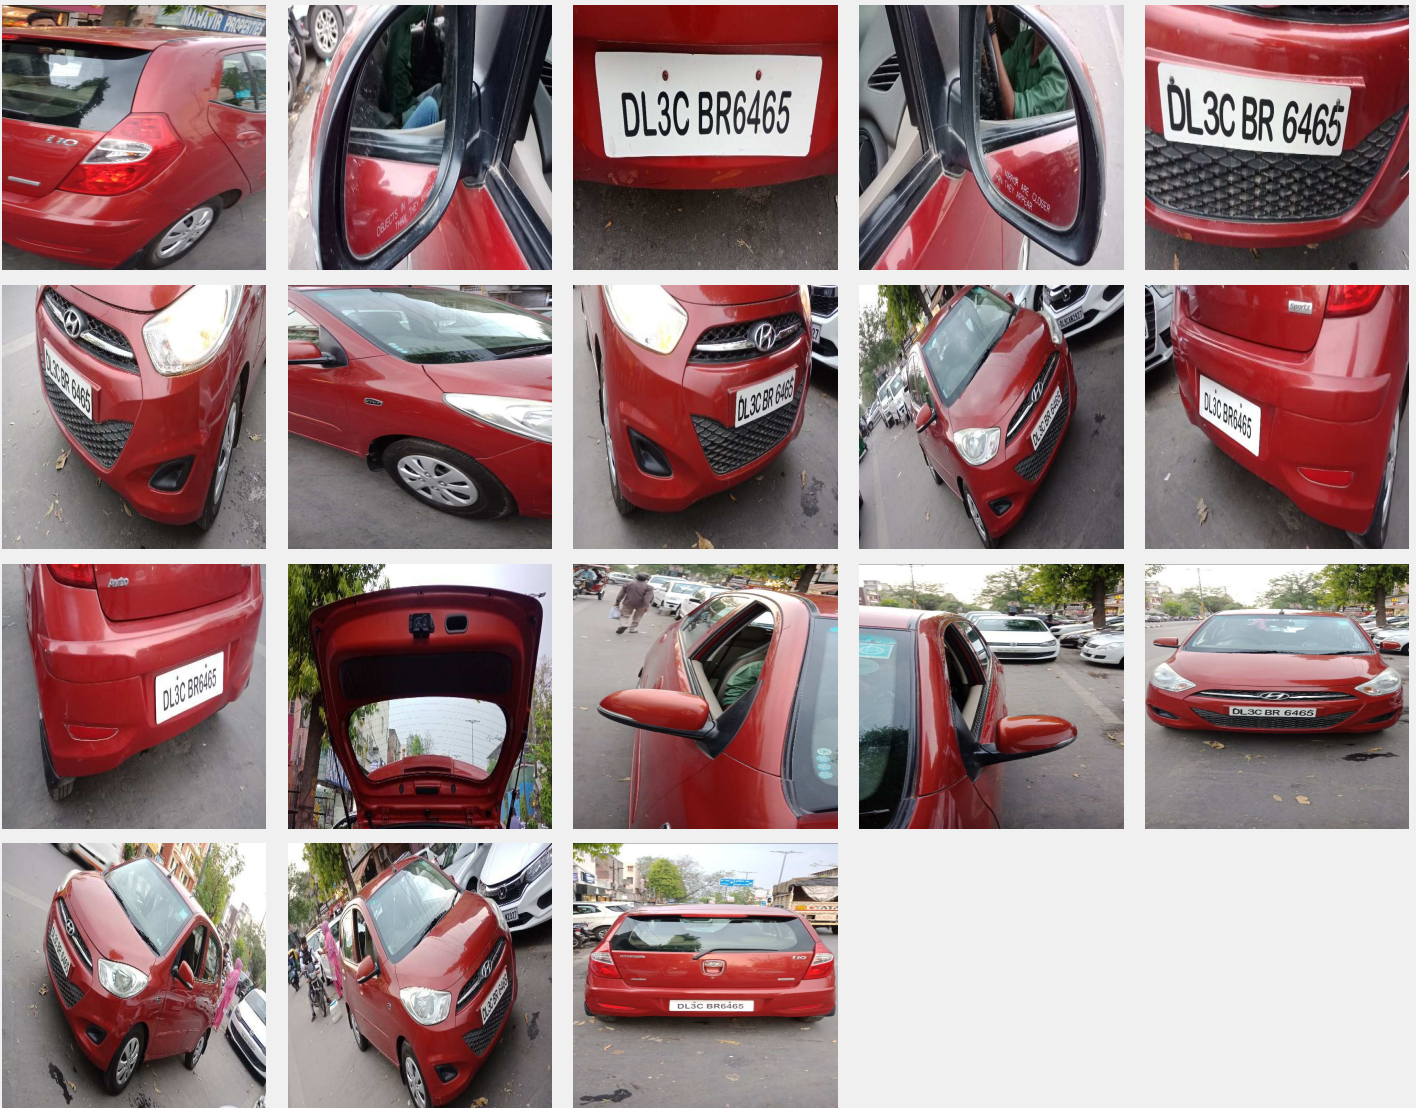
INSPECTION CHECKPOINTS	SCORE(X/10)	REMARKS/COMMENTS	OPTIONAL SPEND EST. (RS)
RH FENDER	7		0
BODY RUST	7		0
ROOF (REGULAR)	7		0
PAINT CONDITION	7		0
FOG LAMPS	0	NOT AVAILABLE	0

All body is good condition and all lights working properly without rhs mirror turn signal and LHS t
