ECO INSPECTION CERTIFICATE

Order ID : 60858

121 Points Vehicle Inspection Certificate

Maruti Suzuki Ciaz Zxi, 2014

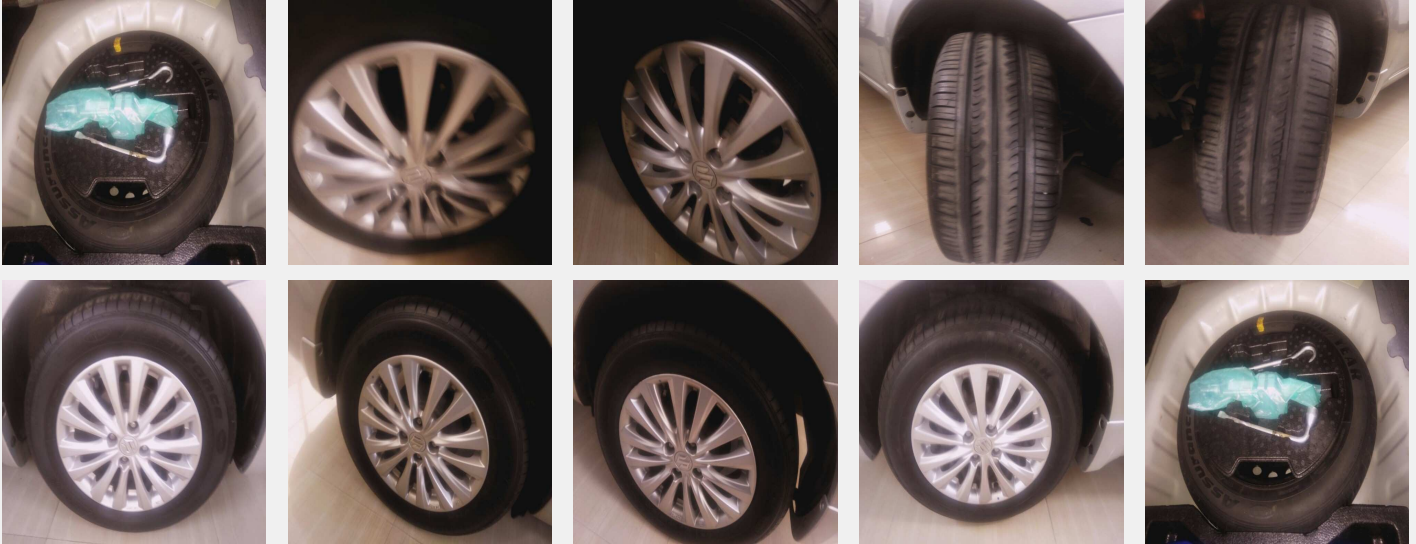
IMAGES

INSPECTION CHECKPOINTS	SCORE(X/10)	REMARKS/COMMENTS	OPTIONAL SPEND EST. (RS)
TYRES	7		0
SPARE TYRE (YES)	8		0
WHEEL ASSEMBLY (ALLOY RIM)	8		0

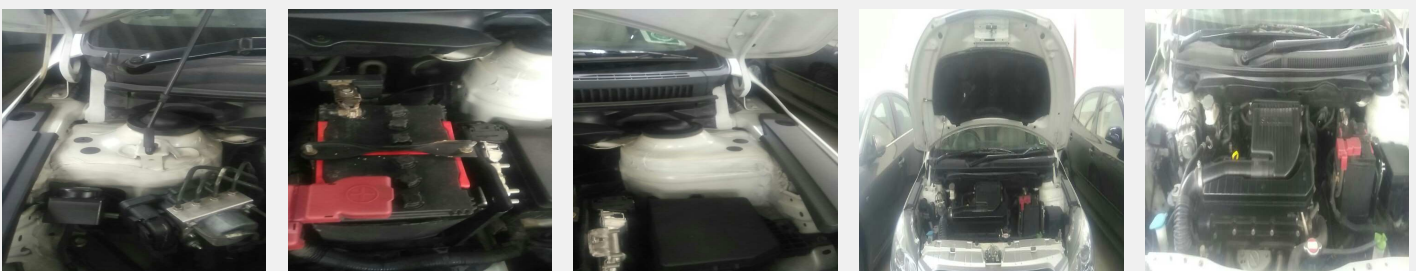
IMAGES

INSPECTION CHECKPOINTS	SCORE(X/10)	REMARKS/COMMENTS	OPTIONAL SPEND EST. (RS)
LH APRON	8		0
RH APRON	6		0
RADIATOR	7		0
WIRING	8		0
BATTERY	8		0
BRAKE FLUID LEVEL	7		0
ENGINE OIL	7		0
COOLANT LEVEL	7		0
BRAKE & COOLANT HOSE PIPES	7		0
UNDERCARRIAGE	8		0
EXHAUST SYSTEM	8		0

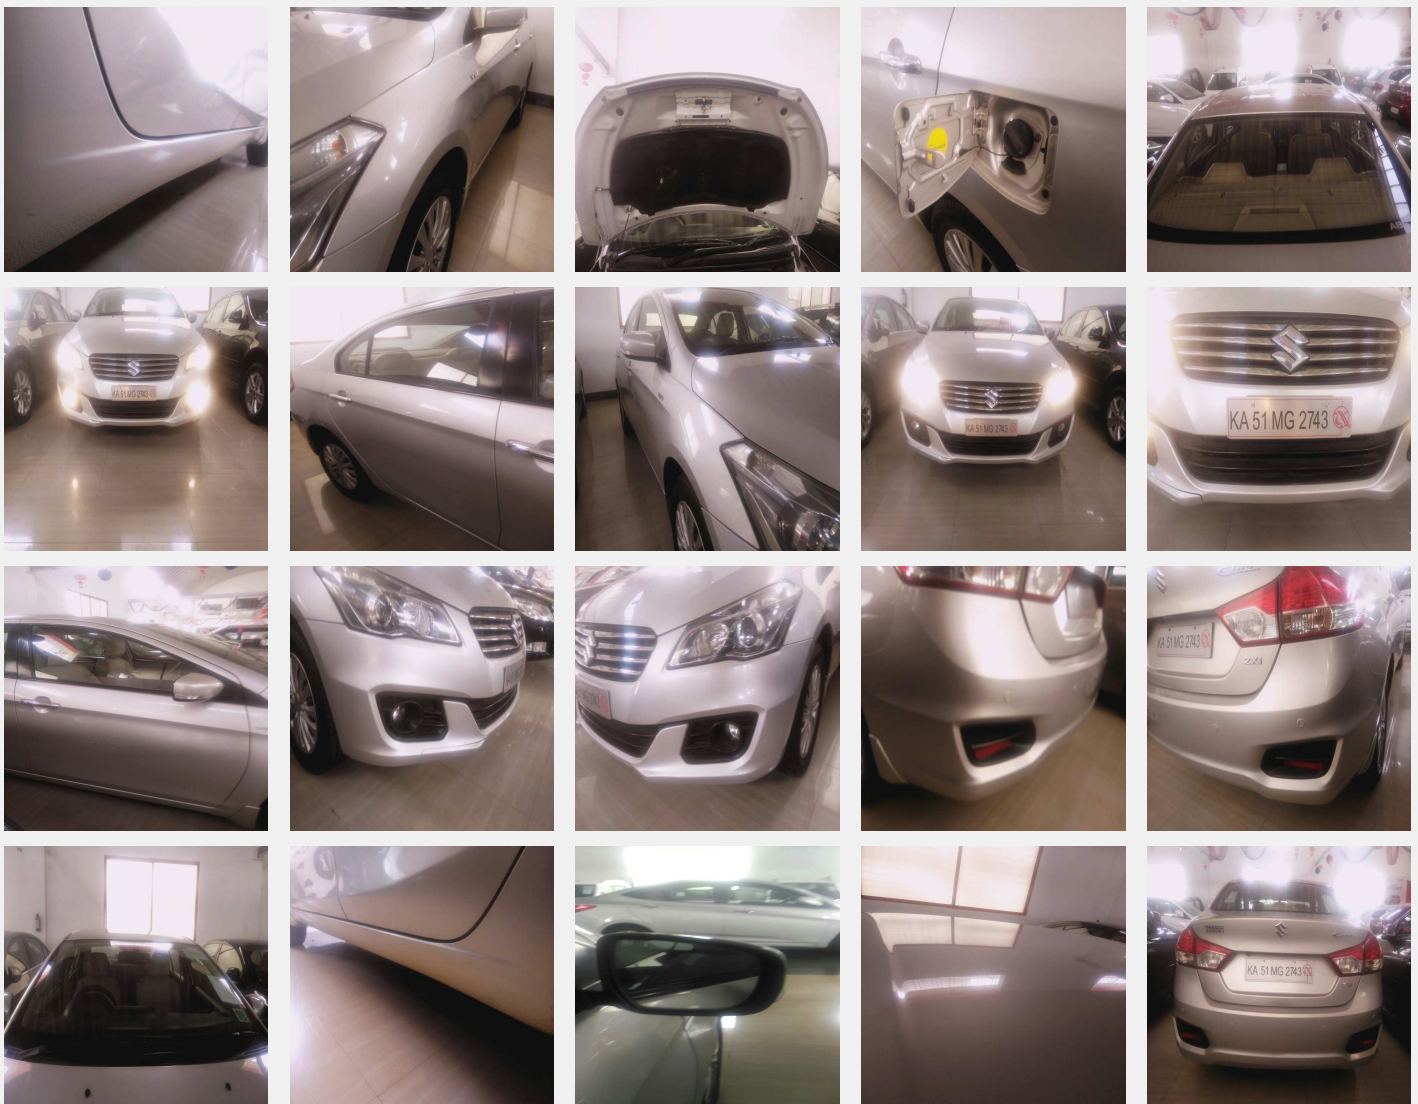
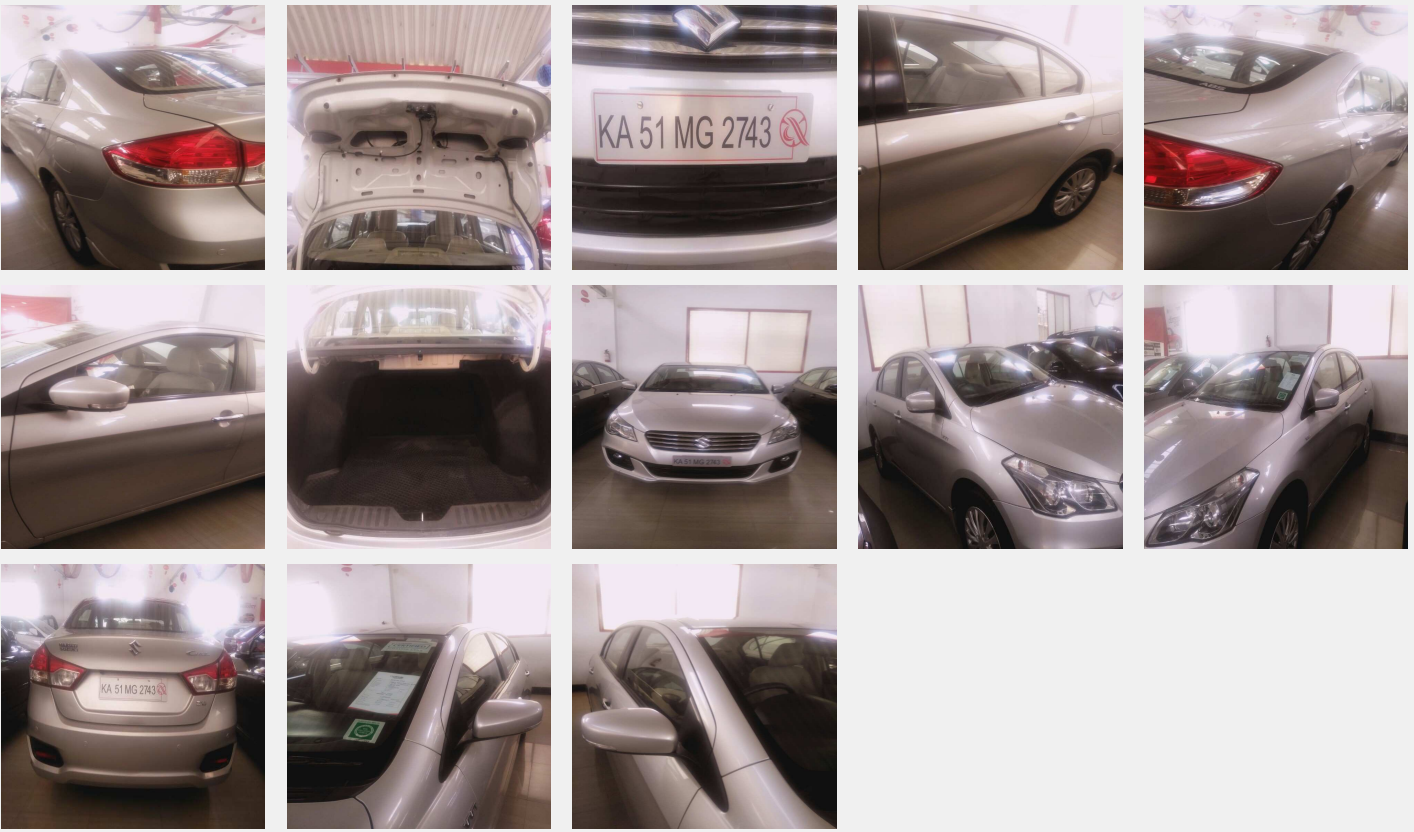
IMAGES

INSPECTION CHECKPOINTS	SCORE(X/10)	REMARKS/COMMENTS	OPTIONAL SPEND EST. (RS)
RH FRONT DOOR	8		0
RH FENDER	7		0
BODY RUST	8		0
ROOF (REGULAR)	8		0
PAINT CONDITION	9		0
