ECO INSPECTION CERTIFICATE

Order ID : 64985

121 Points Vehicle Inspection Certificate

Honda City S I-VTEC, 2011

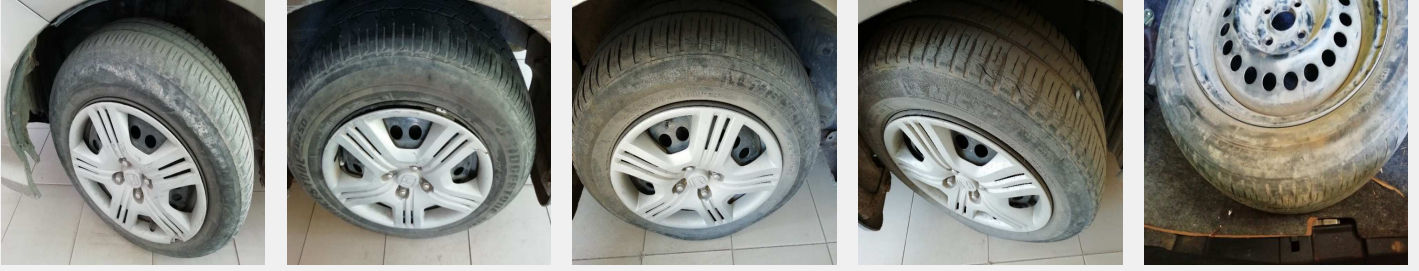
IMAGES

INSPECTION CHECKPOINTS	SCORE(X/10)	REMARKS/COMMENTS	OPTIONAL SPEND EST. (RS)
TYRES	6	NEUTRAL CONDITION	0
SPARE TYRE (YES)	6	NEUTRAL CONDITION	0
WHEEL ASSEMBLY (STEEL RIM)	8	GOOD CONDITION	0

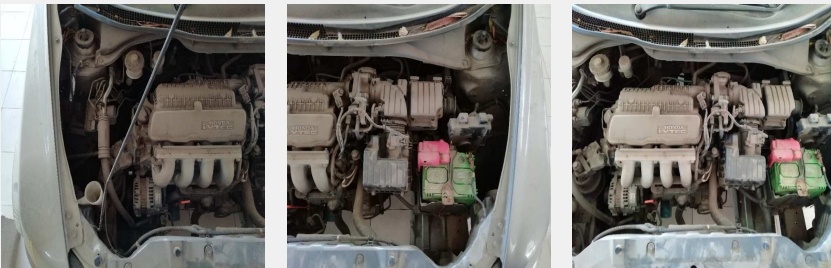
IMAGES

INSPECTION CHECKPOINTS	SCORE(X/10)	REMARKS/COMMENTS	OPTIONAL SPEND EST. (RS)
LH APRON	8	GOOD CONDITION	0
RH APRON	8	GOOD CONDITION	0
RADIATOR	7	GOOD CONDITION	0
WIRING	7	GOOD CONDITION	0
BATTERY	7	GOOD CONDITION	0
BRAKE FLUID LEVEL	7	GOOD CONDITION	0
ENGINE OIL	7	GOOD CONDITION	0
COOLANT LEVEL	7	GOOD CONDITION	0
BRAKE & COOLANT HOSE PIPES	7	GOOD CONDITION	0
UNDERCARRIAGE	7	GOOD CONDITION	0
EXHAUST SYSTEM	7	GOOD CONDITION	0
