ECO INSPECTION CERTIFICATE

Order ID : 62852

121 Points Vehicle Inspection Certificate

Ford Ecosport Trend 1.5L TDCi, 2016

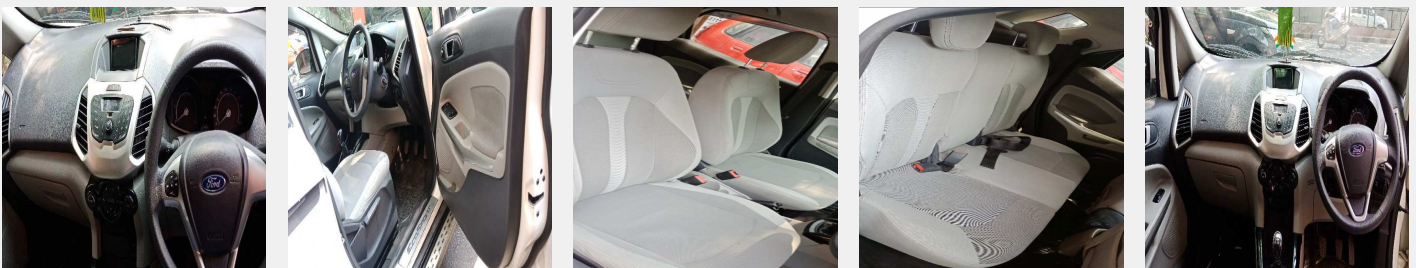
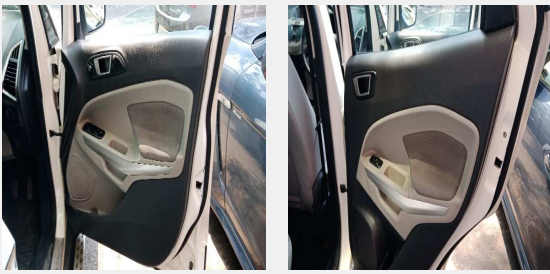
IMAGES

INSPECTION CHECKPOINTS	SCORE(X/10)	REMARKS/COMMENTS	OPTIONAL SPEND EST. (RS)
DOOR PANEL	7		0
DOOR HINGES	7		0
CARPET & FLOOR MAT	7		0
SEAT & SEAT BELT	6	REAR SEAT BELT BROKEN NEED REPLACE	2000
DASHBOARD & INSTRUMENT PANEL	7		0
HORN	7		0
SPEAKERS & MUSIC SYSTEM	7		0
HANDBRAKE	7		0
STEERING-MOUNTED CONTROLS	7		0
PEDALS	7		0
CENTRAL LOCK	7		0
A/C VENTS & HEATER	7		0
CUP HOLDERS	7		0
NAVIGATION (NO)	10		0
ODOMETER	7		0
POWER WINDOWS (YES)	7		0
HAZARD LIGHT	7		0

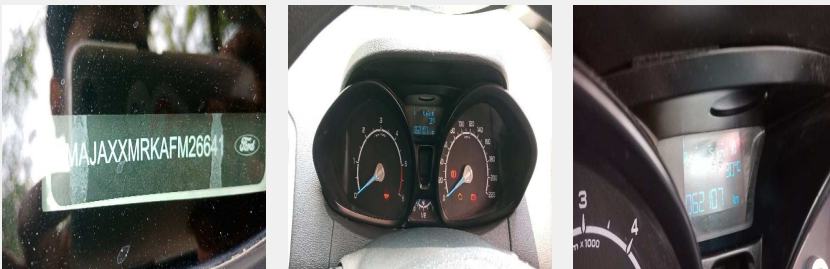
IMAGES

INSPECTION CHECKPOINTS	SCORE(X/10)	REMARKS/COMMENTS	OPTIONAL SPEND EST. (RS)
STEERING PERFORMANCE	7		0
BRAKE PERFORMANCE	7		0
CLUTCH PERFORMANCE	7		0
ENGINE NOISE	7		0
IGNITION SYSTEM	7		0
SUSPENSION PERFORMANCE	7		0
SUSPENSION FRONT SHOCKS	7		0
SUSPENSION REAR SHOCKS	7		0
TRANSMISSION ENGAGE	7		0
CRUISE CONTROL (NO)	10		0
REAR PARKING SENSORS (YES)	7		0
REAR VIEW CAMERA (YES)	6	CAMERA SCREEN BLURING NEED TO CHECK AND REPAIR	2000

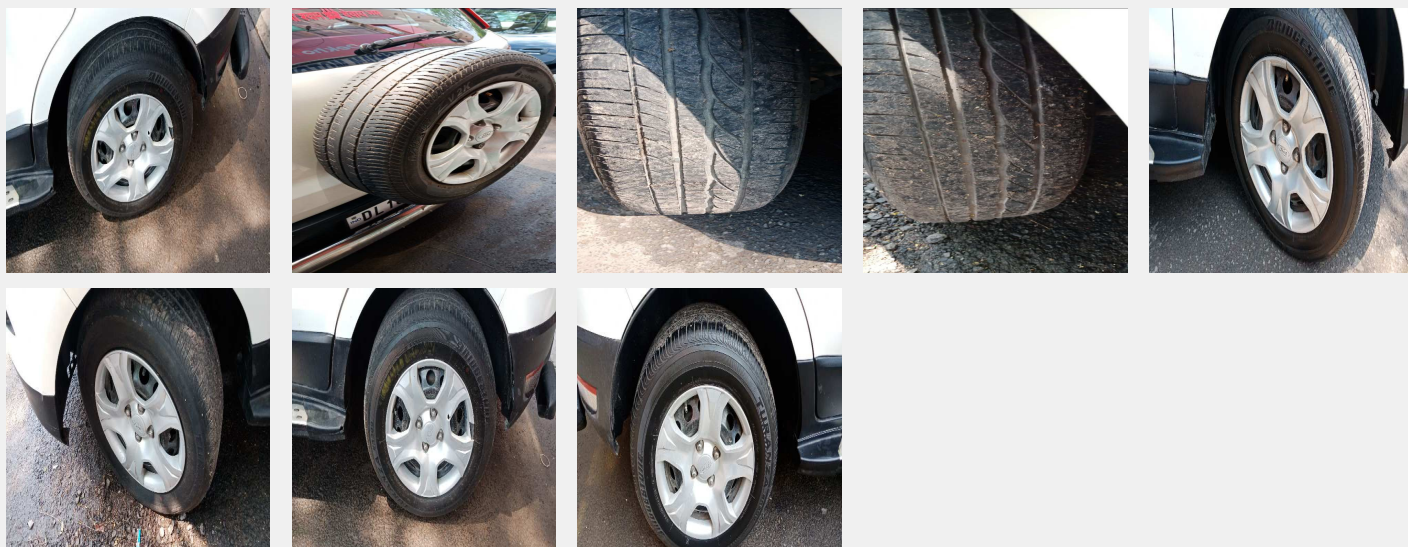
IMAGES

INSPECTION CHECKPOINTS	SCORE(X/10)	REMARKS/COMMENTS	OPTIONAL SPEND EST. (RS)
TYRES	8		0
SPARE TYRE (YES)	7		0

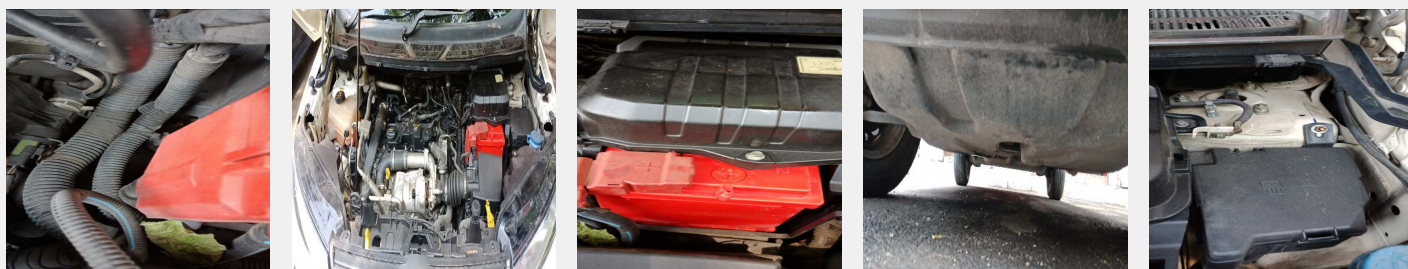
IMAGES

INSPECTION CHECKPOINTS	SCORE(X/10)	REMARKS/COMMENTS	OPTIONAL SPEND EST. (RS)
LH APRON	7		0
RH APRON	7		0
RADIATOR	7		0
WIRING	7		0
BATTERY	7		0
BRAKE FLUID LEVEL	7		0
ENGINE OIL	7		0
COOLANT LEVEL	7		0
BRAKE & COOLANT HOSE PIPES	7		0
UNDERCARRIAGE	7		0
EXHAUST SYSTEM	7		0

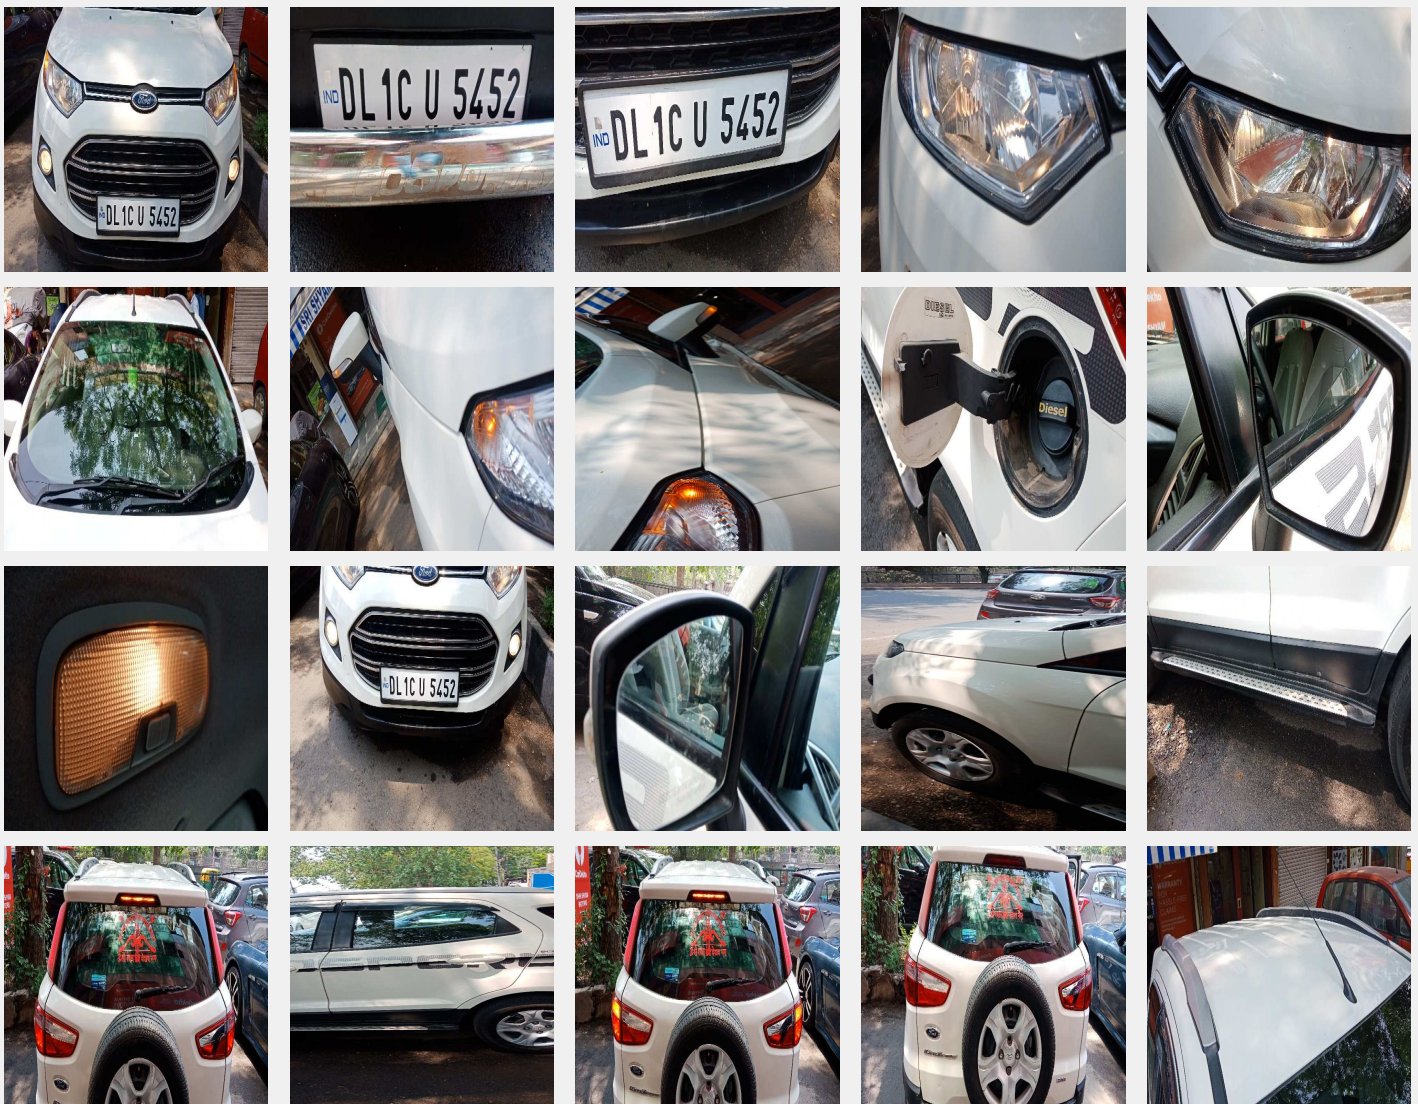
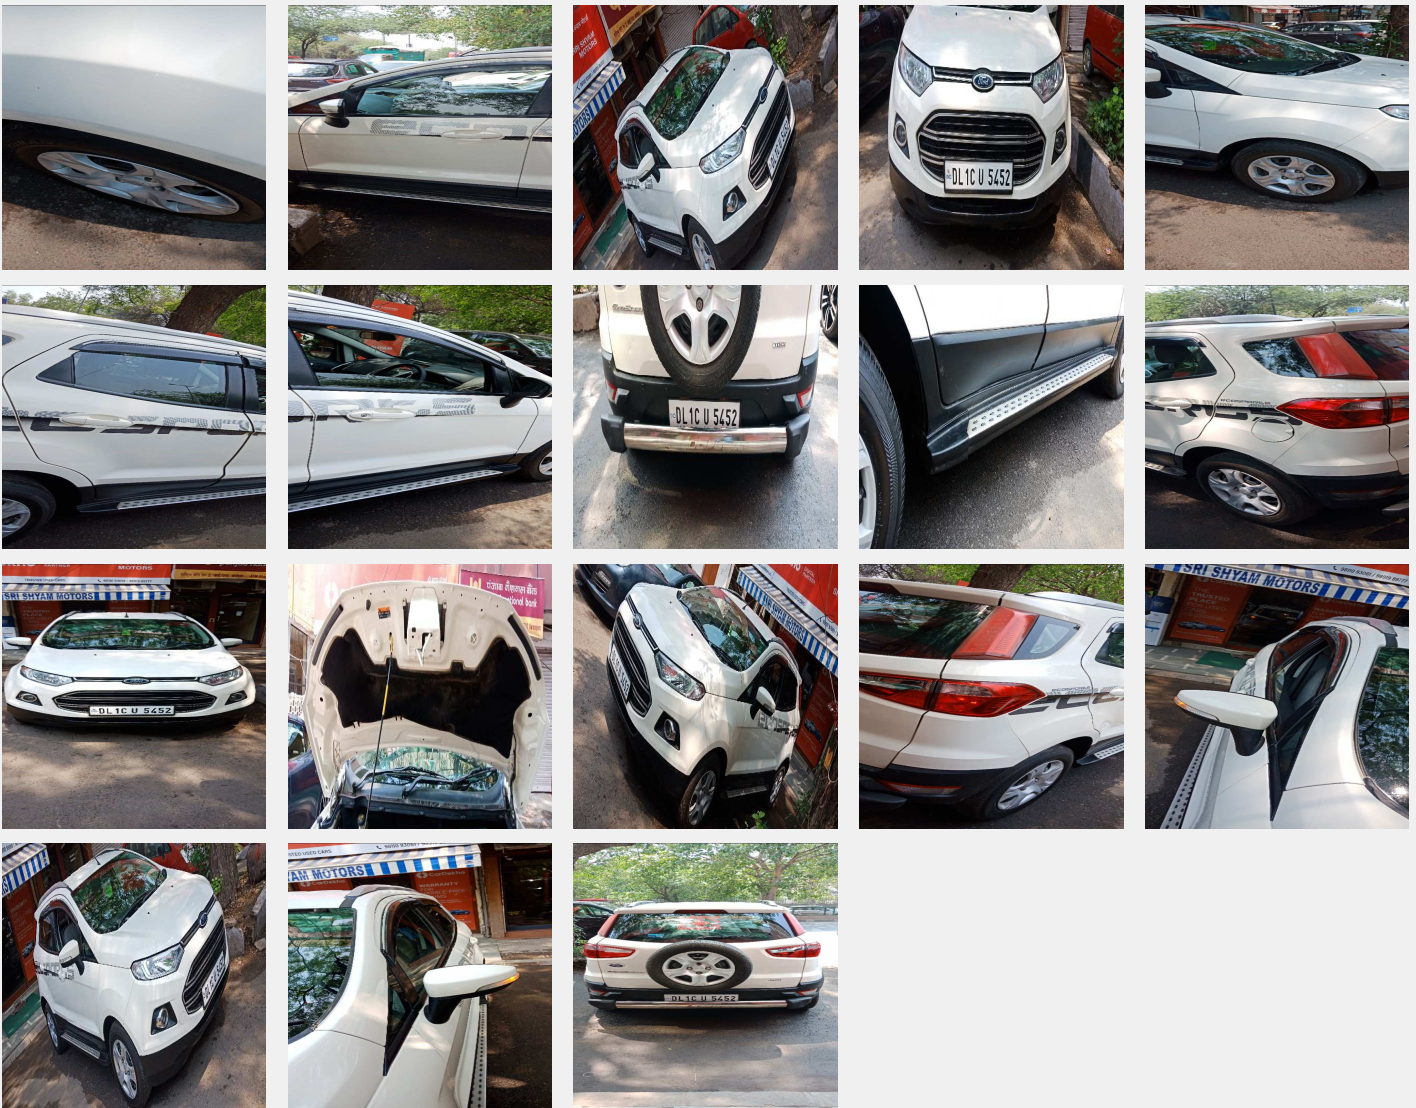
IMAGES

INSPECTION CHECKPOINTS	SCORE(X/10)	REMARKS/COMMENTS	OPTIONAL SPEND EST. (RS)
RH FRONT DOOR	7		0
RH FENDER	7		0
BODY RUST	7		0
ROOF (REGULAR)	7		0
PAINT CONDITION	7		0
