ECO INSPECTION CERTIFICATE

Order ID : 63531

121 Points Vehicle Inspection Certificate

Maruti Suzuki Swift VDI, 2012

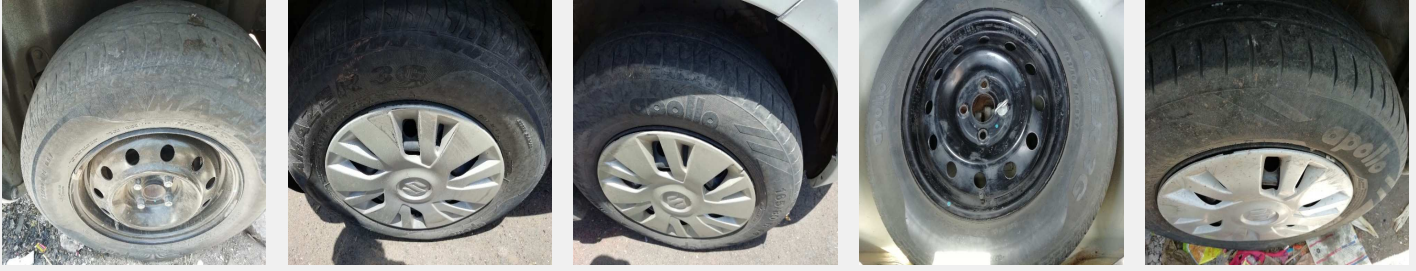
INSPECTION CHECKPOINTS	SCORE(X/10)	REMARKS/COMMENTS	OPTIONAL SPEND EST. (RS)
TYRES	6	GOOD CONDITION	0
SPARE TYRE (YES)	6	GOOD CONDITION	0
WHEEL ASSEMBLY (STEEL RIM)	8	GOOD CONDITION	0

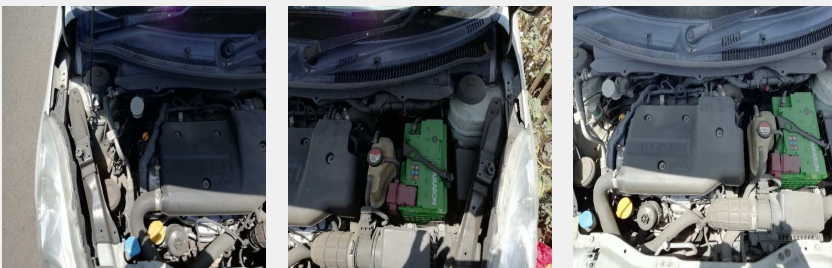
HOOD

INSPECTION CHECKPOINTS	SCORE(X/10)	REMARKS/COMMENTS	OPTIONAL SPEND EST. (RS)
LH APRON	8	GOOD CONDITION	0
RH APRON	8	GOOD CONDITION	0
RADIATOR	7	GOOD CONDITION	0
WIRING	7	GOOD CONDITION	0
BATTERY	7	GOOD CONDITION	0
BRAKE FLUID LEVEL	7	GOOD CONDITION	0
ENGINE OIL	7	GOOD CONDITION	0
COOLANT LEVEL	7	GOOD CONDITION	0
BRAKE & COOLANT HOSE PIPES	7	GOOD CONDITION	0
UNDERCARRIAGE	8	GOOD CONDITION	0
EXHAUST SYSTEM	8	GOOD CONDITION	0
