# ECO INSPECTION CERTIFICATE

Order ID : 61246

121 Points Vehicle Inspection Certificate

## Bajaj Ct 100 ES ALLOY, 2018

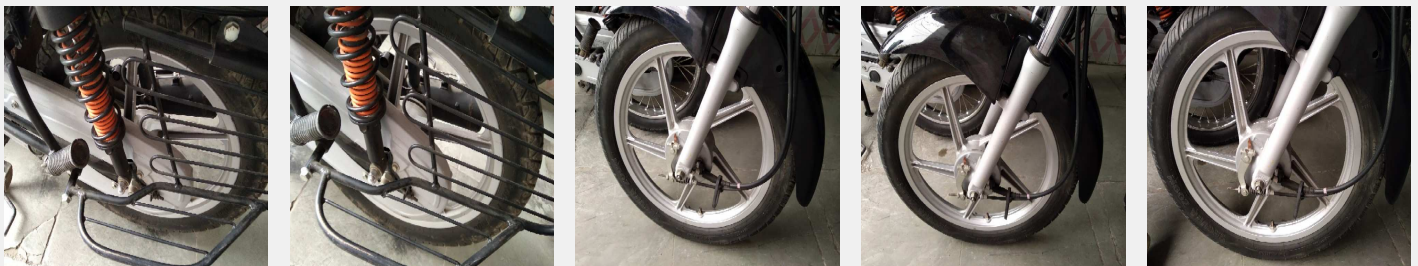
## TYRE

INSPECTION CHECKPOINTS	SCORE(X/10)	REMARKS/COMMENTS	OPTIONAL SPEND EST. (RS)
FRONT TYRE CONDITION & AIR PRESSURE	7		0
REAR TYRE CONDITION & AIR PRESSURE	7		0
WHEEL SPOKES FRONT	8		0
WHEEL SPOKES REAR	8		0
WHEEL RIM FRONT	8		0
WHEEL RIM REAR	8		0
WHEEL BEARINGS FRONT	8		0
WHEEL BEARINGS REAR	8		0
WHEEL SEALS FRONT	8		0
WHEEL SEALS REAR	8		0
BRAKE FUNCTION FRONT	8		0
BRAKE FUNCTION REAR	8		0
BRAKES CONDITION FRONT	8		0
BRAKES CONDITION REAR	8		0

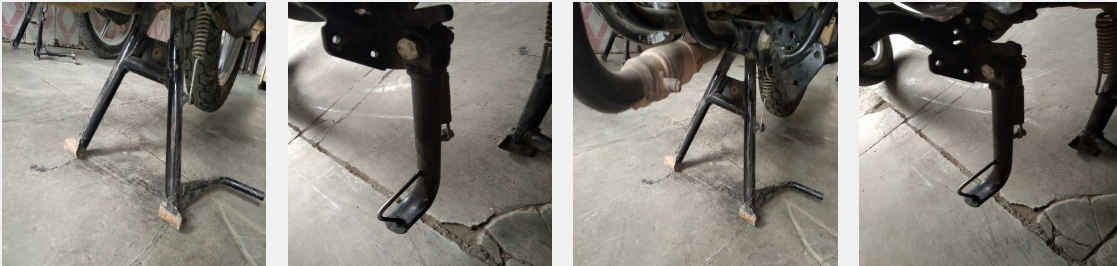
## STAND

INSPECTION CHECKPOINTS	SCORE(X/10)	REMARKS/COMMENTS	OPTIONAL SPEND EST. (RS)
CENTRE STAND CONDITION	7		0
CENTRE STAND RETENTION	7		0
SIDE STAND CONDITION	7		0
SIDE STAND RETENTION	7		0

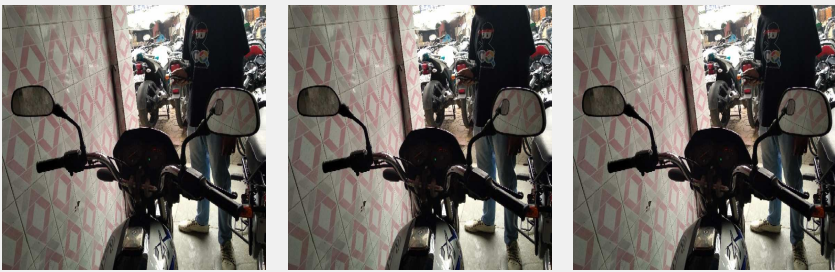
## CONTROL

INSPECTION CHECKPOINTS	SCORE(X/10)	REMARKS/COMMENTS	OPTIONAL SPEND EST. (RS)
HANDLEBARS CONDITION	8		0
LEVERS & PEDAL CONDITION	8		0
PIVOTS	8		0
CABLES CONDITION	8		0
CABLES ROUTING	8		0
HOSES CONDITION	8		0
HOSES ROUTING	8		0
THROTTLE OPERATION	8		0

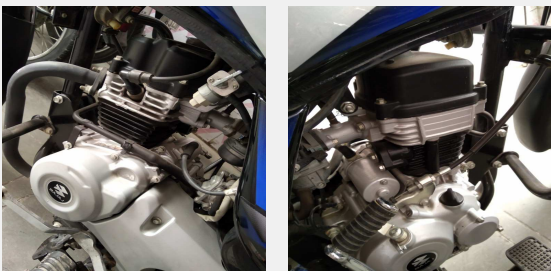
## OIL

INSPECTION CHECKPOINTS	SCORE(X/10)	REMARKS/COMMENTS	OPTIONAL SPEND EST. (RS)
LEVELS - ENGINE OIL	8		0
LEVELS - GEAR OIL/SHAFT DRIVE (NO)	10		0
LEVELS - HYDRAULIC FLUID (NO)	10		0
LEVELS - COOLANT (NO)	10		0
LEVELS - FUEL	8		0
LEAKS - ENGINE OIL	8		0
LEAKS - GEAR OIL	8		0
LEAKS - HYDRAULIC FLUID	8		0
LEAKS - COOLANT	8		0
LEAKS - FUEL	8		0
