# ECO INSPECTION CERTIFICATE

121 Points Vehicle Inspection Certificate

<b>Ordered By :</b> Praveen	<b>Inspection Date :</b> 2019-04-23	<b>Location :</b> SEC 18	<b>Inspected By</b>   <b>Manoj Kumar</b>
--------------------------------	--	-----------------------------	---

## Fiat Linea EMOTION 1.3, 2015

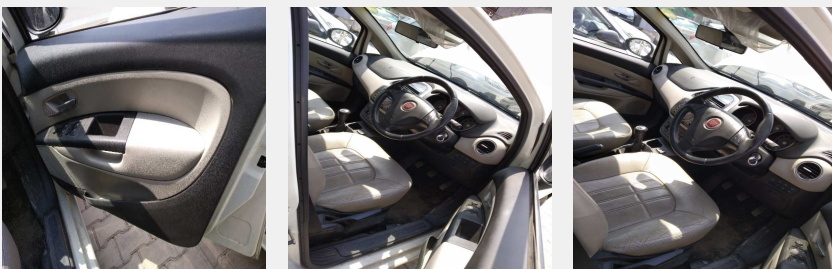
## IMAGES

INSPECTION CHECKPOINTS	SCORE(X/10)	REMARKS/COMMENTS	OPTIONAL SPEND EST. (RS)
DOOR PANEL	8	GOOD	0
DOOR HINGES	8	GOOD	0
CARPET & FLOOR MAT	8	GOOD	0
SEAT & SEAT BELT	8	GOOD	0
DASHBOARD & INSTRUMENT PANEL	8	GOOD	0
HORN	8	GOOD	0
SPEAKERS & MUSIC SYSTEM	8	GOOD	0
HANDBRAKE	8	GOOD	0
STEERING-MOUNTED CONTROLS	8	GOOD	0
PEDALS	8	GOOD	0
CENTRAL LOCK	8	GOOD	0
A/C VENTS & HEATER	8	GOOD	0
CUP HOLDERS	8	GOOD	0
NAVIGATION (NO)	10		0
ODOMETER	8	GOOD	0
POWER WINDOWS (YES)	8	GOOD	0
HAZARD LIGHT	8	GOOD	0

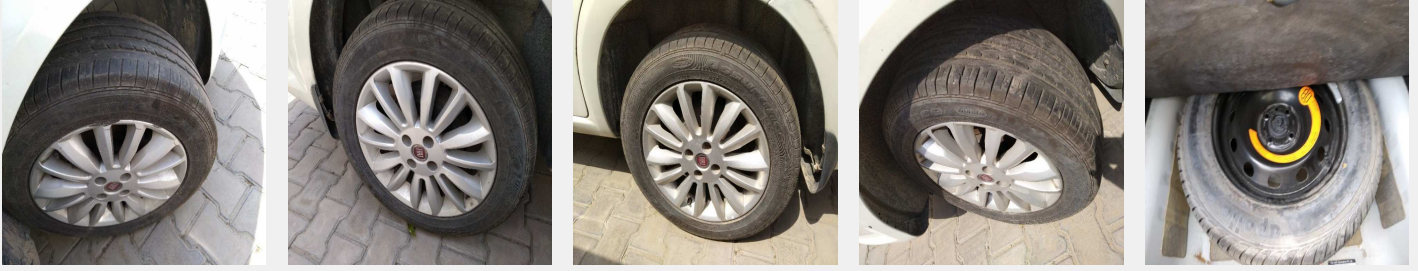
IMAGES

INSPECTION CHECKPOINTS	SCORE(X/10)	REMARKS/COMMENTS	OPTIONAL SPEND EST. (RS)
TYRES	7	GOOD	0
SPARE TYRE (YES)	8	GOOD	0
WHEEL ASSEMBLY (ALLOY RIM)	8	GOOD	0

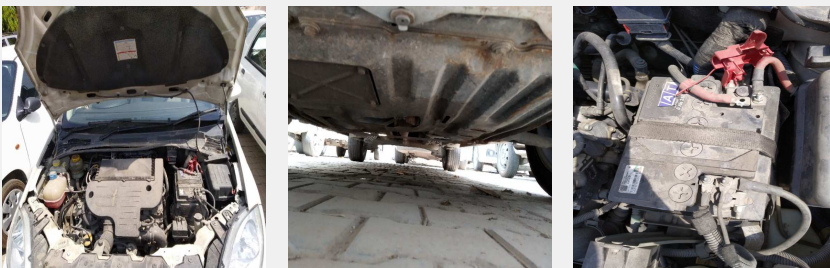
IMAGES

INSPECTION CHECKPOINTS	SCORE(X/10)	REMARKS/COMMENTS	OPTIONAL SPEND EST. (RS)
LH APRON	8	GOOD	0
RH APRON	8	GOOD	0
RADIATOR	8	GOOD	0
WIRING	8	GOOD	0
BATTERY	8	GOOD	0
BRAKE FLUID LEVEL	8	GOOD	0
ENGINE OIL	8	GOOD	0
COOLANT LEVEL	8	GOOD	0
BRAKE & COOLANT HOSE PIPES	8	GOOD	0
UNDERCARRIAGE	8	GOOD	0
EXHAUST SYSTEM	8	GOOD	0

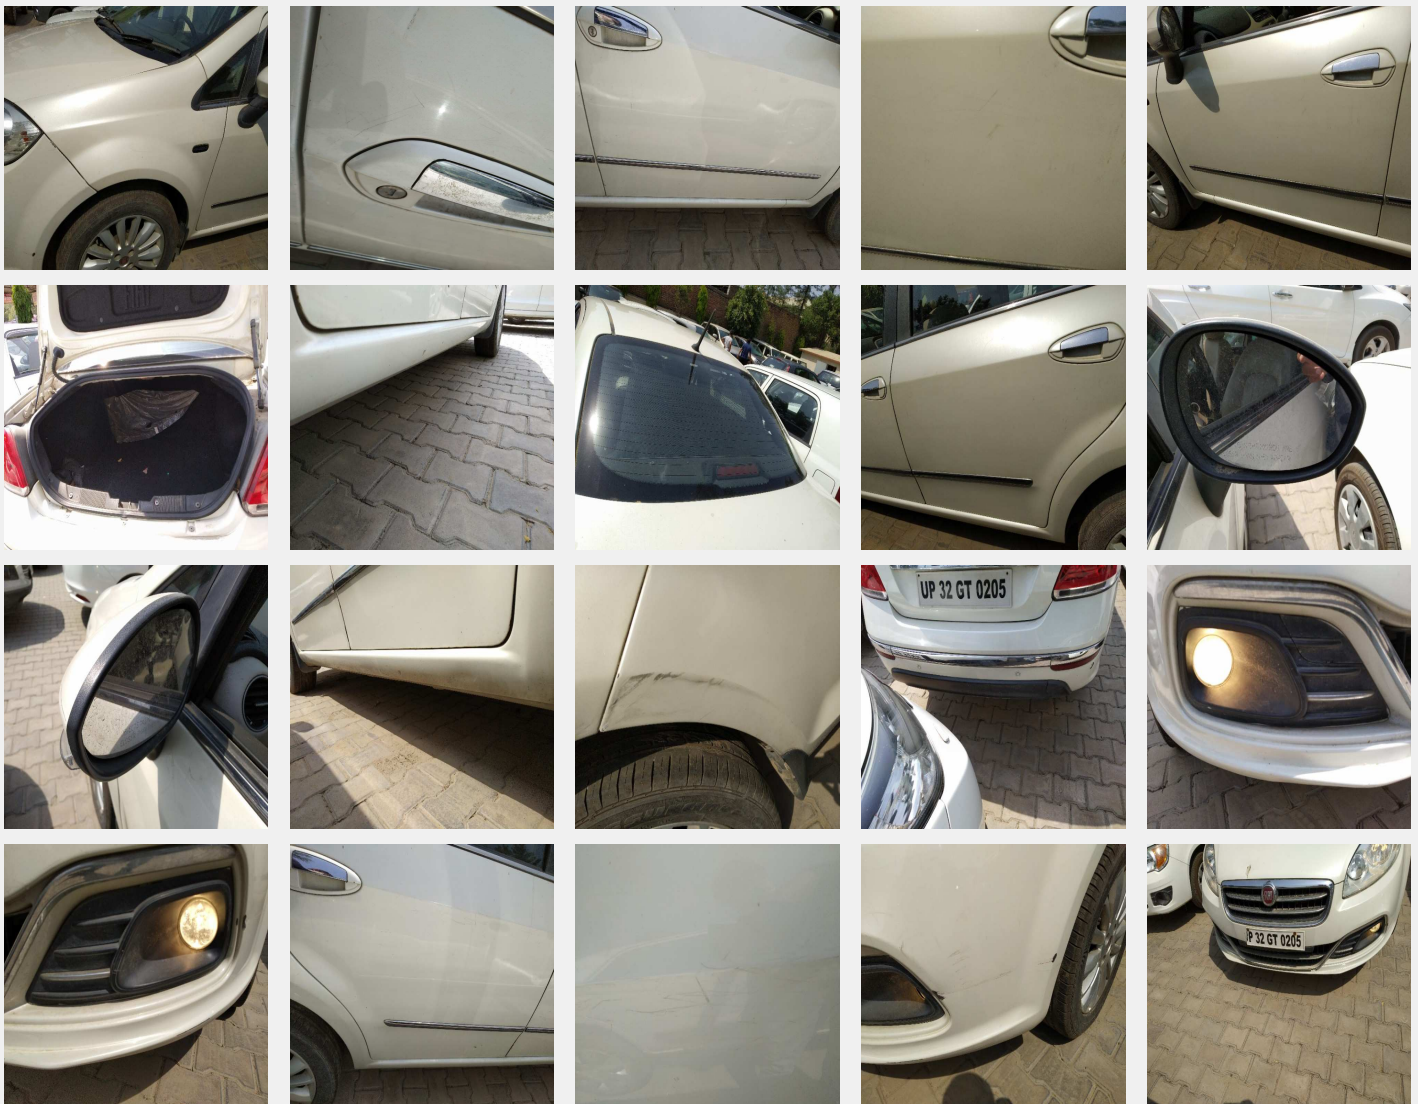
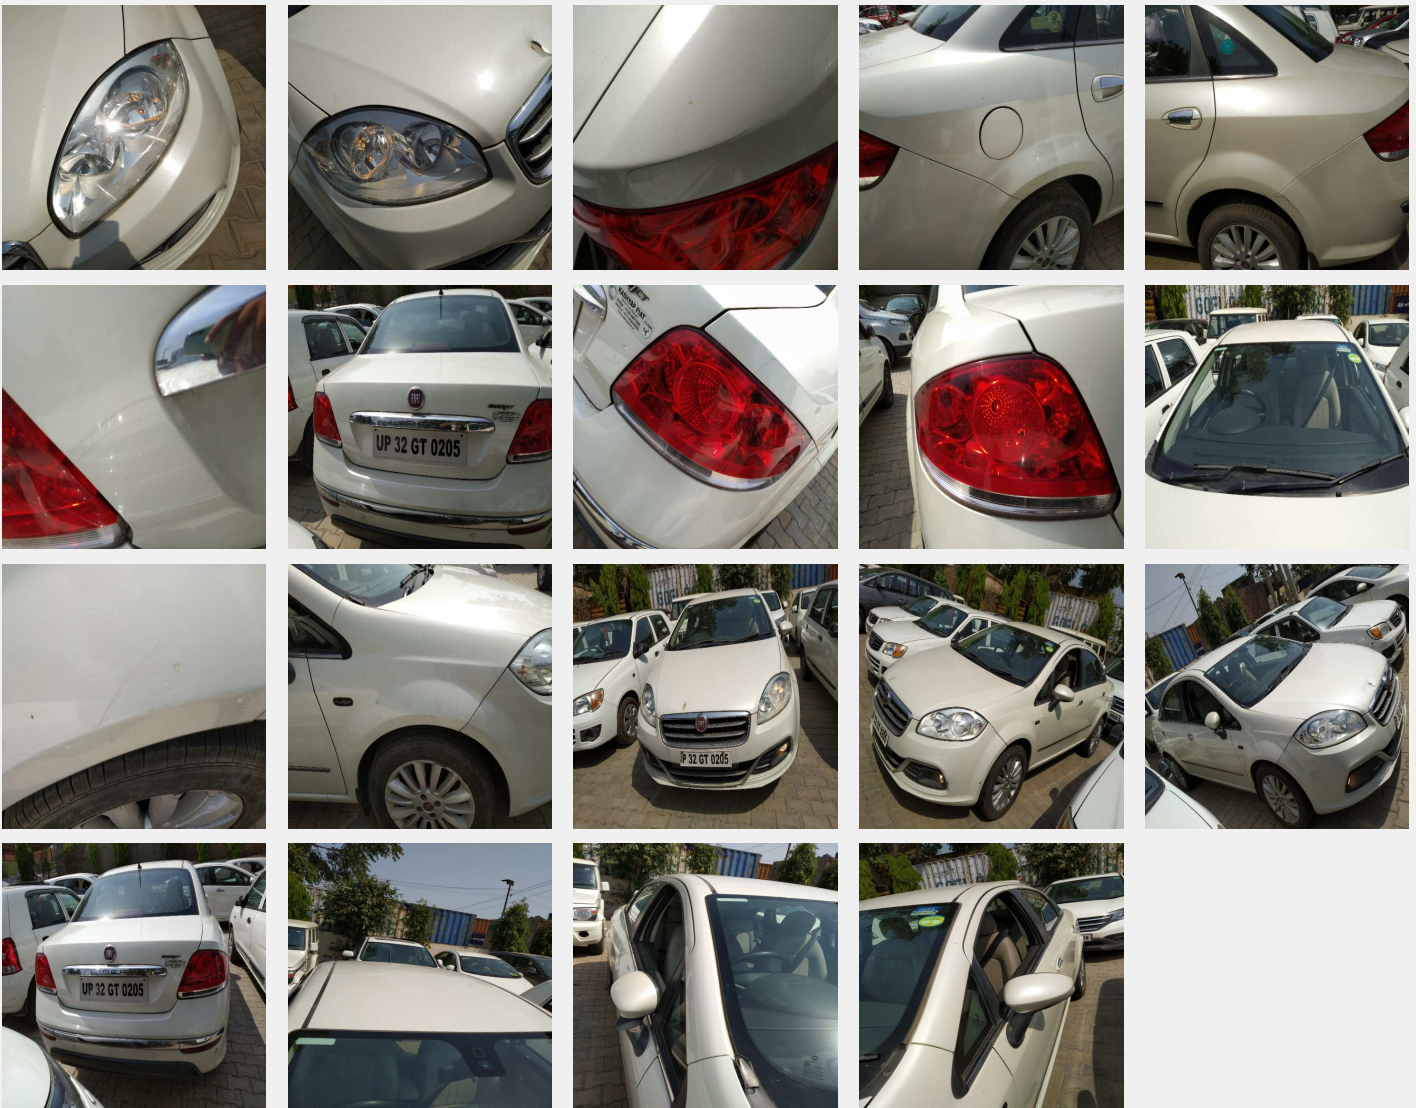
**IMAGES**

INSPECTION CHECKPOINTS	SCORE(X/10)	REMARKS/COMMENTS	OPTIONAL SPEND EST. (RS)
FRONT BUMPER	6	MINOR SCRATCHES	200
HEAD LIGHTS	7	GOOD	0
GRILLE	7	GOOD	0
TURN SIGNAL	7	GOOD	0
FOG LAMPS	8	GOOD	0
PILLAR	7	GOOD	0
FRONT WINDSHIELD	7	GOOD	0
SIDE VIEW MIRRORS	7	GOOD	0
LH FENDER	7	GOOD	0
LH FRONT DOOR	6	MINOR SCRATCHES	200
LH REAR DOOR	7	GOOD	0
LH RUNNING BOARD	7	GOOD	0
LH QUARTER PANEL	7	GOOD	0
FUEL LID	7	GOOD	0
REAR WINDSHIELD	8	GOOD	0
REAR BUMPER	6	MINOR SCRATCHES	200
TAIL LIGHT	7	GOOD	0
TRUNK LID/TAIL GATE	6	MINOR SCRATCHES	300
LUGGAGE COMPARTMENT LIGHT	7	GOOD	0
RH QUARTER PANEL	6	MINOR SCRATCHES	300
RH RUNNING BOARD	7	GOOD	0
RH REAR DOOR	6	MINOR SCRATCHES	300
RH FRONT DOOR	6	MINOR SCRATCHES	200
RH FENDER	6	MINOR SCRATCHES	200

INSPECTION CHECKPOINTS	SCORE(X/10)	REMARKS/COMMENTS	OPTIONAL SPEND EST. (RS)
BODY RUST	7	GOOD	0
ROOF (REGULAR)	7	GOOD	0
PAINT CONDITION	7	FULL PAINTED	0
LICENSE PLATE	3	NEED TO REPLACE	200
HOOD	3	NEED TO REPAIR	4000

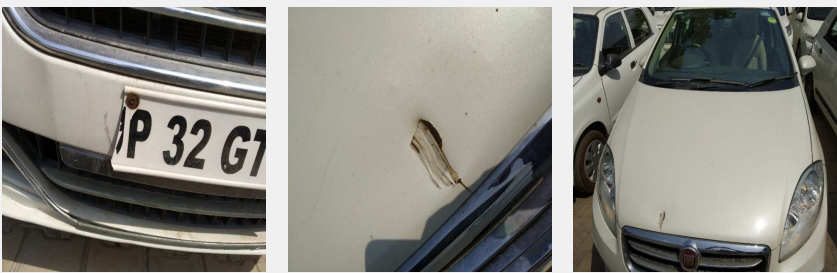
**NEED ATTENTION**

odometer transmitted car fully painted minor scratches and minor dent all tyres already replaced
