ECO INSPECTION CERTIFICATE

Order ID : 67189

121 Points Vehicle Inspection Certificate

Chevrolet Beat LT PETROL, 2010

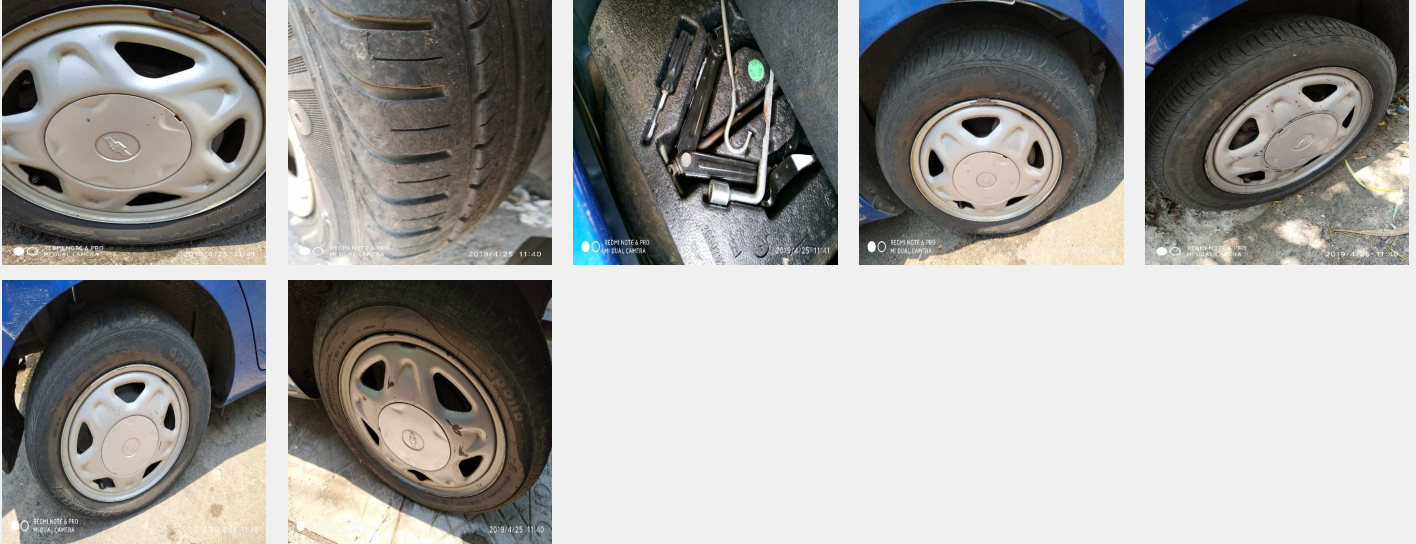
INSPECTION CHECKPOINTS	SCORE(X/10)	REMARKS/COMMENTS	OPTIONAL SPEND EST. (RS)
TYRES	7	OK	0
SPARE TYRE (YES)	7	OK	0
WHEEL ASSEMBLY (STEEL RIM)	7	OK	0

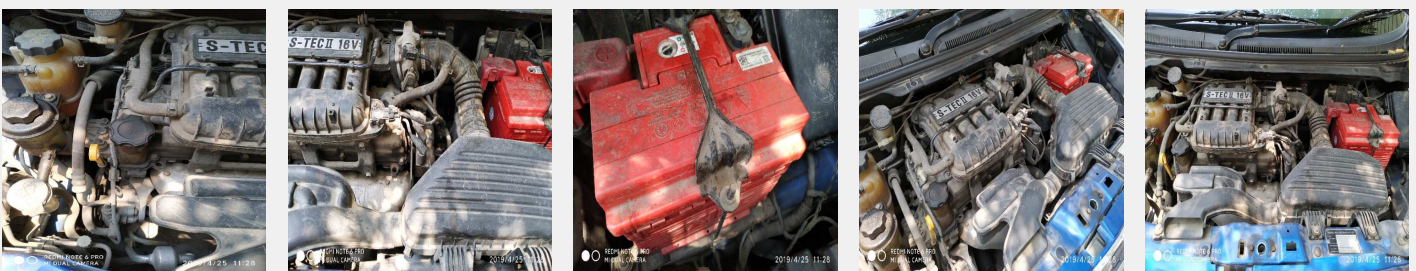
HOOD

INSPECTION CHECKPOINTS	SCORE(X/10)	REMARKS/COMMENTS	OPTIONAL SPEND EST. (RS)
LH APRON	7	OK	0
RH APRON	7	OK	0
RADIATOR	7	OK	0
WIRING	7	OK	0
BATTERY	7	OK	0
BRAKE FLUID LEVEL	7	OK	0
ENGINE OIL	7	OK	0
COOLANT LEVEL	7	OK	0
BRAKE & COOLANT HOSE PIPES	7	OK	0
UNDERCARRIAGE	7	OK	0
EXHAUST SYSTEM	7	OK	0

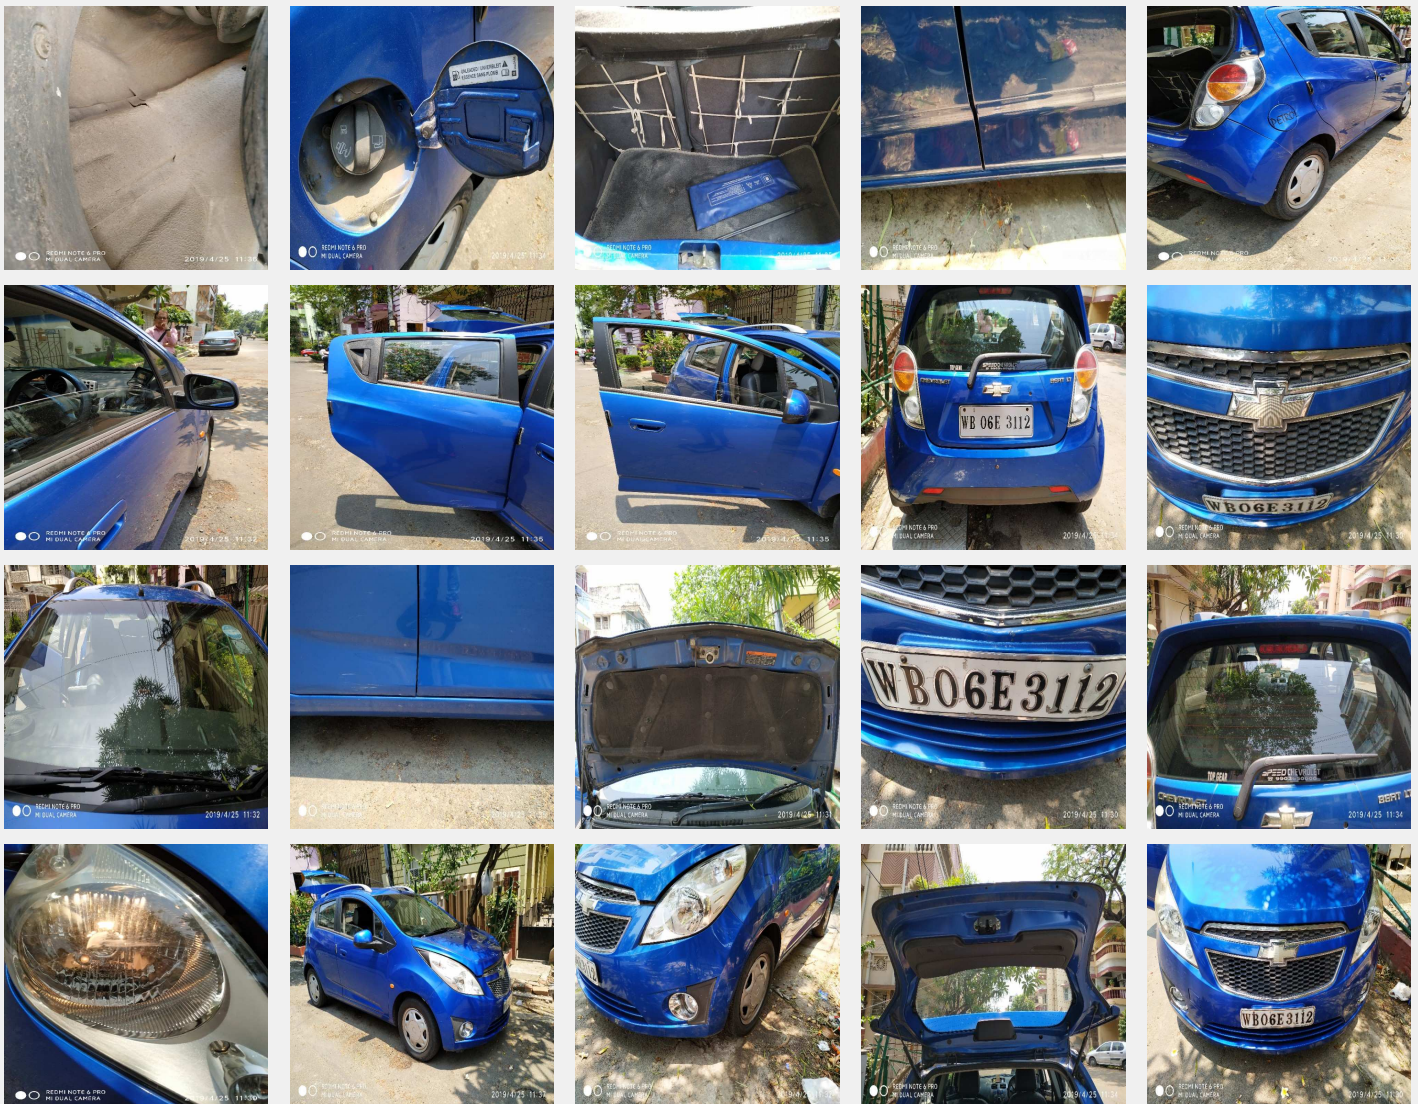
EXTERIOR (CONTINUED)

INSPECTION CHECKPOINTS	SCORE(X/10)	REMARKS/COMMENTS	OPTIONAL SPEND EST. (RS)
RH FRONT DOOR	7	OK	0
BODY RUST	7	OK	0
ROOF (REGULAR)	6	OK	0
PAINT CONDITION	7	OK	0
RH FENDER	5	DENT	1000
