ECO INSPECTION CERTIFICATE

121 Points Vehicle Inspection Certificate

Ordered By : JALIL	Inspection Date : 2019-04-22	Location : PUNE

Maruti Suzuki Wagon R LXI CNG, 2018

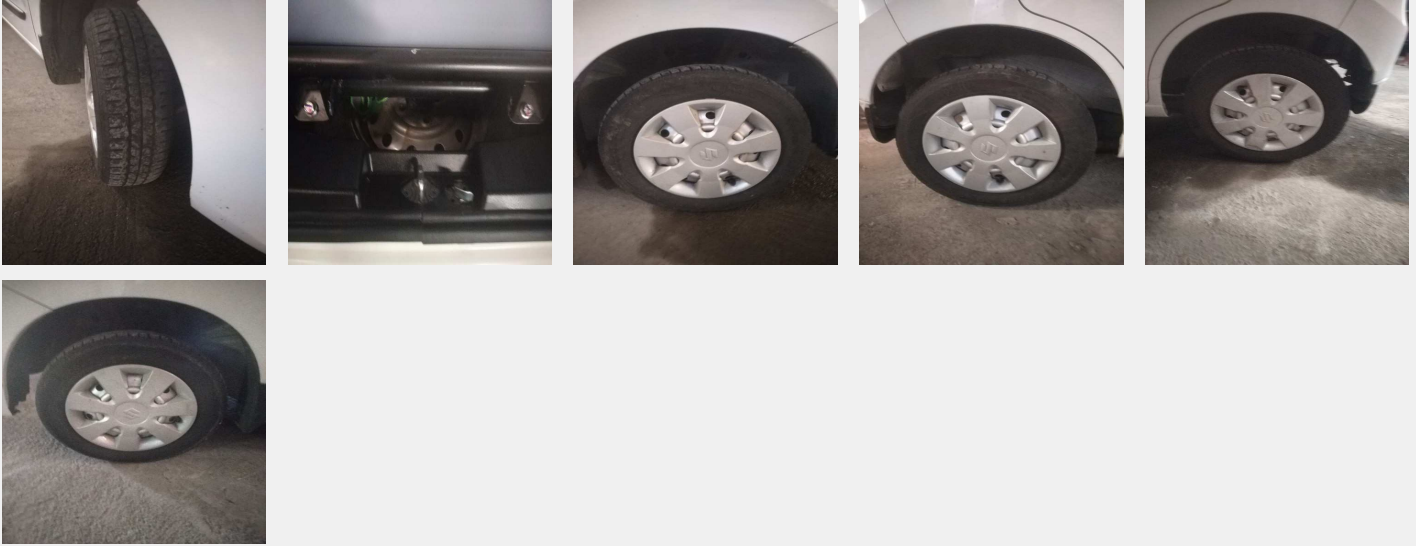
INSPECTION CHECKPOINTS	SCORE(X/10)	REMARKS/COMMENTS	OPTIONAL SPEND EST. (RS)
TYRES	7	GOOD TREAD	0
SPARE TYRE (YES)	7	GOOD CONDITION	0
WHEEL ASSEMBLY (STEEL RIM)	7	GOOD CONDITION	0

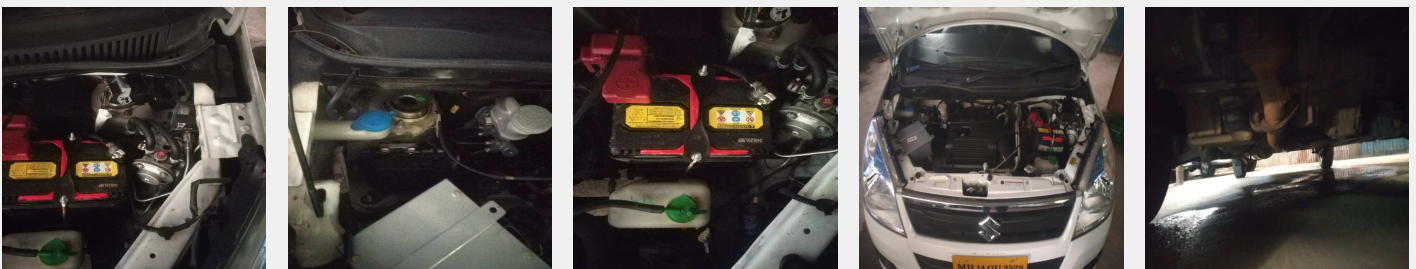
HOOD

INSPECTION CHECKPOINTS	SCORE(X/10)	REMARKS/COMMENTS	OPTIONAL SPEND EST. (RS)
LH APRON	7	GOOD CONDITION	0
RH APRON	7	GOOD CONDITION	0
RADIATOR	7	GOOD CONDITION	0
WIRING	7	GOOD CONDITION	0
BATTERY	7	FULLY CHARGE	0
BRAKE FLUID LEVEL	7	MAX LEVEL	0
ENGINE OIL	7	MAX LEVEL	0
COOLANT LEVEL	7	MAX LEVEL	0
BRAKE & COOLANT HOSE PIPES	7	GOOD CONDITION	0
UNDERCARRIAGE	7	NO RUSTY	0
EXHAUST SYSTEM	7	NO SMOKE	0

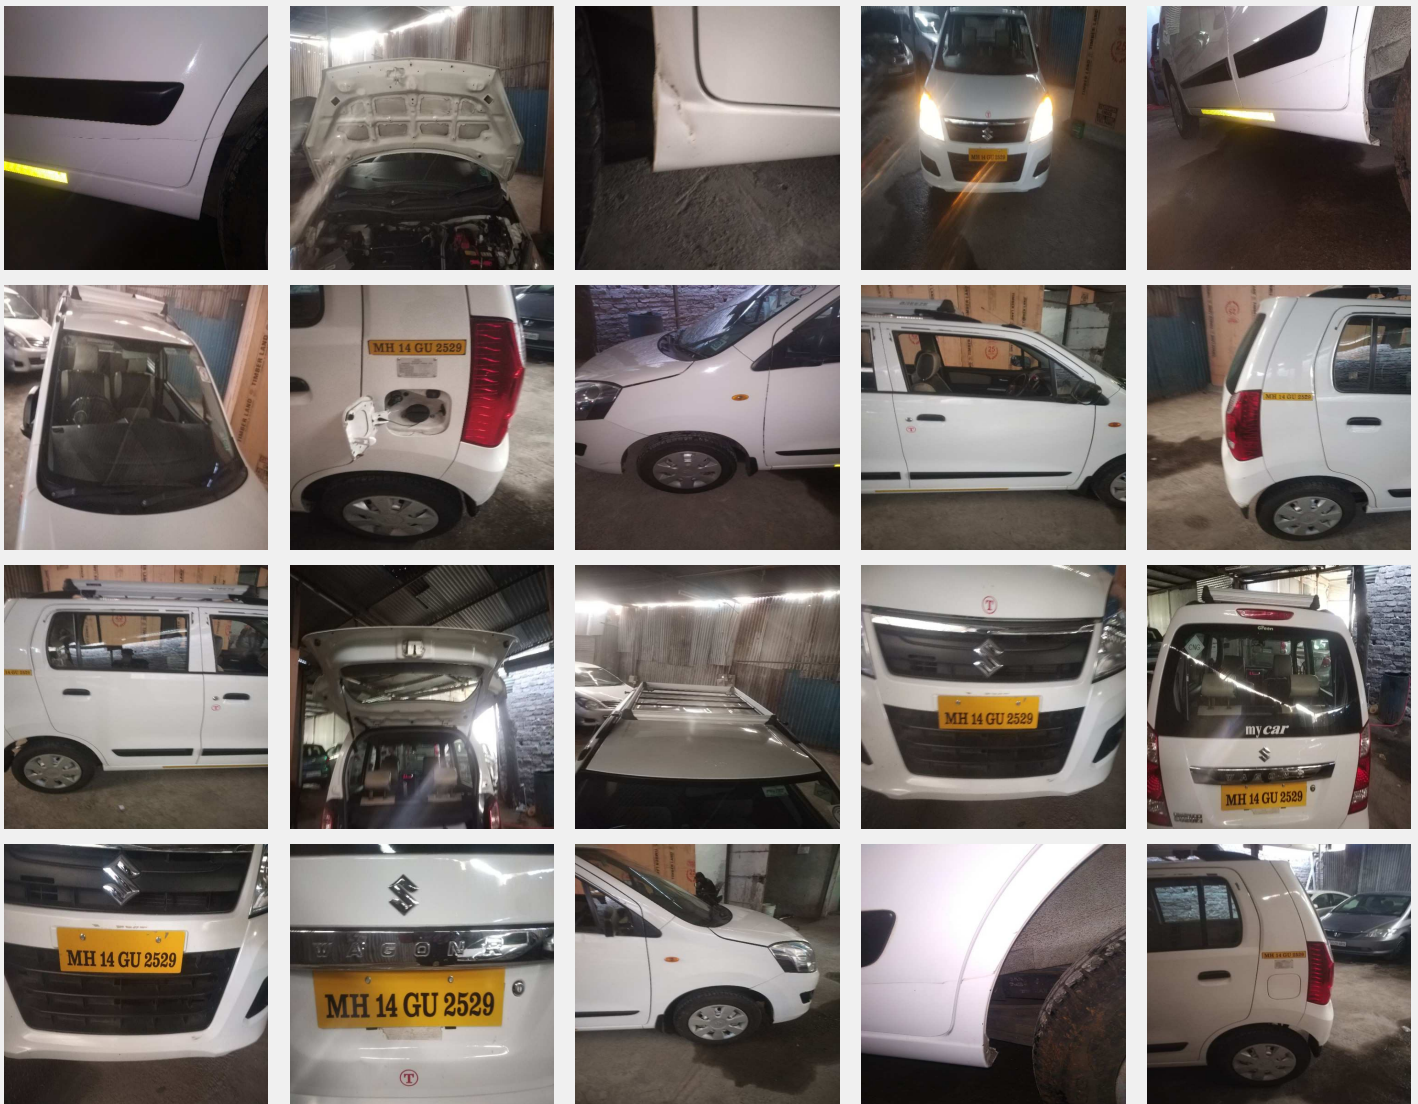
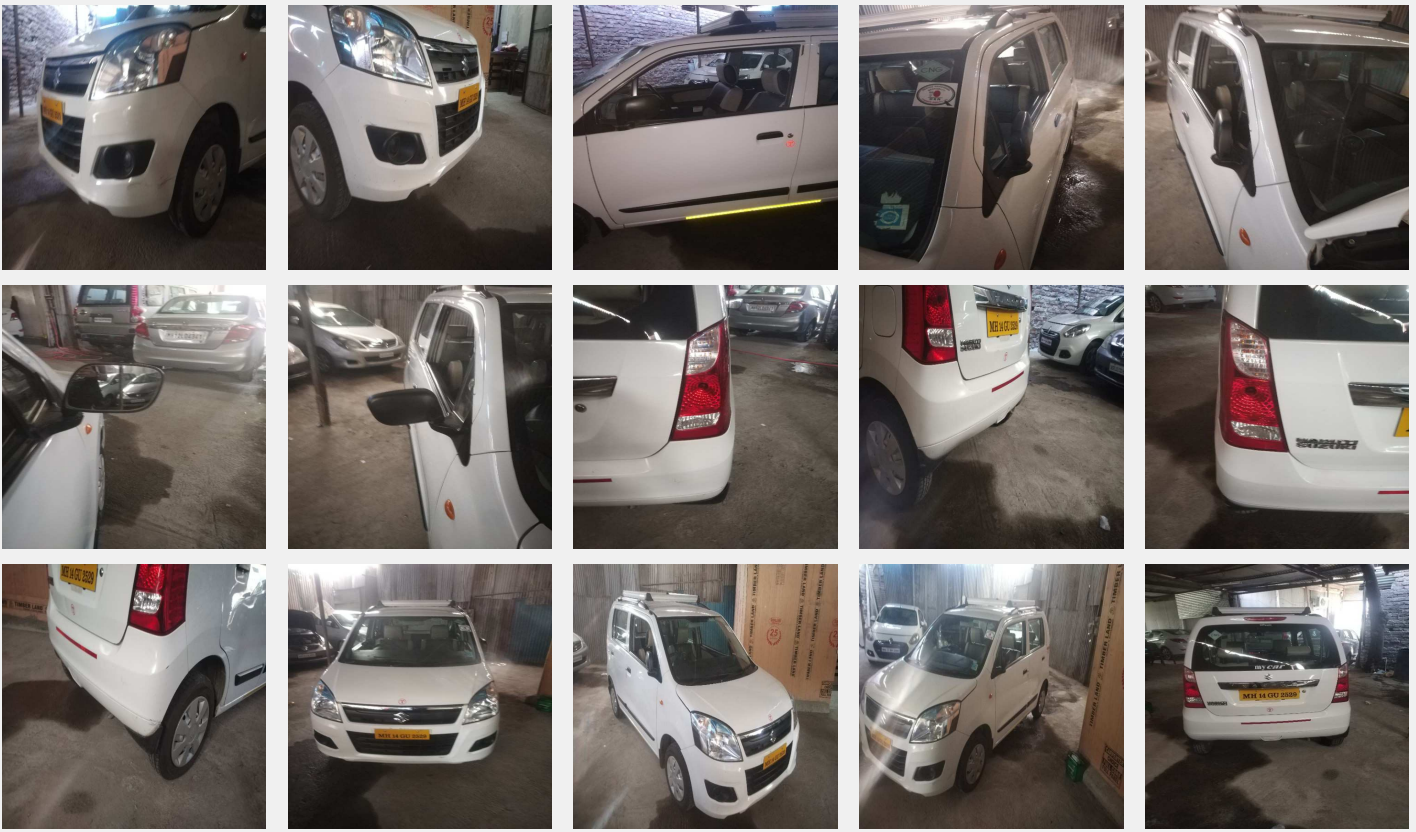
EXTERIOR (CONTINUED)

INSPECTION CHECKPOINTS	SCORE(X/10)	REMARKS/COMMENTS	OPTIONAL SPEND EST. (RS)
LICENSE PLATE	7	GOOD CONDITION	0
FRONT BUMPER	7	SCRATCH ON IT	0
HEAD LIGHTS	7	GOOD CONDITION	0
GRILLE	7	GOOD CONDITION	0
TURN SIGNAL	7	WORKING	0
HOOD	7	GOOD CONDITION	0
PILLAR	7	GOOD CONDITION	0
FRONT WINDSHIELD	7	GOOD VISIBILITY	0
SIDE VIEW MIRRORS	7	GOOD CONDITION	0
LH FENDER	7	GOOD CONDITION	0
LH FRONT DOOR	7	GOOD CONDITION	0
LH REAR DOOR	6	SCRATCH ON IT	800
LH RUNNING BOARD	7	GOOD CONDITION	0
LH QUARTER PANEL	6	SCRATCH ON IT	0
FUEL LID	7	GOOD CONDITION	0
REAR WINDSHIELD	7	GOOD VISIBILITY	0
REAR BUMPER	7	SCRATCH ON IT	0
TAIL LIGHT	7	GOOD CONDITION	0
TRUNK LID/TAIL GATE	7	GOOD CONDITION	0
RH QUARTER PANEL	7	GOOD CONDITION	0
RH RUNNING BOARD	6	DAMAGED	0
RH REAR DOOR	7	GOOD CONDITION	0
RH FRONT DOOR	7	GOOD CONDITION	0
RH FENDER	7	GOOD CONDITION	0

INSPECTION CHECKPOINTS	SCORE(X/10)	REMARKS/COMMENTS	OPTIONAL SPEND EST. (RS)
BODY RUST	7	NO BODY RUST	0
ROOF (REGULAR)	7	GOOD CONDITION	0
PAINT CONDITION	7	GOOD CONDITION	0
FOG LAMPS	5	NOT AVAILABLE	0
LUGGAGE COMPARTMENT LIGHT	5	NO SPACE	0
