# ECO INSPECTION CERTIFICATE

121 Points Vehicle Inspection Certificate

Ordered By : Rahul Monga	Inspection Date : 2019-04-22	Location : LUDHIANA	Inspected By

## Nissan Micra Xv Diesel, 2011

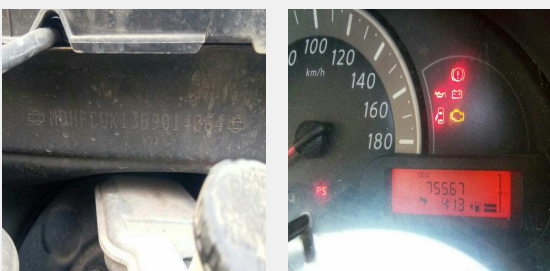
## IMAGES

INSPECTION CHECKPOINTS	SCORE(X/10)	REMARKS/COMMENTS	OPTIONAL SPEND EST. (RS)
STEERING PERFORMANCE	7	GOOD	0
BRAKE PERFORMANCE	8	WELL	0
CLUTCH PERFORMANCE	8	GOOD	0
ENGINE NOISE	7	LESS NOISE	0
IGNITION SYSTEM	8	SMOOTH	0
SUSPENSION PERFORMANCE	7	SAFE	0
SUSPENSION FRONT SHOCKS	8	SAFE	0
SUSPENSION REAR SHOCKS	7	GOOD	0
TRANSMISSION ENGAGE	8	SMOOTH	0
CRUISE CONTROL (NO)	10		0
REAR PARKING SENSORS (NO)	10		0
REAR VIEW CAMERA (NO)	10		0

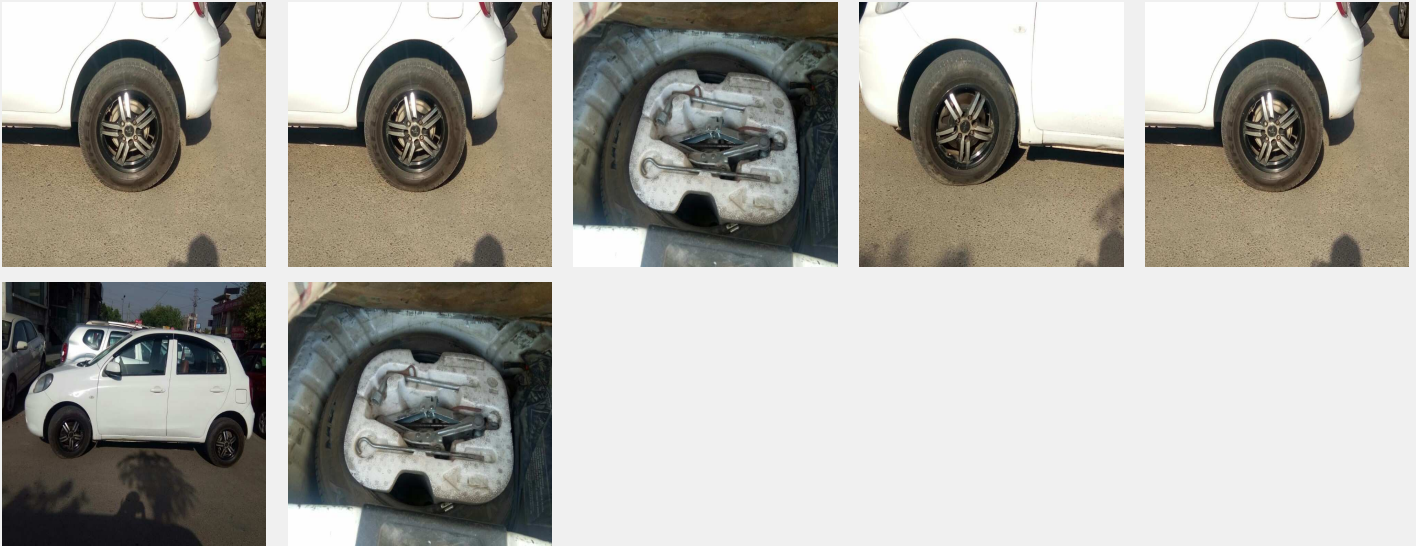
IMAGES

INSPECTION CHECKPOINTS	SCORE(X/10)	REMARKS/COMMENTS	OPTIONAL SPEND EST. (RS)
TYRES	7	GOOD	0
SPARE TYRE (YES)	7	GOOD	0
WHEEL ASSEMBLY (STEEL RIM)	7	GOOD	0

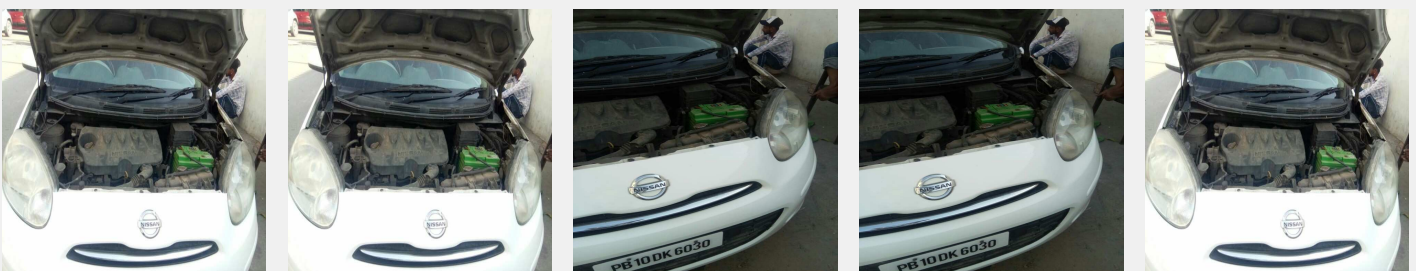
IMAGES

INSPECTION CHECKPOINTS	SCORE(X/10)	REMARKS/COMMENTS	OPTIONAL SPEND EST. (RS)
LH APRON	7	GOOD	0
RH APRON	7	GOOD	0
RADIATOR	8	SAFE	0
WIRING	7	GOOD	0
BATTERY	7	GOOD	0
BRAKE FLUID LEVEL	7	ABOVE AVERAGE	0
ENGINE OIL	7	GOOD	0
COOLANT LEVEL	8	ABOVE AVERAGE	0
BRAKE & COOLANT HOSE PIPES	8	SAFE	0
UNDERCARRIAGE	8	BETTER	0
EXHAUST SYSTEM	7	BETTER	0

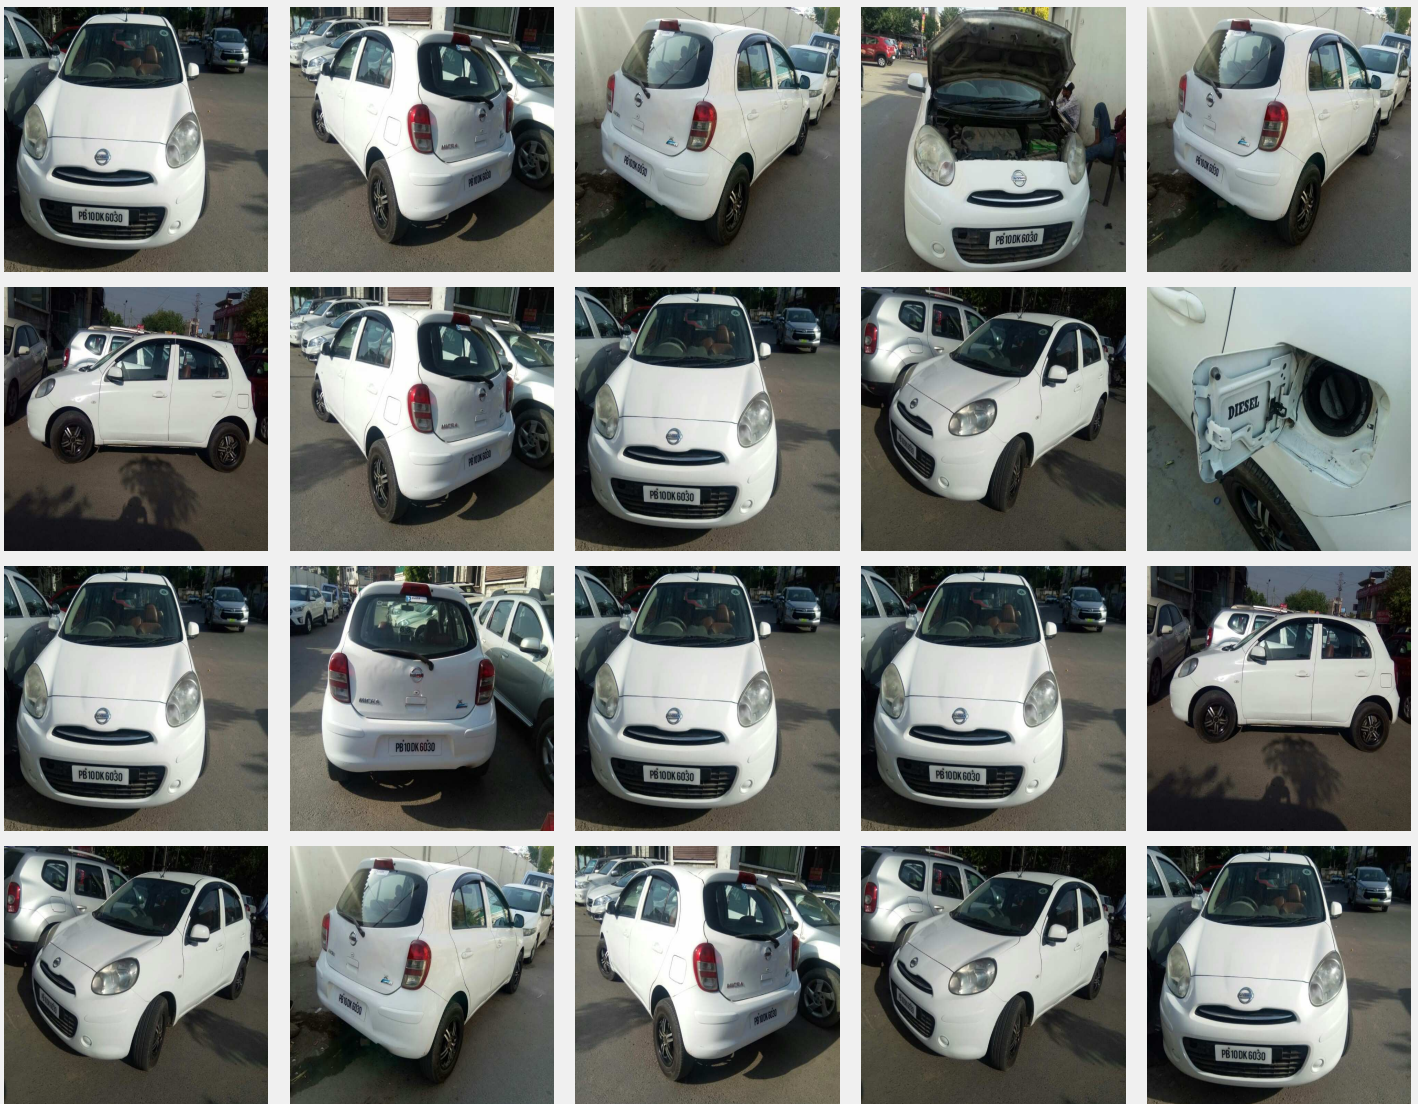
**IMAGES**

INSPECTION CHECKPOINTS	SCORE(X/10)	REMARKS/COMMENTS	OPTIONAL SPEND EST. (RS)
RH FRONT DOOR	7	SAFE	0
RH FENDER	7	SAFE	0
BODY RUST	7	NO RUST	0
ROOF (REGULAR)	7	SMOOTH	0
PAINT CONDITION	8	GOOD	0
