ECO INSPECTION CERTIFICATE

121 Points Vehicle Inspection Certificate

Ordered By : Atul Chotai	Inspection Date : 2019-04-25	Location : NAGPUR	Inspected By

Volkswagen Vento COMFORTLINE PETROL, 2012

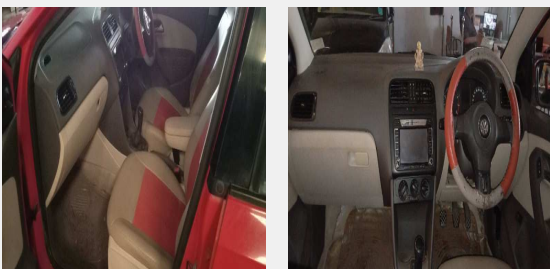
IMAGES

INSPECTION CHECKPOINTS	SCORE(X/10)	REMARKS/COMMENTS	OPTIONAL SPEND EST. (RS)
DOOR PANEL	6		0
DOOR HINGES	6		0
CARPET & FLOOR MAT	6		0
SEAT & SEAT BELT	6		0
DASHBOARD & INSTRUMENT PANEL	6		0
HORN	6		0
SPEAKERS & MUSIC SYSTEM	6		0
HANDBRAKE	6		0
PEDALS	6		0
CENTRAL LOCK	6		0
A/C VENTS & HEATER	6		0
CUP HOLDERS	6		0
NAVIGATION (NO)	10		0
ODOMETER	6		0
POWER WINDOWS (YES)	6		0
HAZARD LIGHT	6		0
STEERING-MOUNTED CONTROLS	0	NA	5000

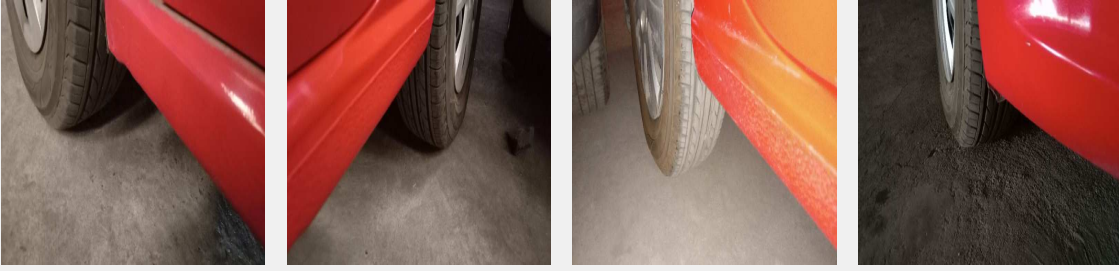
IMAGES

INSPECTION CHECKPOINTS	SCORE(X/10)	REMARKS/COMMENTS	OPTIONAL SPEND EST. (RS)
TYRES	6		0
SPARE TYRE (YES)	6		0
WHEEL ASSEMBLY (STEEL RIM)	6		0

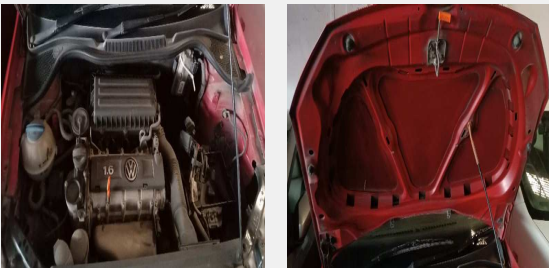
IMAGES

INSPECTION CHECKPOINTS	SCORE(X/10)	REMARKS/COMMENTS	OPTIONAL SPEND EST. (RS)
LH APRON	6		0
RH APRON	6		0
RADIATOR	6		0
WIRING	6		0
BATTERY	6		0
BRAKE FLUID LEVEL	6		0
ENGINE OIL	6		0
COOLANT LEVEL	6		0
BRAKE & COOLANT HOSE PIPES	6		0
UNDERCARRIAGE	6		0
EXHAUST SYSTEM	6		0
