ECO INSPECTION CERTIFICATE

121 Points Vehicle Inspection Certificate

Ordered By : Roahan	Inspection Date : 2019-04-27	Location : INDRANAGAR	Inspected By

Maruti Suzuki Eeco 5 STR AC, 2011

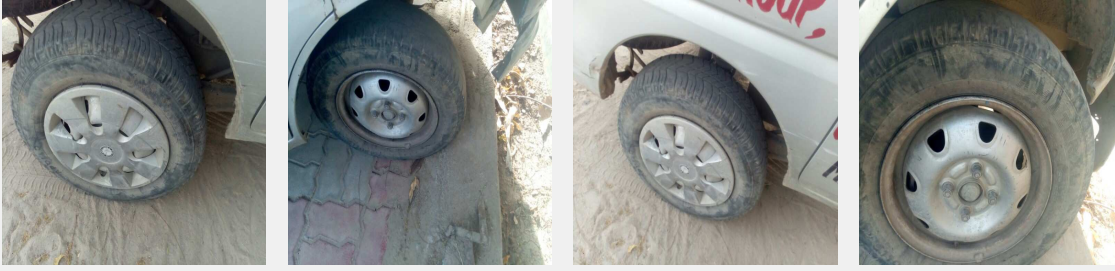
INSPECTION CHECKPOINTS	SCORE(X/10)	REMARKS/COMMENTS	OPTIONAL SPEND EST. (RS)
TYRES	6		5000
SPARE TYRE (YES)	6		0
WHEEL ASSEMBLY (STEEL RIM)	6		0
