ECO INSPECTION CERTIFICATE

Order ID : 65813

121 Points Vehicle Inspection Certificate

Hyundai Accent Executive, 2008

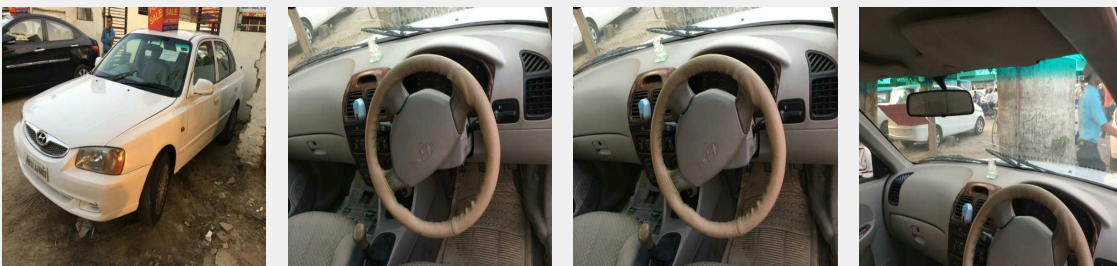
INSPECTION CHECKPOINTS	SCORE(X/10)	REMARKS/COMMENTS	OPTIONAL SPEND EST. (RS)
DOOR PANEL	7	GOOD	0
DOOR HINGES	7	OK	0
CARPET & FLOOR MAT	7	GOOD	0
SEAT & SEAT BELT	7	SAFE	0
DASHBOARD & INSTRUMENT PANEL	7	OK	0
HORN	7	OK	0
SPEAKERS & MUSIC SYSTEM	7	WORKING	0
HANDBRAKE	7	SAFE	0
STEERING-MOUNTED CONTROLS	8	GOOD	0
PEDALS	7	SAFE	0
CENTRAL LOCK	6	OK	0
A/C VENTS & HEATER	7	WORKING	0
CUP HOLDERS	6	OK	0
NAVIGATION (NO)	10		0
ODOMETER	7	OK	0
POWER WINDOWS (YES - FRONT ONLY)	7	OK	0
HAZARD LIGHT	6	OK	0

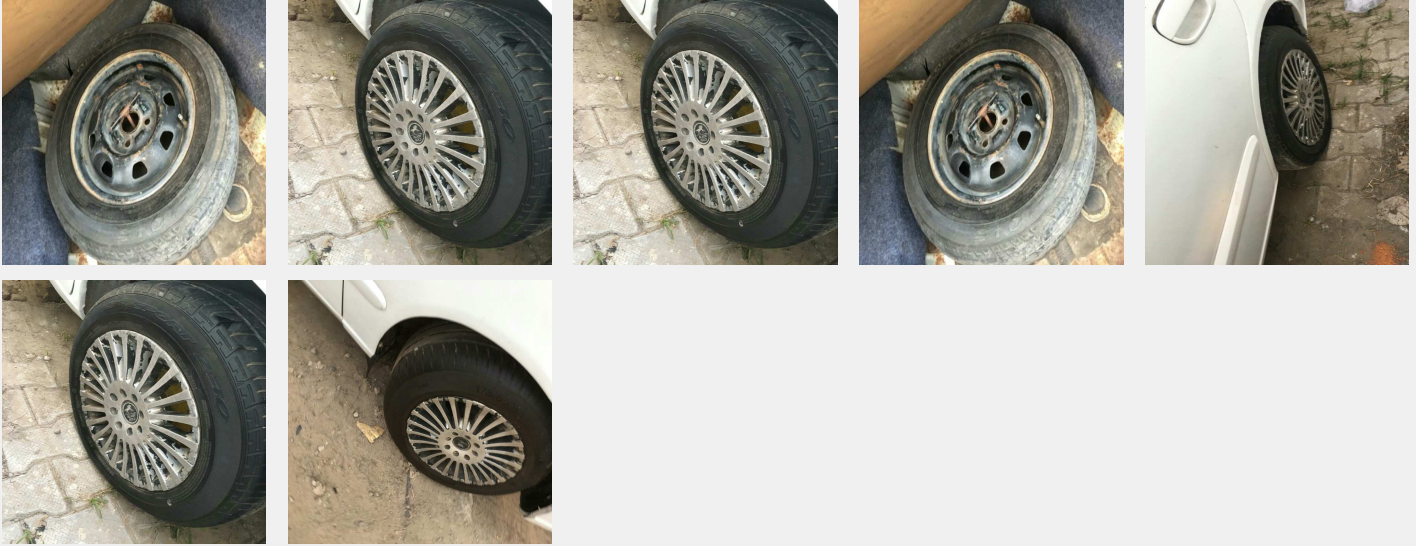
INSPECTION CHECKPOINTS	SCORE(X/10)	REMARKS/COMMENTS	OPTIONAL SPEND EST. (RS)
TYRES	7	GOOD	0
SPARE TYRE (YES)	6	OK	0
WHEEL ASSEMBLY (STEEL RIM)	7	GOOD	0

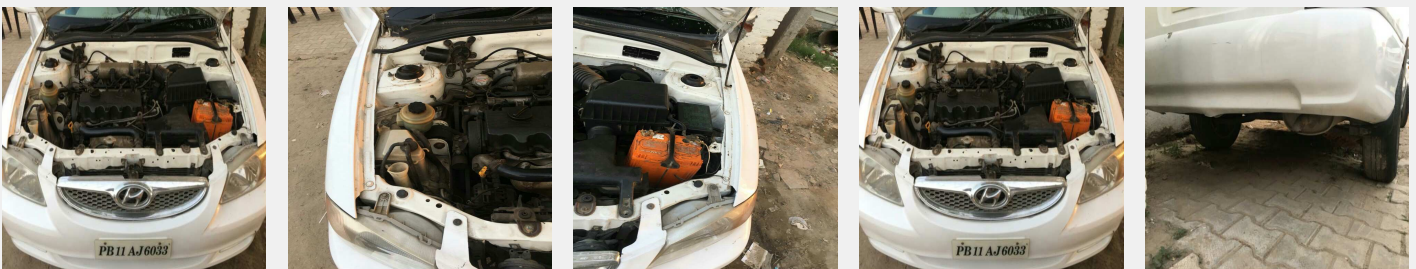
INSPECTION CHECKPOINTS	SCORE(X/10)	REMARKS/COMMENTS	OPTIONAL SPEND EST. (RS)
LH APRON	7	GOOD	0
RH APRON	7	GOOD	0
RADIATOR	7	GOOD	0
WIRING	8	WORKING	0
BATTERY	8	GOOD	0
BRAKE FLUID LEVEL	8	ABOVE AVRAGE	0
ENGINE OIL	7	GOOD	0
COOLANT LEVEL	7	SAFE	0
BRAKE & COOLANT HOSE PIPES	7	GOOD	0
UNDERCARRIAGE	6	OK	0
EXHAUST SYSTEM	7	OK	0

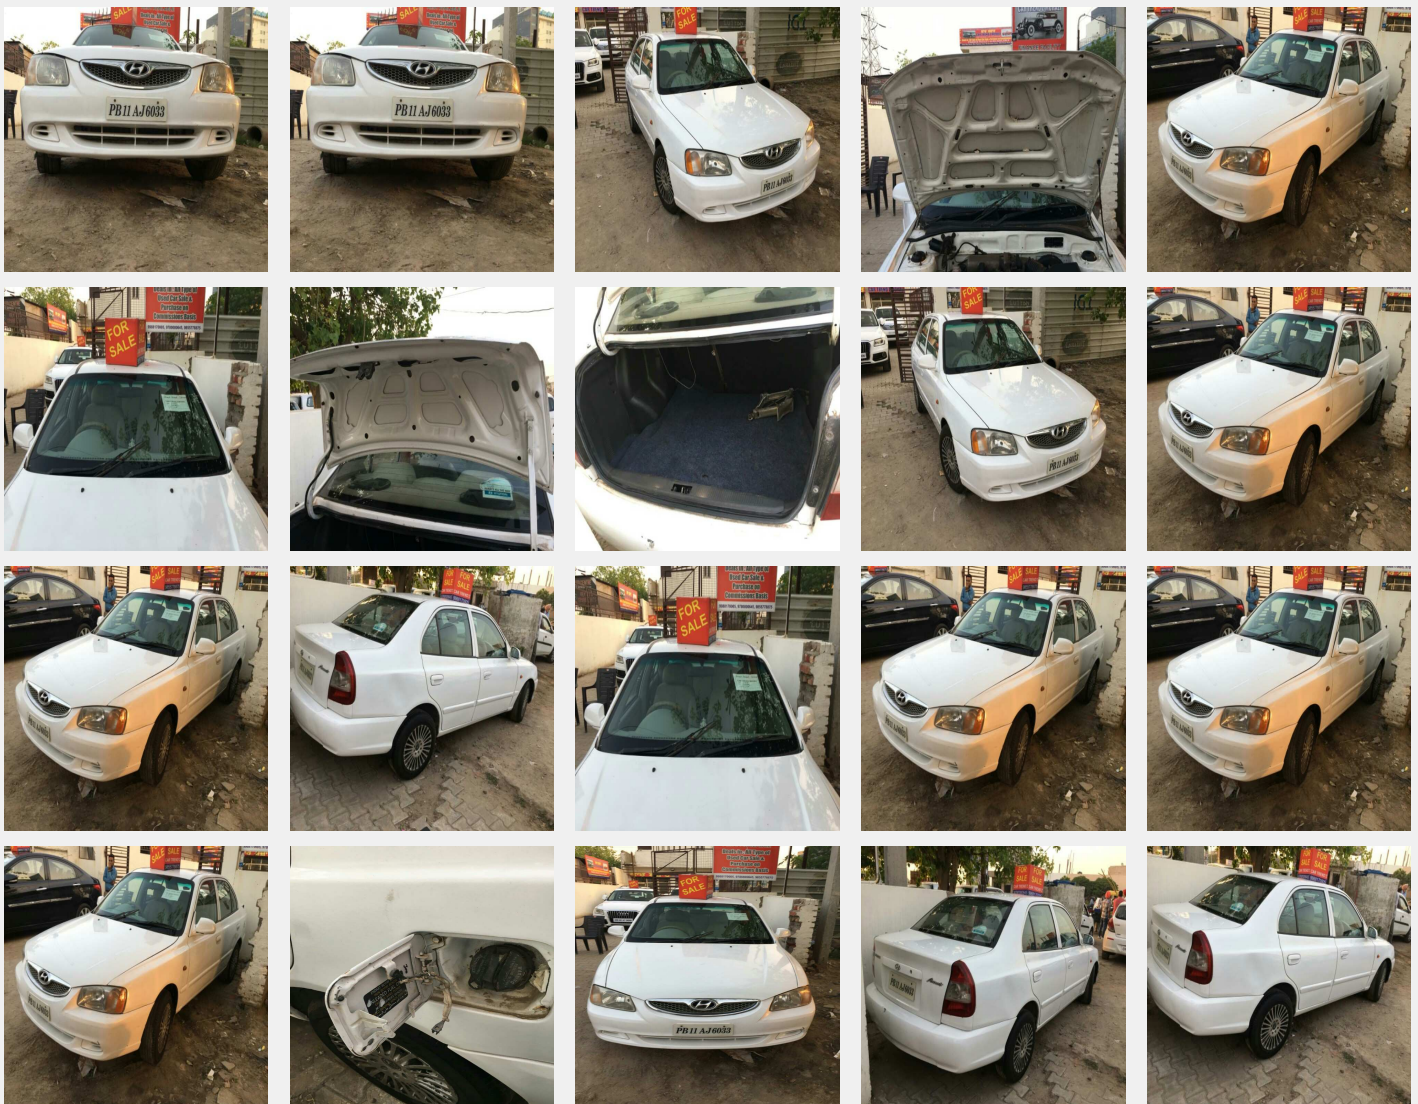
INSPECTION CHECKPOINTS	SCORE(X/10)	REMARKS/COMMENTS	OPTIONAL SPEND EST. (RS)
RH FRONT DOOR	7	OK	0
RH FENDER	7	GOOD	0
BODY RUST	7	NO RUST	0
ROOF (REGULAR)	7	OK	0
PAINT CONDITION	7	OK	0

good
