# ECO INSPECTION CERTIFICATE

121 Points Vehicle Inspection Certificate

Ordered By : Harshit	Inspection Date : 2019-04-15	Location : SAMA	Inspected By

## Tata Safari 4X2 VX DICOR BS IV, 2011

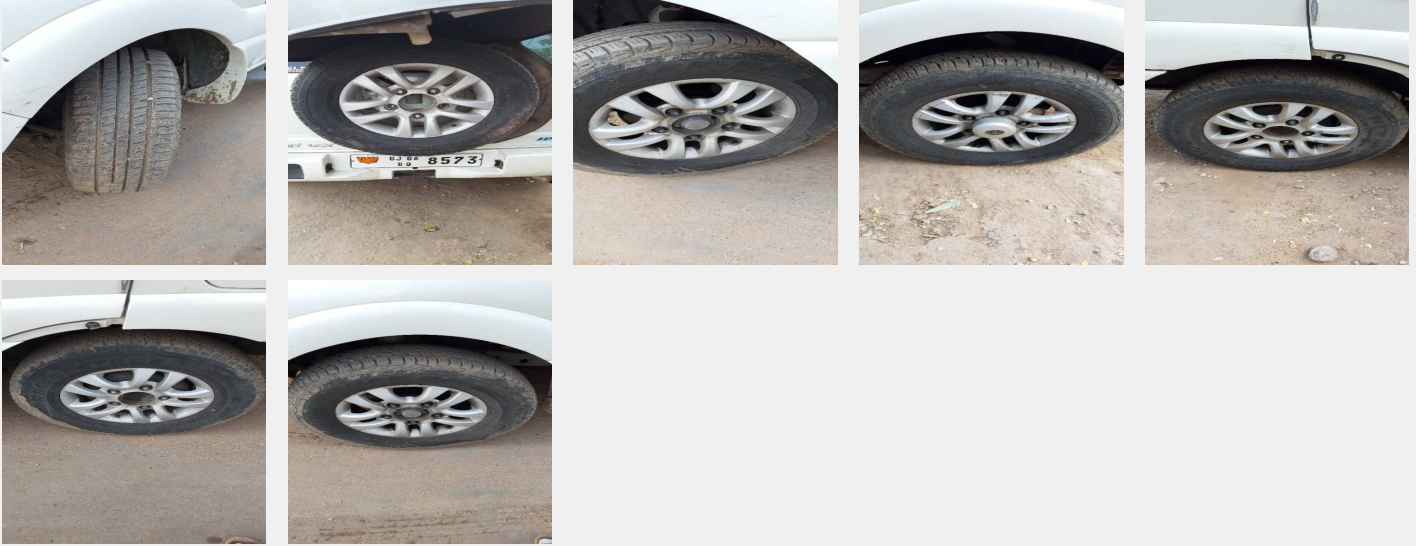
IMAGES

INSPECTION CHECKPOINTS	SCORE(X/10)	REMARKS/COMMENTS	OPTIONAL SPEND EST. (RS)
TYRES	7		0
SPARE TYRE (YES)	7		0
WHEEL ASSEMBLY (ALLOY RIM)	7		0

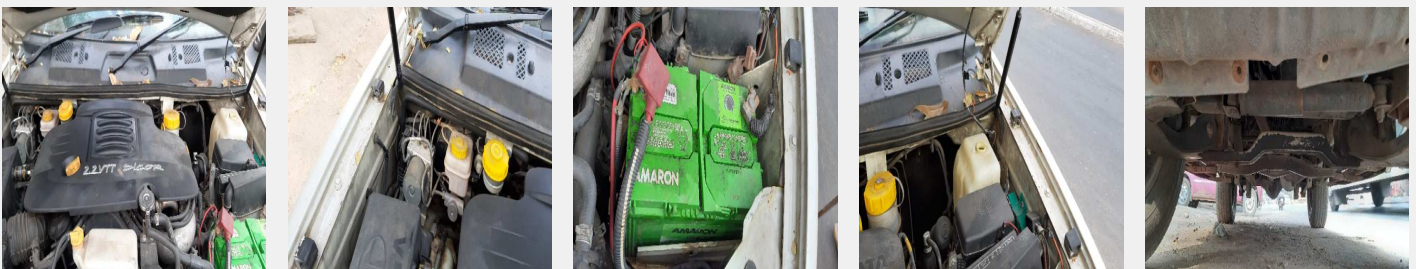
IMAGES

INSPECTION CHECKPOINTS	SCORE(X/10)	REMARKS/COMMENTS	OPTIONAL SPEND EST. (RS)
LH APRON	7		0
RH APRON	7		0
RADIATOR	8		0
WIRING	9		0
BATTERY	8		0
BRAKE FLUID LEVEL	8		0
ENGINE OIL	9		0
COOLANT LEVEL	9		0
BRAKE & COOLANT HOSE PIPES	10		0
UNDERCARRIAGE	9		0
EXHAUST SYSTEM	8		0

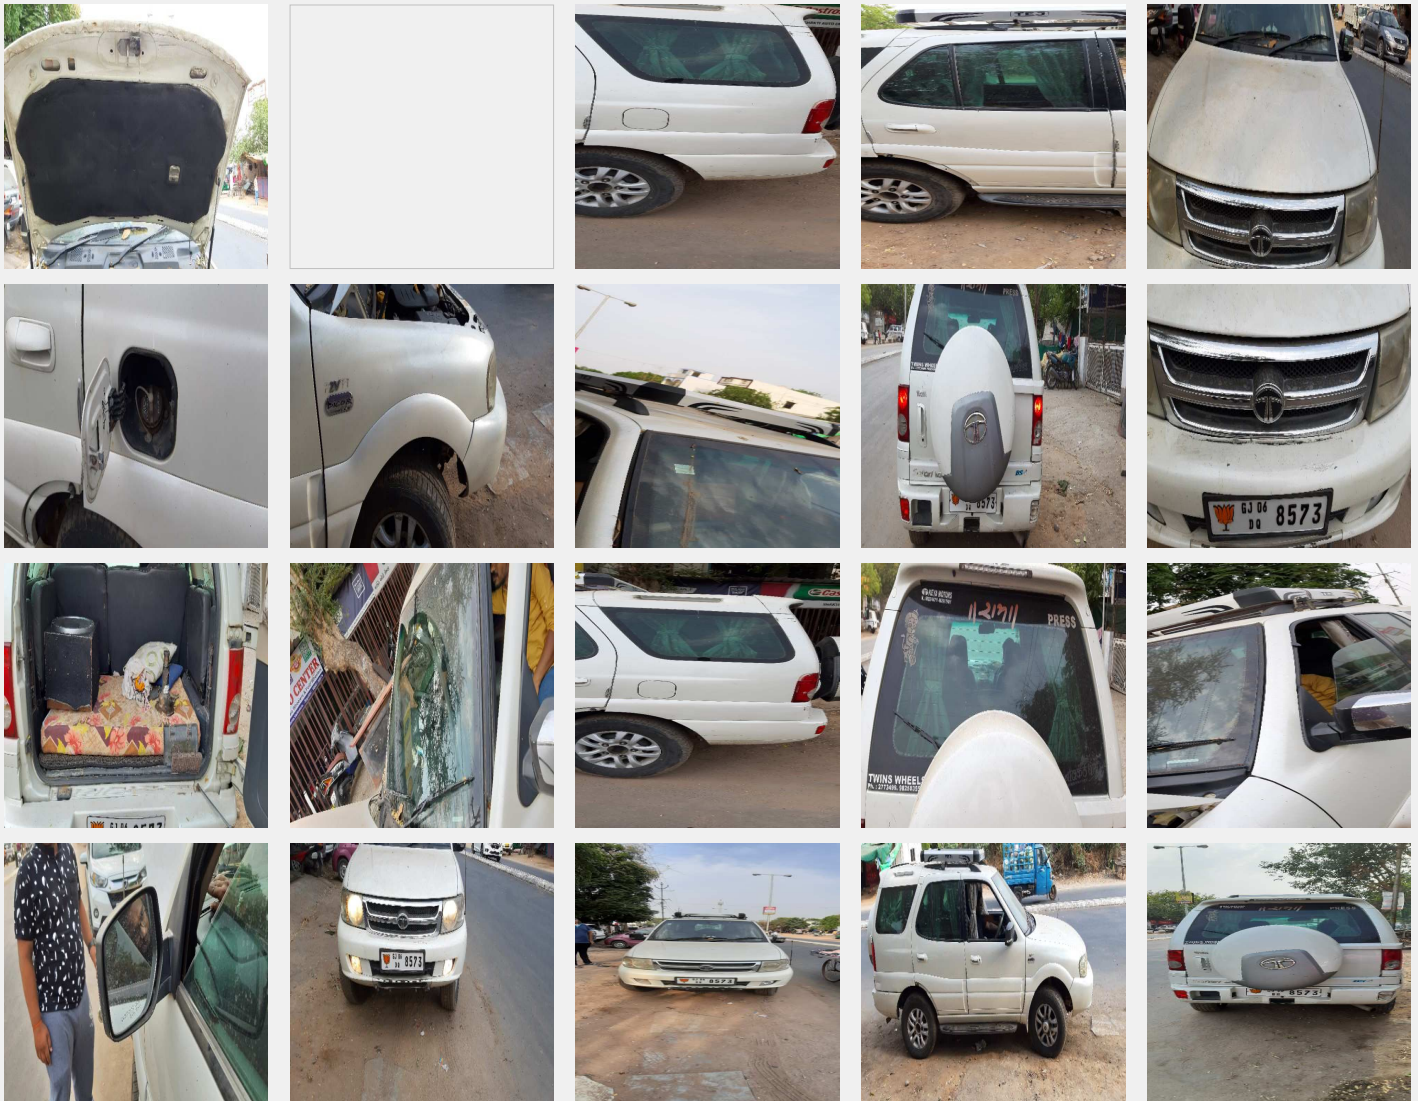
## IMAGES

INSPECTION CHECKPOINTS	SCORE(X/10)	REMARKS/COMMENTS	OPTIONAL SPEND EST. (RS)
HEAD LIGHTS	5	HED LIGHT GLASS DALL	5000
LH FENDER	4	SCRATCH	5000
LH FRONT DOOR	5	SCRATCH	2000
LH REAR DOOR	5	SCRATCH	3000
TRUNK LID/TAIL GATE	5	NOT WORKING	10000

some body part and scrch and dented
