ECO INSPECTION CERTIFICATE

Order ID : 68343

121 Points Vehicle Inspection Certificate

Skoda Rapid 1.6 MPI ELEGANCE, 2014

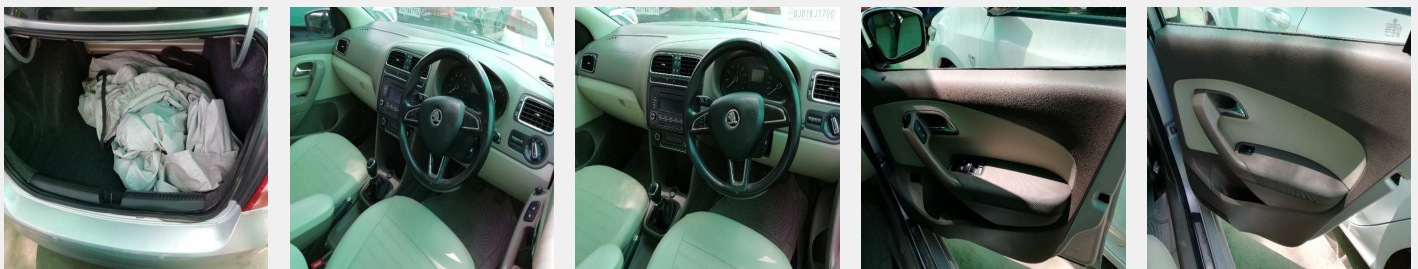
INTERIOR

INSPECTION CHECKPOINTS	SCORE(X/10)	REMARKS/COMMENTS	OPTIONAL SPEND EST. (RS)
DOOR PANEL	8	GOOD CONDITION	0
DOOR HINGES	8	GOOD CONDITION	0
CARPET & FLOOR MAT	8	GOOD CONDITION	0
SEAT & SEAT BELT	8	GOOD CONDITION	0
DASHBOARD & INSTRUMENT PANEL	8	GOOD CONDITION	0
HORN	8	GOOD CONDITION	0
SPEAKERS & MUSIC SYSTEM	8	GOOD CONDITION	0
HANDBRAKE	8	GOOD CONDITION	0
STEERING-MOUNTED CONTROLS	8	GOOD CONDITION	0
PEDALS	8	GOOD CONDITION	0
CENTRAL LOCK	8	GOOD CONDITION	0
A/C VENTS & HEATER	8	GOOD CONDITION	0
CUP HOLDERS	8	GOOD CONDITION	0
NAVIGATION (NO)	10		0
ODOMETER	8	GOOD CONDITION	0
POWER WINDOWS (YES)	8	GOOD CONDITION	0
HAZARD LIGHT	8	GOOD CONDITION	0

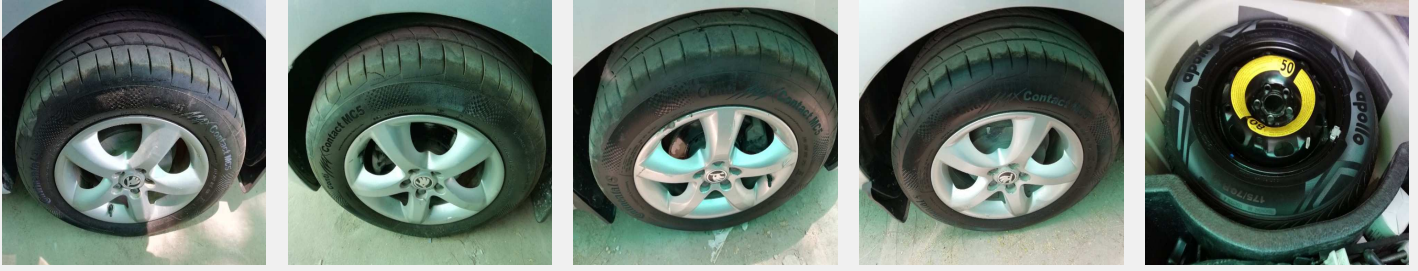
INSPECTION CHECKPOINTS	SCORE(X/10)	REMARKS/COMMENTS	OPTIONAL SPEND EST. (RS)
TYRES	7	GOOD CONDITION	0
SPARE TYRE (YES)	8	GOOD CONDITION	0
WHEEL ASSEMBLY (ALLOY RIM)	8	GOOD CONDITION	0

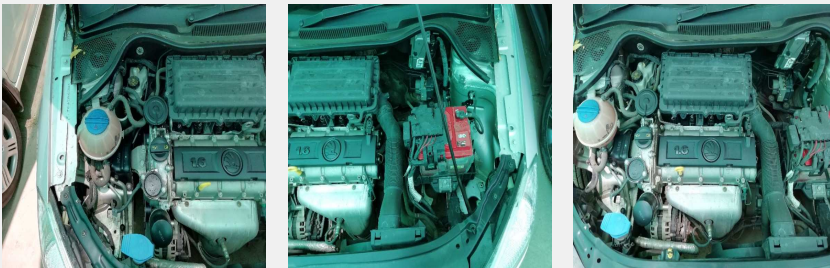
HOOD

INSPECTION CHECKPOINTS	SCORE(X/10)	REMARKS/COMMENTS	OPTIONAL SPEND EST. (RS)
LH APRON	8	GOOD CONDITION	0
RH APRON	8	GOOD CONDITION	0
RADIATOR	7	GOOD CONDITION	0
WIRING	8	GOOD CONDITION	0
BATTERY	7	GOOD CONDITION	0
BRAKE FLUID LEVEL	7	GOOD CONDITION	0
ENGINE OIL	7	GOOD CONDITION	0
COOLANT LEVEL	7	GOOD CONDITION	0
BRAKE & COOLANT HOSE PIPES	8	GOOD CONDITION	0
UNDERCARRIAGE	8	GOOD CONDITION	0
EXHAUST SYSTEM	8	GOOD CONDITION	0
