ECO INSPECTION CERTIFICATE

Order ID : 68805

121 Points Vehicle Inspection Certificate

Toyota Innova 2.5 G, 2006

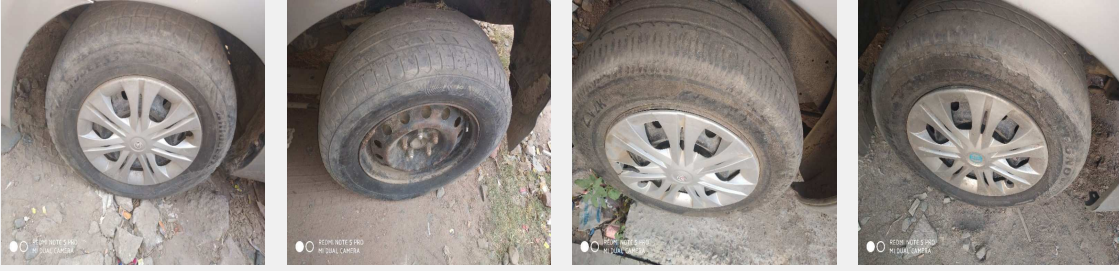
IMAGES

INSPECTION CHECKPOINTS	SCORE(X/10)	REMARKS/COMMENTS	OPTIONAL SPEND EST. (RS)
TYRES	6		0
SPARE TYRE (YES)	6		0
WHEEL ASSEMBLY (STEEL RIM)	6		0

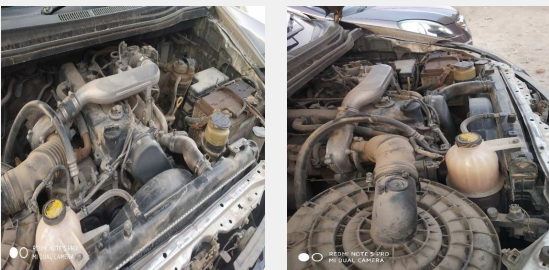
IMAGES

INSPECTION CHECKPOINTS	SCORE(X/10)	REMARKS/COMMENTS	OPTIONAL SPEND EST. (RS)
LH APRON	6		0
RH APRON	6		0
RADIATOR	6		0
WIRING	6		0
BATTERY	6		0
BRAKE FLUID LEVEL	6		0
ENGINE OIL	6		0
COOLANT LEVEL	6		0
BRAKE & COOLANT HOSE PIPES	6		0
UNDERCARRIAGE	7		0
EXHAUST SYSTEM	6		0
