ECO INSPECTION CERTIFICATE

Order ID : 58024

121 Points Vehicle Inspection Certificate

Chevrolet Beat Lt Diesel, 2013

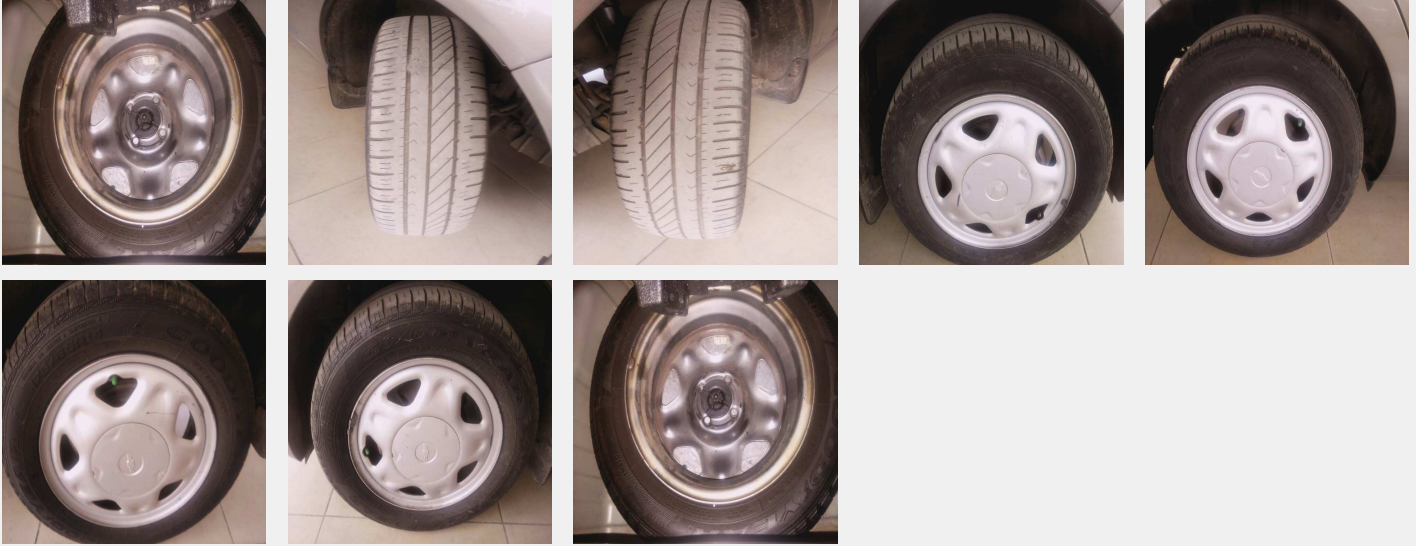
IMAGES

INSPECTION CHECKPOINTS	SCORE(X/10)	REMARKS/COMMENTS	OPTIONAL SPEND EST. (RS)
TYRES	7		0
SPARE TYRE (YES)	8		0
WHEEL ASSEMBLY (STEEL RIM)	8		0

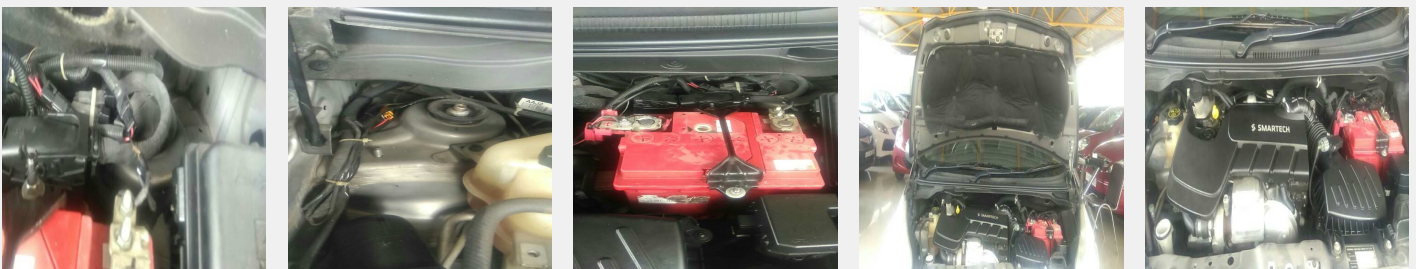
IMAGES

INSPECTION CHECKPOINTS	SCORE(X/10)	REMARKS/COMMENTS	OPTIONAL SPEND EST. (RS)
LH APRON	8		0
RH APRON	8		0
RADIATOR	8		0
WIRING	8		0
BATTERY	8		0
BRAKE FLUID LEVEL	8		0
ENGINE OIL	6		0
COOLANT LEVEL	7		0
BRAKE & COOLANT HOSE PIPES	8		0
UNDERCARRIAGE	8		0
EXHAUST SYSTEM	7		0

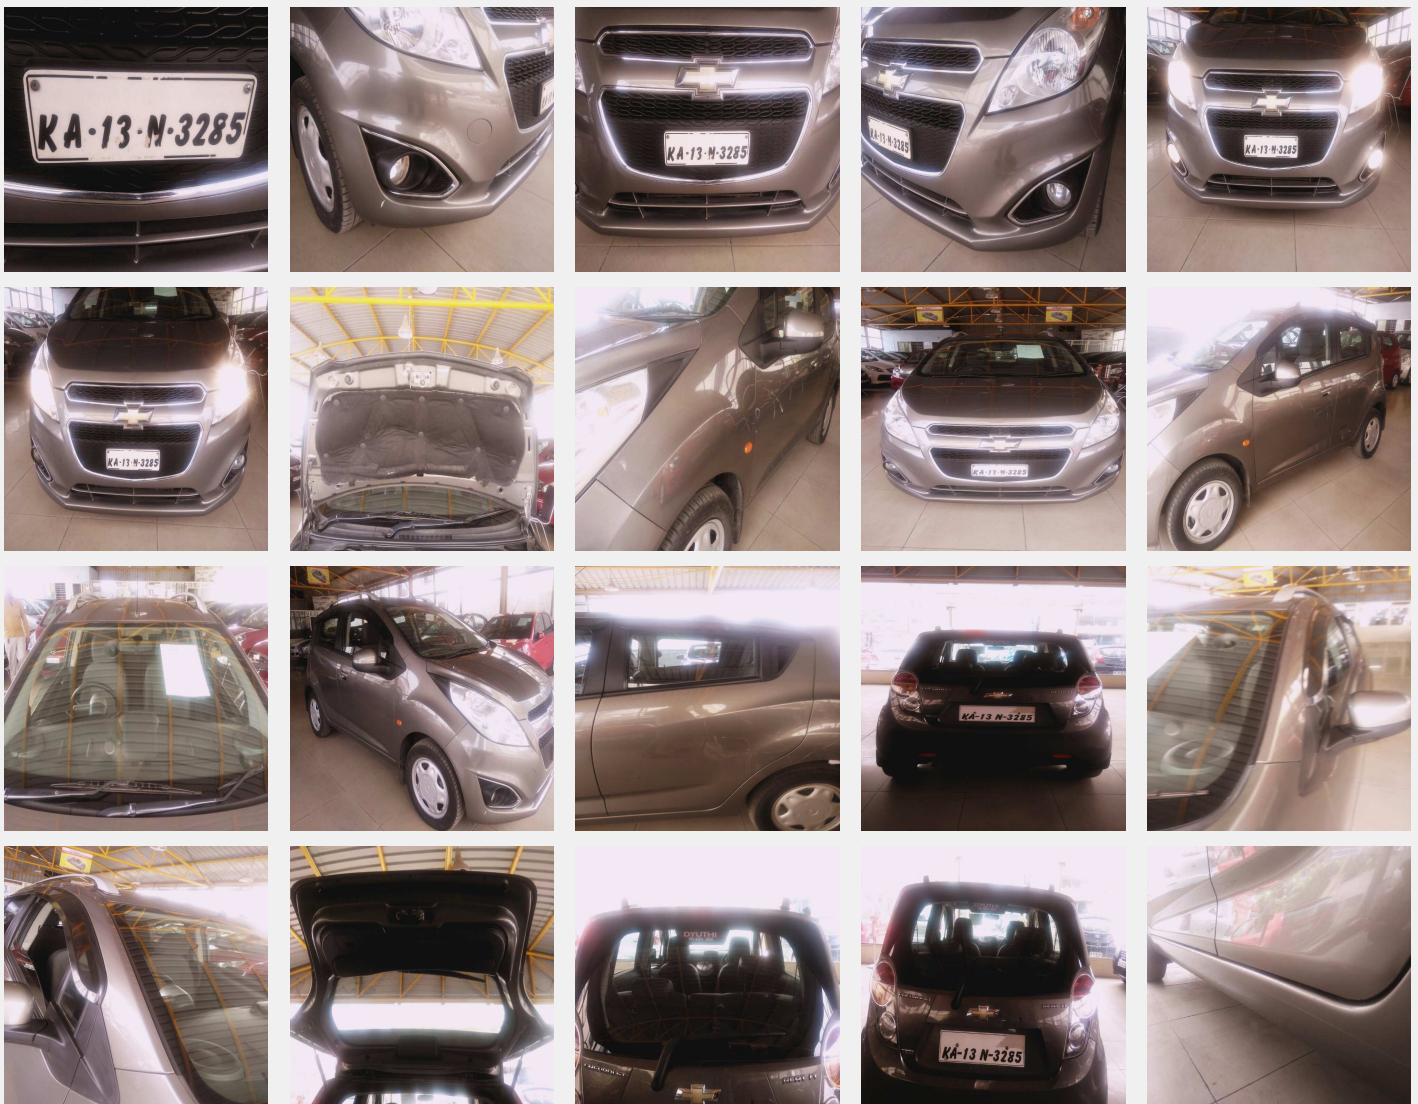
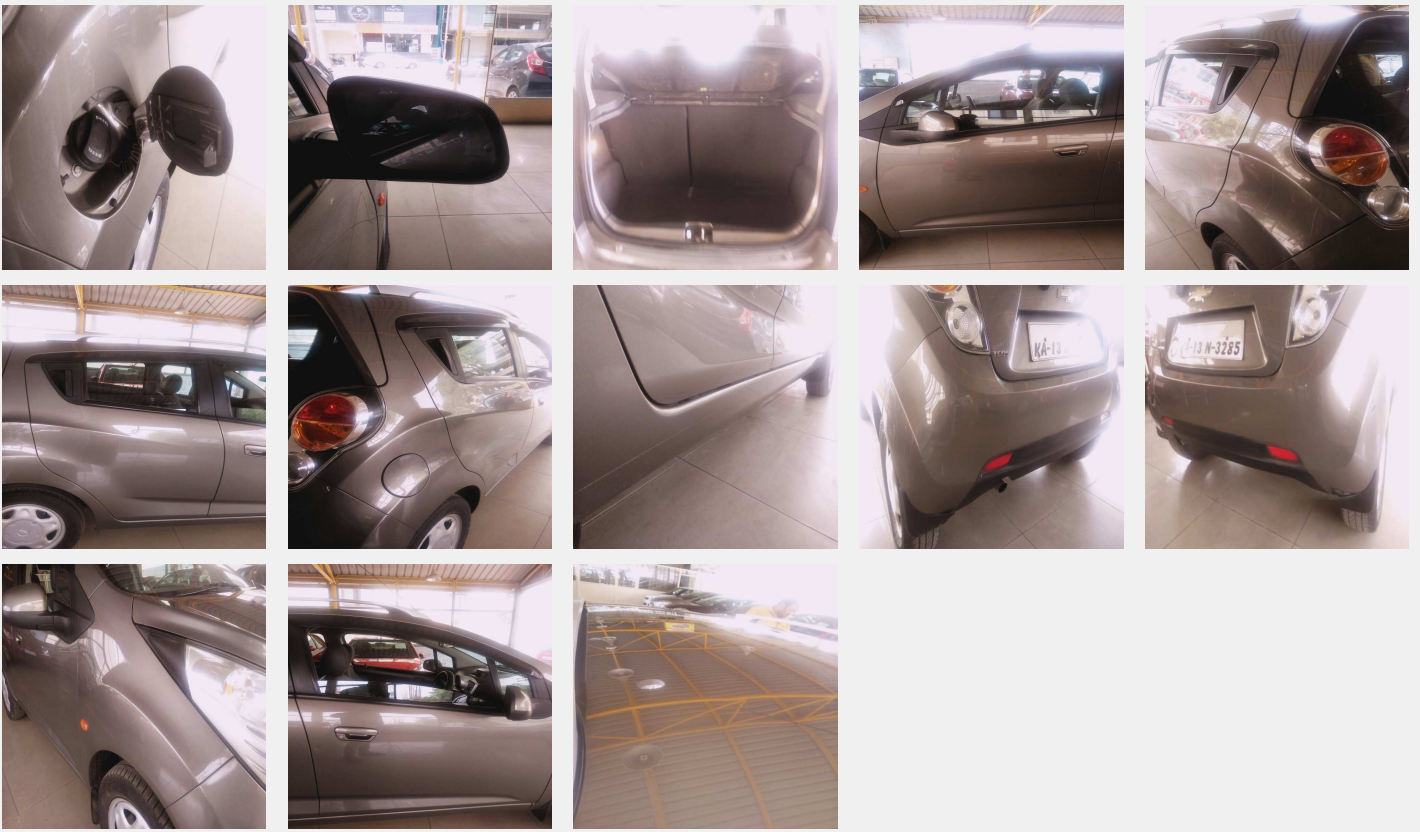
IMAGES

INSPECTION CHECKPOINTS	SCORE(X/10)	REMARKS/COMMENTS	OPTIONAL SPEND EST. (RS)
RH FRONT DOOR	7		0
RH FENDER	8		0
BODY RUST	8		0
ROOF (REGULAR)	8		0
PAINT CONDITION	8		0
