ECO INSPECTION CERTIFICATE

Order ID : 68554

121 Points Vehicle Inspection Certificate

Chevrolet Spark LS 1.0, 2010

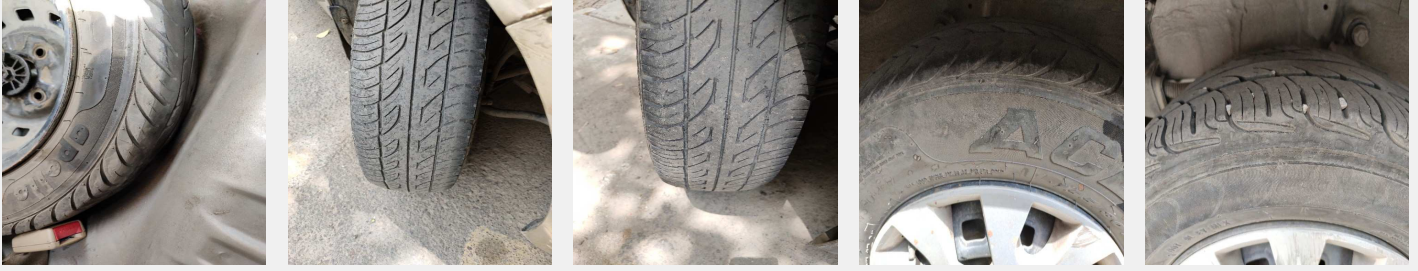
IMAGES

INSPECTION CHECKPOINTS	SCORE(X/10)	REMARKS/COMMENTS	OPTIONAL SPEND EST. (RS)
TYRES	6	AVERAGE CONDITION	0
SPARE TYRE (YES)	6	AVERAGE CONDITION	0
WHEEL ASSEMBLY (STEEL RIM)	6	AVERAGE CONDITION	0

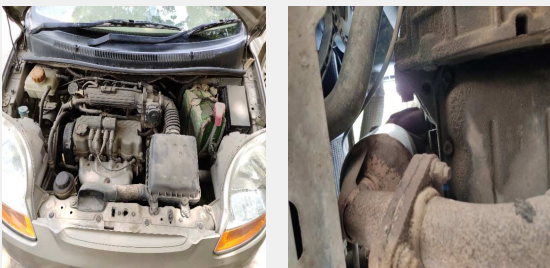
IMAGES

INSPECTION CHECKPOINTS	SCORE(X/10)	REMARKS/COMMENTS	OPTIONAL SPEND EST. (RS)
LH APRON	7		0
RH APRON	7		0
RADIATOR	6	AVERAGE CONDITION	0
WIRING	6	AVERAGE CONDITION	0
BATTERY	7		0
BRAKE FLUID LEVEL	7		0
ENGINE OIL	7		0
COOLANT LEVEL	7		0
BRAKE & COOLANT HOSE PIPES	6	AVERAGE CONDITION	0
UNDERCARRIAGE	6	AVERAGE CONDITION	0
EXHAUST SYSTEM	7		0

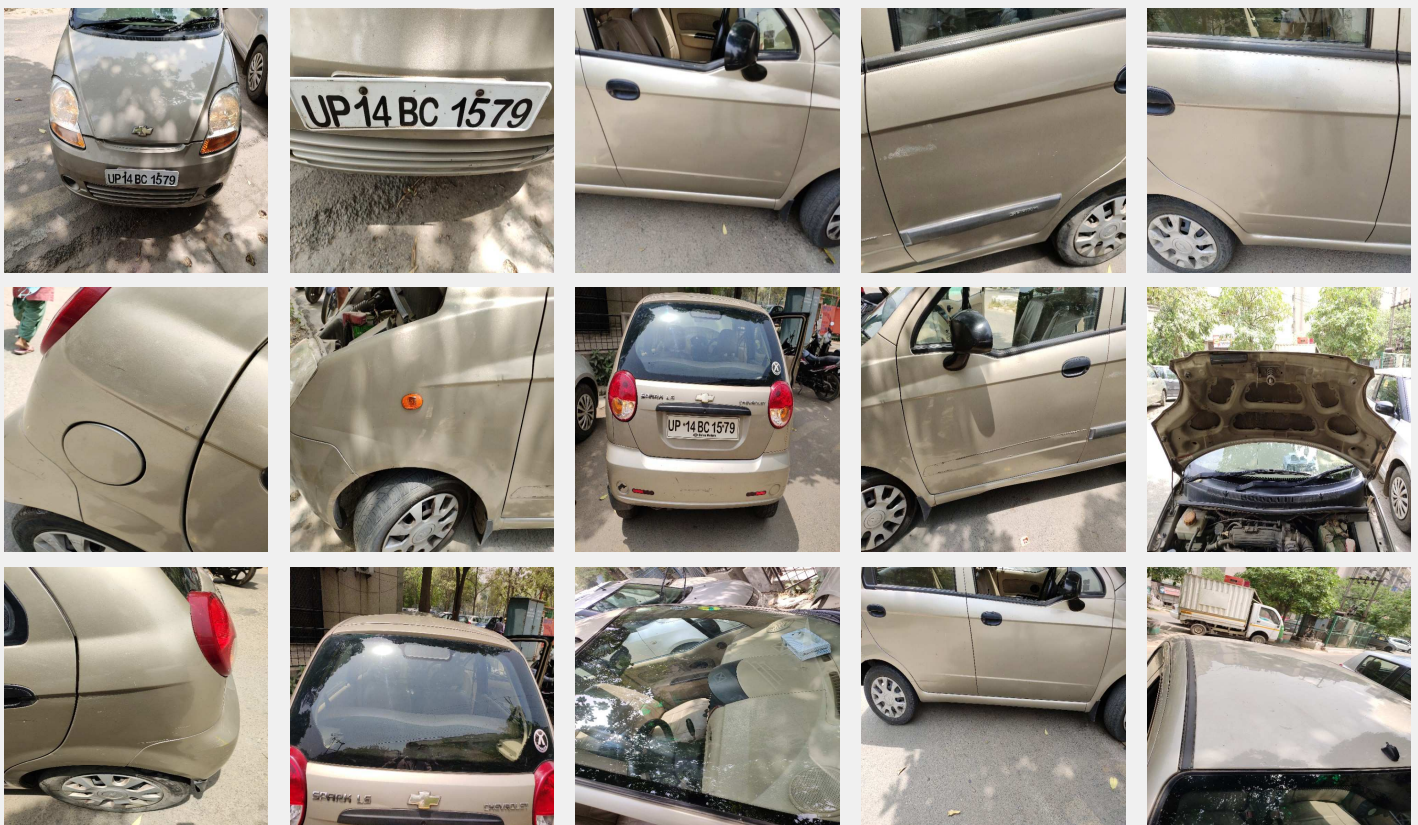
IMAGES

INSPECTION CHECKPOINTS	SCORE(X/10)	REMARKS/COMMENTS	OPTIONAL SPEND EST. (RS)
ROOF (REGULAR)	7		0
PAINT CONDITION	6	AVERAGE CONDITION	0
FOG LAMPS	0	NA	0
LH RUNNING BOARD	5	DENT AND SCRATCHES NEED TO BE REPAIR	500
RH FENDER	5	DENT AND SCRATCHES NEED TO BE REAPIR	500

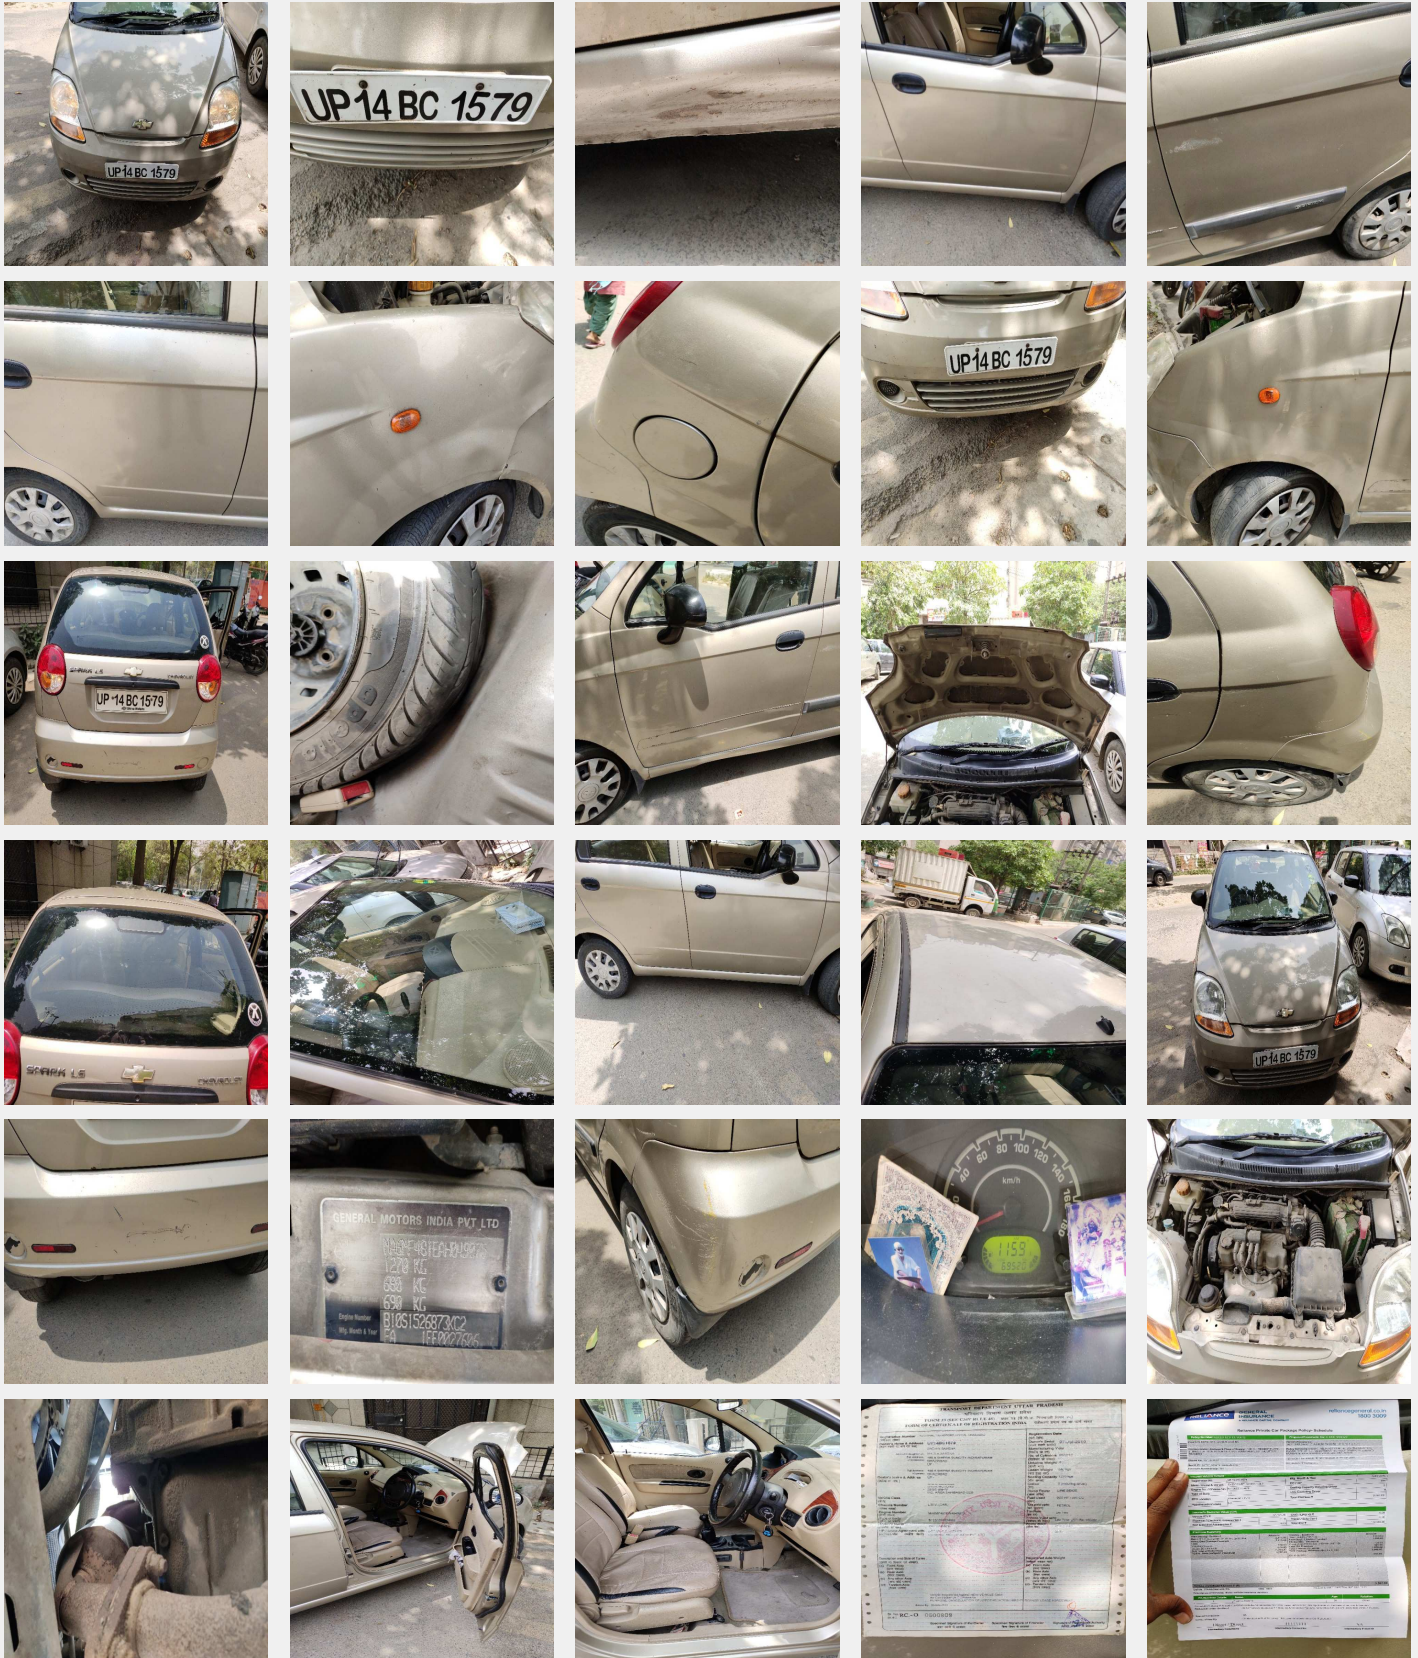
IMAGES

all body scratches minor dent need to be repair
