ECO INSPECTION CERTIFICATE

Order ID : 63040

121 Points Vehicle Inspection Certificate

Maruti Suzuki Swift Vdi , 2010

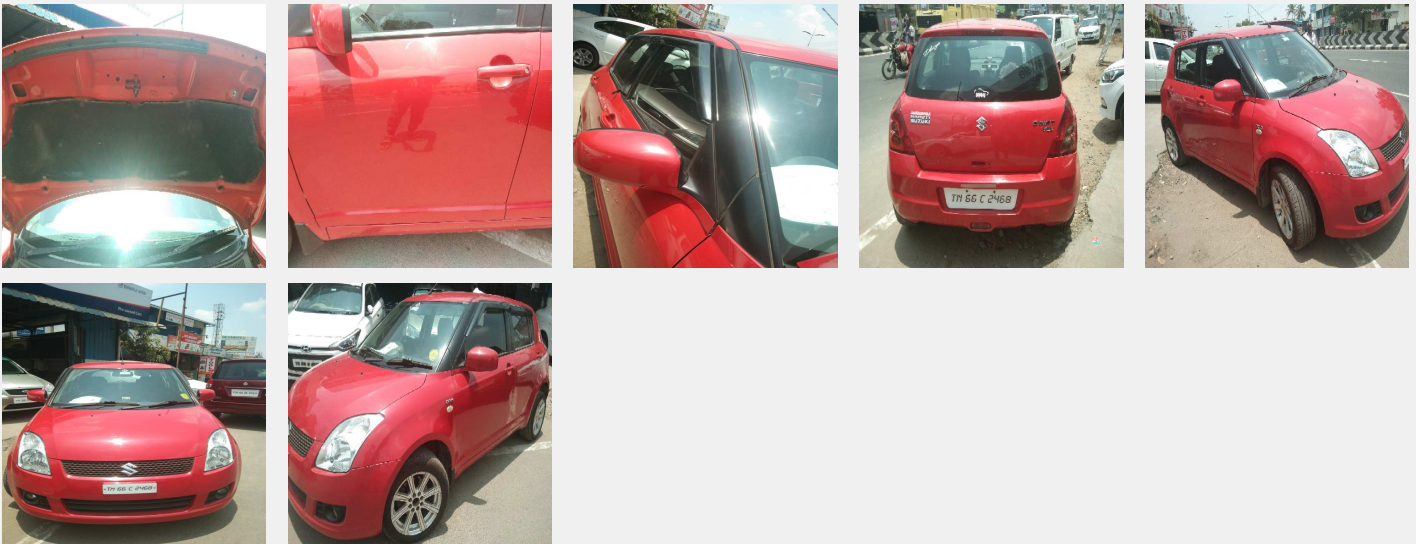
INSPECTION CHECKPOINTS	SCORE(X/10)	REMARKS/COMMENTS	OPTIONAL SPEND EST. (RS)
BODY RUST	7	GOOD	0
ROOF (REGULAR)	7	GOOD	0
PAINT CONDITION	7	GOOD	0
LICENSE PLATE	5	DAMAGE	1000
REAR BUMPER	5	DAMEGE	2500

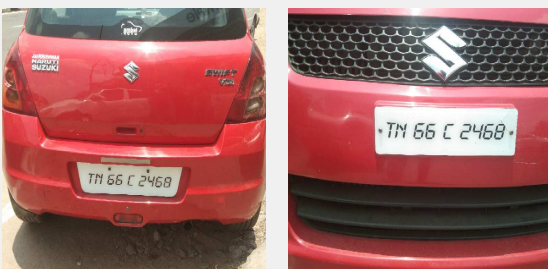
NEED ATTENTION ⚠️

veichle good condition bt lite scratches in RH FENDER AND REAR BUMBER
