# ECO INSPECTION CERTIFICATE

121 Points Vehicle Inspection Certificate

Ordered By : Kritika	Inspection Date : 2019-05-06	Location : GHAZIABAD
-------------------------	---------------------------------	-------------------------

## Maruti Suzuki Wagon R LXI, 2009

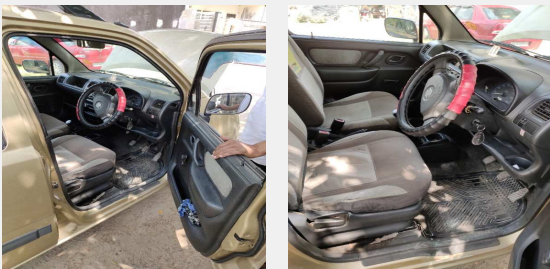
## IMAGES

INSPECTION CHECKPOINTS	SCORE(X/10)	REMARKS/COMMENTS	OPTIONAL SPEND EST. (RS)
DOOR PANEL	7		0
DOOR HINGES	7		0
CARPET & FLOOR MAT	7		0
SEAT & SEAT BELT	7		0
DASHBOARD & INSTRUMENT PANEL	7		0
HORN	7		0
SPEAKERS & MUSIC SYSTEM	7		0
HANDBRAKE	7		0
PEDALS	7		0
A/C VENTS & HEATER	7		0
CUP HOLDERS	7		0
ODOMETER	7		0
HAZARD LIGHT	7		0
STEERING-MOUNTED CONTROLS	0	NA	0
CENTRAL LOCK	0	NA	0
NAVIGATION (YES)	0	NA	0
POWER WINDOWS (YES)	0	NA	0

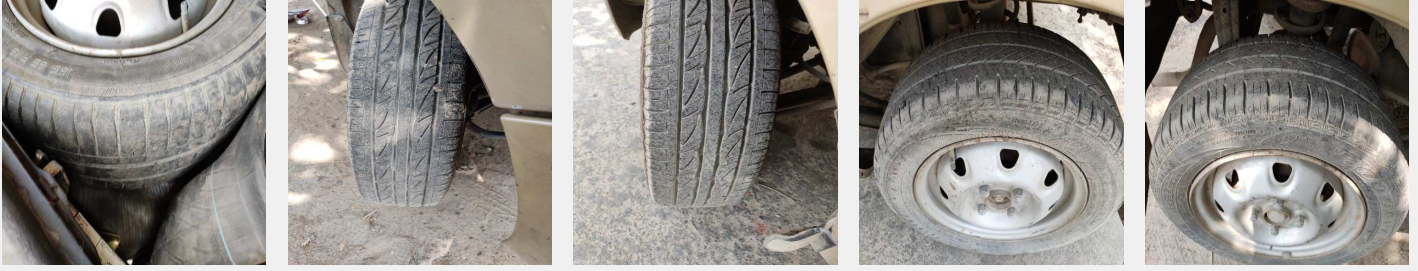
IMAGES

INSPECTION CHECKPOINTS	SCORE(X/10)	REMARKS/COMMENTS	OPTIONAL SPEND EST. (RS)
TYRES	7		0
SPARE TYRE (YES)	7		0
WHEEL ASSEMBLY (STEEL RIM)	6	AVERAGE CONDITION	0

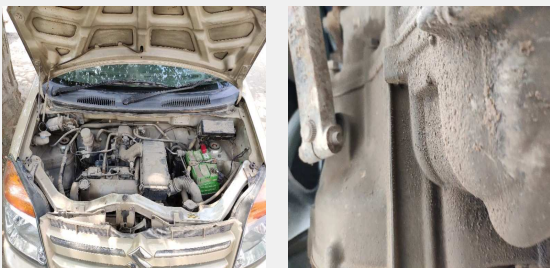
IMAGES

INSPECTION CHECKPOINTS	SCORE(X/10)	REMARKS/COMMENTS	OPTIONAL SPEND EST. (RS)
LH APRON	6	AVERAGE CONDITION	0
RH APRON	6	AVERAGE CONDITION	0
RADIATOR	6	AVERAGE CONDITION	0
WIRING	6	AVERAGE CONDITION	0
BATTERY	7		0
BRAKE FLUID LEVEL	7		0
ENGINE OIL	7		0
COOLANT LEVEL	7		0
BRAKE & COOLANT HOSE PIPES	6	AVERAGE CONDITION	0
UNDERCARRIAGE	6	AVERAGE CONDITION	0
EXHAUST SYSTEM	6	AVERAGE CONDITION	0

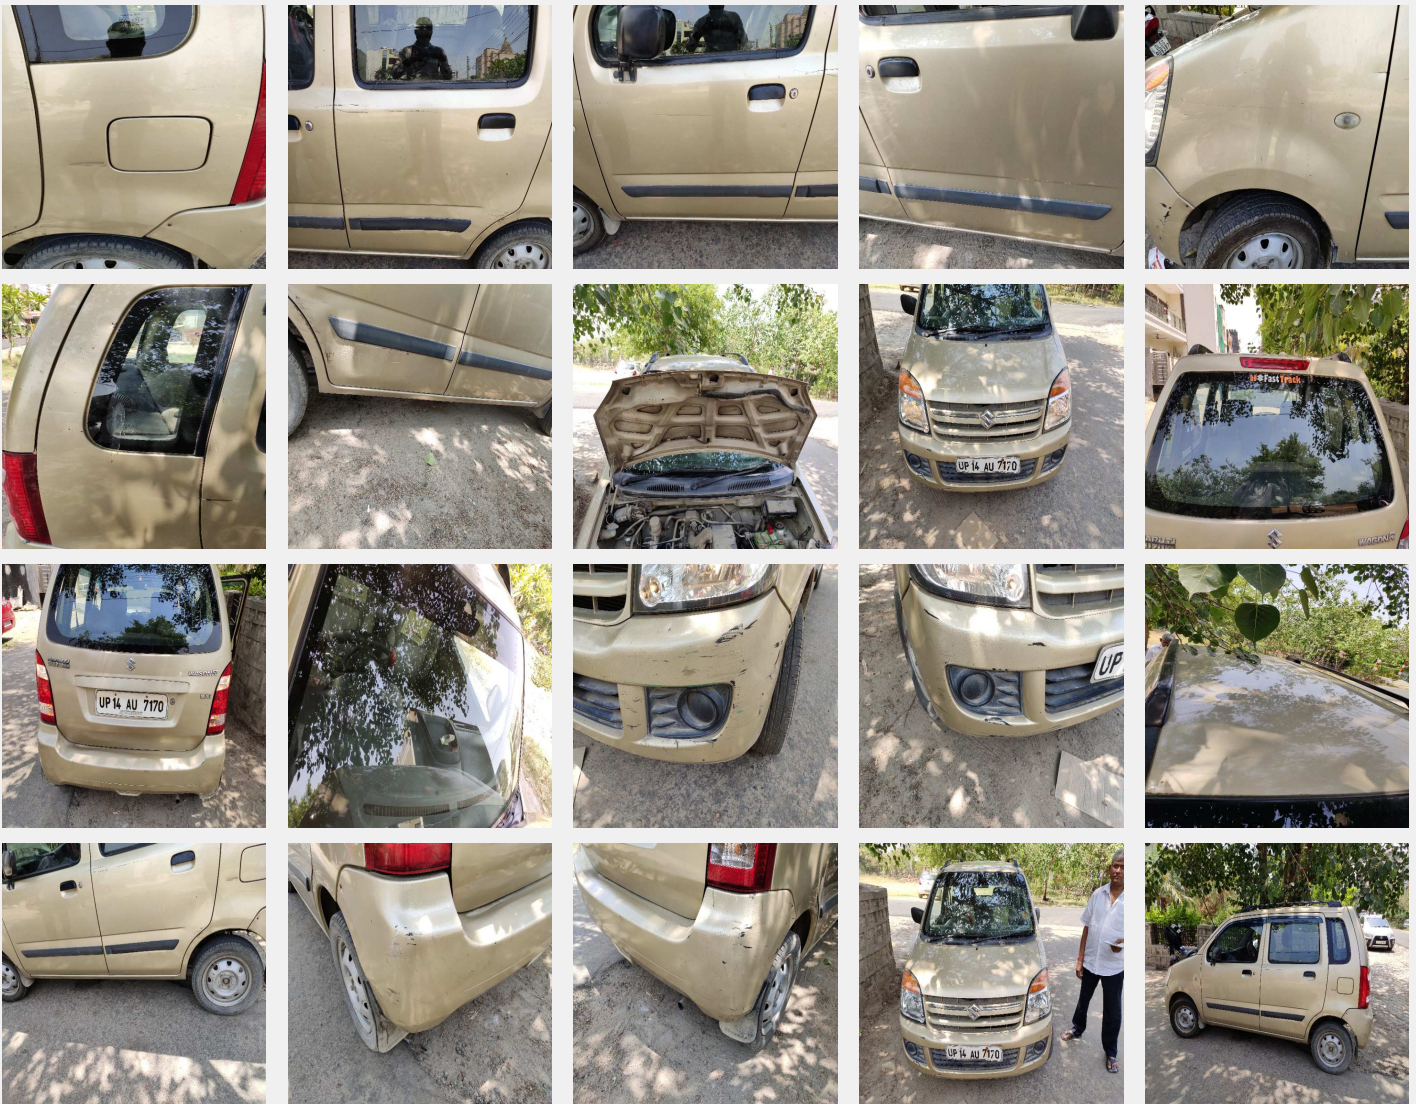
## IMAGES

INSPECTION CHECKPOINTS	SCORE(X/10)	REMARKS/COMMENTS	OPTIONAL SPEND EST. (RS)
LICENSE PLATE	6	AVERAGE CONDITION	0
FRONT BUMPER	6	SCRATCHES	400
HEAD LIGHTS	7		0
GRILLE	7		0
TURN SIGNAL	7		0
HOOD	6	AVERAGE CONDITION	0
PILLAR	6	AVERAGE CONDITION	0
FRONT WINDSHIELD	6	SCRATCHES	150
SIDE VIEW MIRRORS	6	AVERAGE CONDITION	0
LH FENDER	6	SCRATCHES	100
LH FRONT DOOR	6	SCRATCHES	200
LH REAR DOOR	6	SCRATCHES	200
LH RUNNING BOARD	7		0
LH QUARTER PANEL	6	SCRATCHES	100
FUEL LID	6	AVERAGE CONDITION	0
REAR WINDSHIELD	7		0
REAR BUMPER	6	SCRATCHES	350
TAIL LIGHT	7		0
TRUNK LID/TAIL GATE	6	AVERAGE CONDITION	0
LUGGAGE COMPARTMENT LIGHT	7		0
RH QUARTER PANEL	6	SCRATCHES	100
RH RUNNING BOARD	7		0
RH FRONT DOOR	6	SCRATCHES	100
BODY RUST	6	AVERAGE CONDITION	0

INSPECTION CHECKPOINTS	SCORE(X/10)	REMARKS/COMMENTS	OPTIONAL SPEND EST. (RS)
ROOF (REGULAR)	6	AVERAGE CONDITION	0
PAINT CONDITION	6	AVERAGE CONDITION	0
FOG LAMPS	0	NA	0
RH REAR DOOR	5	SCRATCHES	500
RH FENDER	5	SCRATCHES AND DENT NEED TO BE REPAIR	250

all body scratches and dent need to be repair
