ECO INSPECTION CERTIFICATE

121 Points Vehicle Inspection Certificate

Ordered By : Syed Ali	Inspection Date : 2019-05-07	Location : DOMLUR	Inspected By Sanjeev Kumar
--------------------------	---------------------------------	----------------------	-----------------------------------

Skoda Superb Elegance 2.0 Tdi Cr At, 2015

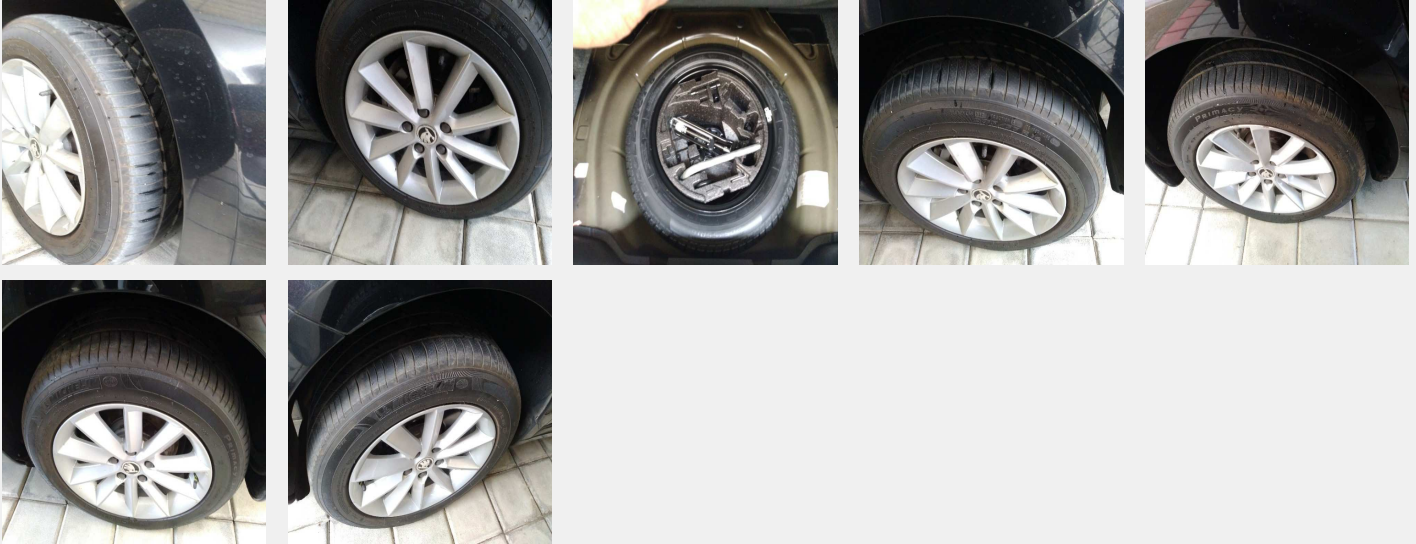
INSPECTION CHECKPOINTS	SCORE(X/10)	REMARKS/COMMENTS	OPTIONAL SPEND EST. (RS)
TYRES	7		0
SPARE TYRE (YES)	8		0
WHEEL ASSEMBLY (ALLOY RIM)	8		0

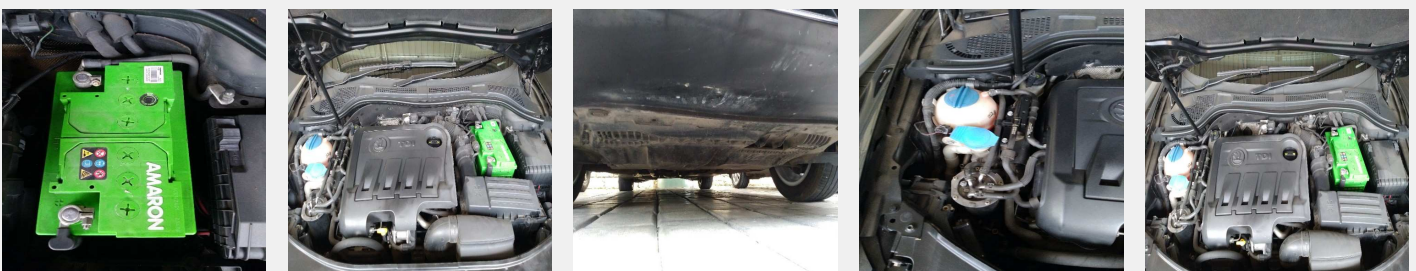
HOOD

INSPECTION CHECKPOINTS	SCORE(X/10)	REMARKS/COMMENTS	OPTIONAL SPEND EST. (RS)
LH APRON	8		0
RH APRON	8		0
RADIATOR	8		0
WIRING	8		0
BATTERY	9		0
BRAKE FLUID LEVEL	8		0
ENGINE OIL	8		0
COOLANT LEVEL	8		0
BRAKE & COOLANT HOSE PIPES	8		0
UNDERCARRIAGE	8		0
EXHAUST SYSTEM	8		0

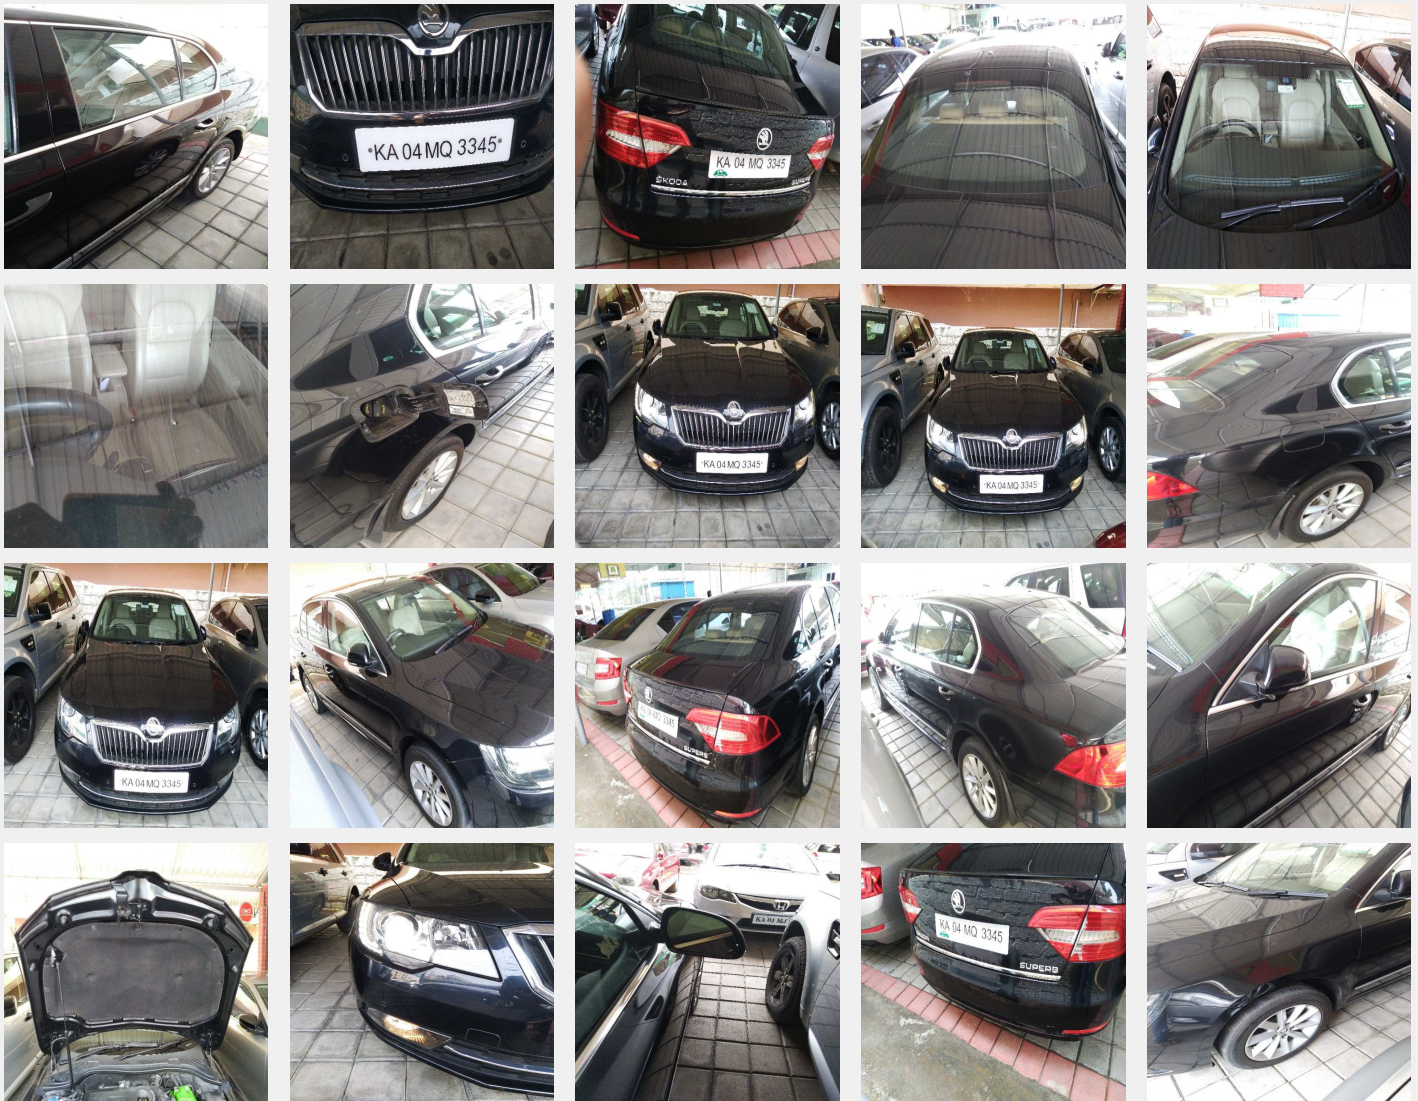
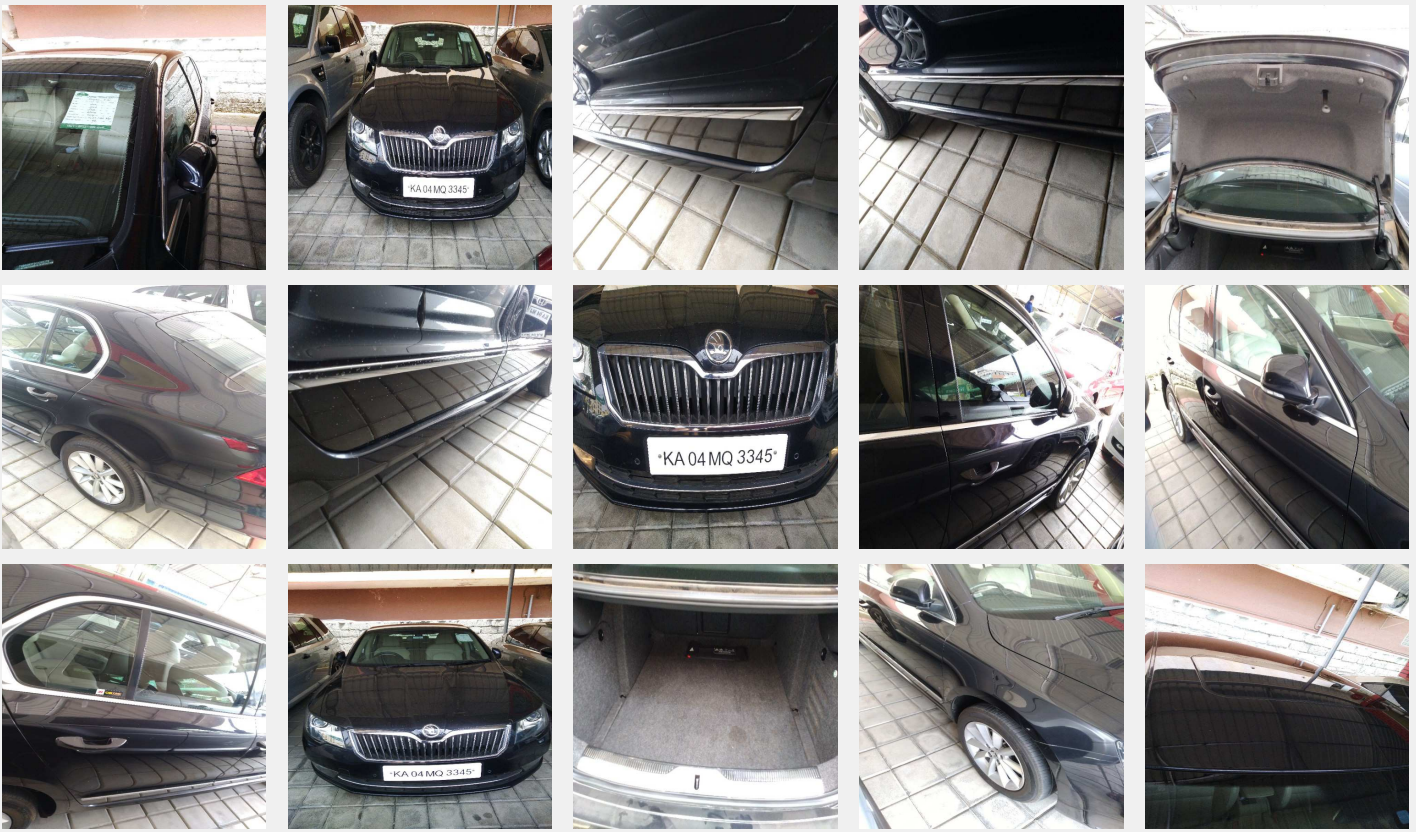
EXTERIOR (CONTINUED)

INSPECTION CHECKPOINTS	SCORE(X/10)	REMARKS/COMMENTS	OPTIONAL SPEND EST. (RS)
LICENSE PLATE	8		0
FRONT BUMPER	7		0
HEAD LIGHTS	8		0
GRILLE	7		0
TURN SIGNAL	8		0
FOG LAMPS	8		0
HOOD	8		0
PILLAR	8		0
FRONT WINDSHIELD	6	STONE MARK	0
SIDE VIEW MIRRORS	8		0
LH FENDER	8		0
LH FRONT DOOR	8		0
LH REAR DOOR	8		0
LH RUNNING BOARD	8		0
LH QUARTER PANEL	8		0
FUEL LID	8		0
REAR WINDSHIELD	8		0
REAR BUMPER	8		0
TAIL LIGHT	8		0
TRUNK LID/TAIL GATE	8		0
LUGGAGE COMPARTMENT LIGHT	8		0
RH QUARTER PANEL	8		0
RH RUNNING BOARD	8		0
RH REAR DOOR	8		0

INSPECTION CHECKPOINTS	SCORE(X/10)	REMARKS/COMMENTS	OPTIONAL SPEND EST. (RS)
RH FRONT DOOR	8		0
RH FENDER	8		0
BODY RUST	10		0
ROOF (SUN ROOF)	8		0
PAINT CONDITION	9		0
