ECO INSPECTION CERTIFICATE

Order ID : 65282

121 Points Vehicle Inspection Certificate

Tata Indica Vista AQUA QUADRAJET BS-III, 2010

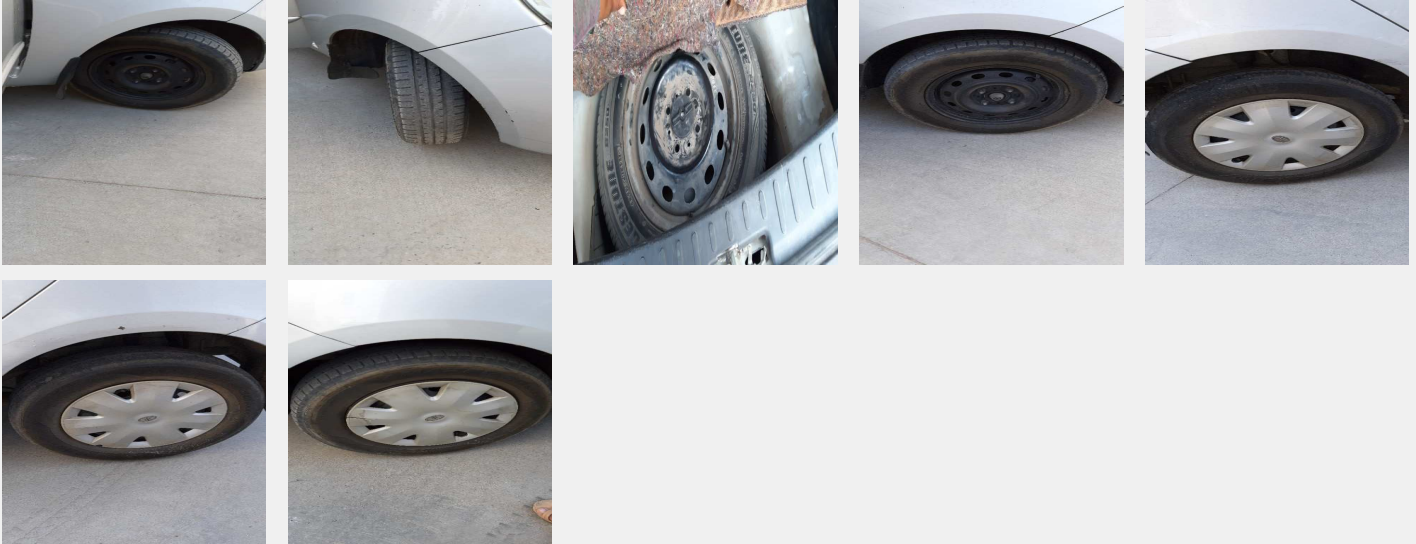
IMAGES

INSPECTION CHECKPOINTS	SCORE(X/10)	REMARKS/COMMENTS	OPTIONAL SPEND EST. (RS)
TYRES	8		0
SPARE TYRE (YES)	8		0
WHEEL ASSEMBLY (STEEL RIM)	7		0

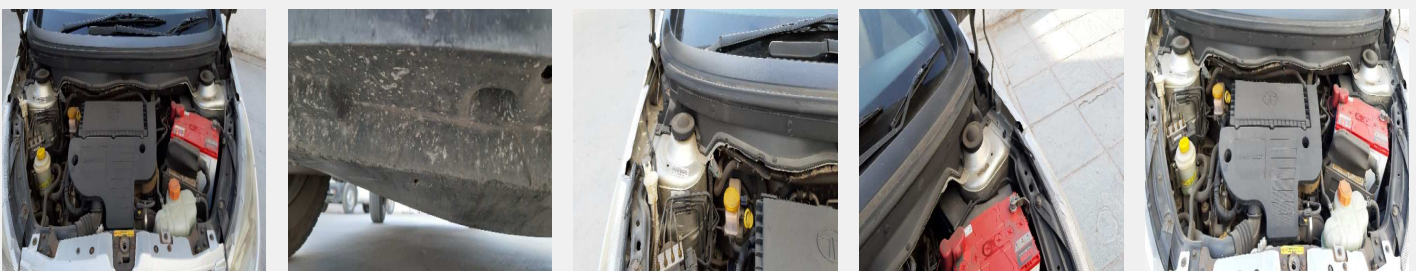
IMAGES

INSPECTION CHECKPOINTS	SCORE(X/10)	REMARKS/COMMENTS	OPTIONAL SPEND EST. (RS)
LH APRON	8		0
RH APRON	7		0
RADIATOR	7		0
WIRING	7		0
BATTERY	8		0
BRAKE FLUID LEVEL	8		0
ENGINE OIL	8		0
COOLANT LEVEL	8		0
BRAKE & COOLANT HOSE PIPES	8		0
UNDERCARRIAGE	8		0
EXHAUST SYSTEM	8		0

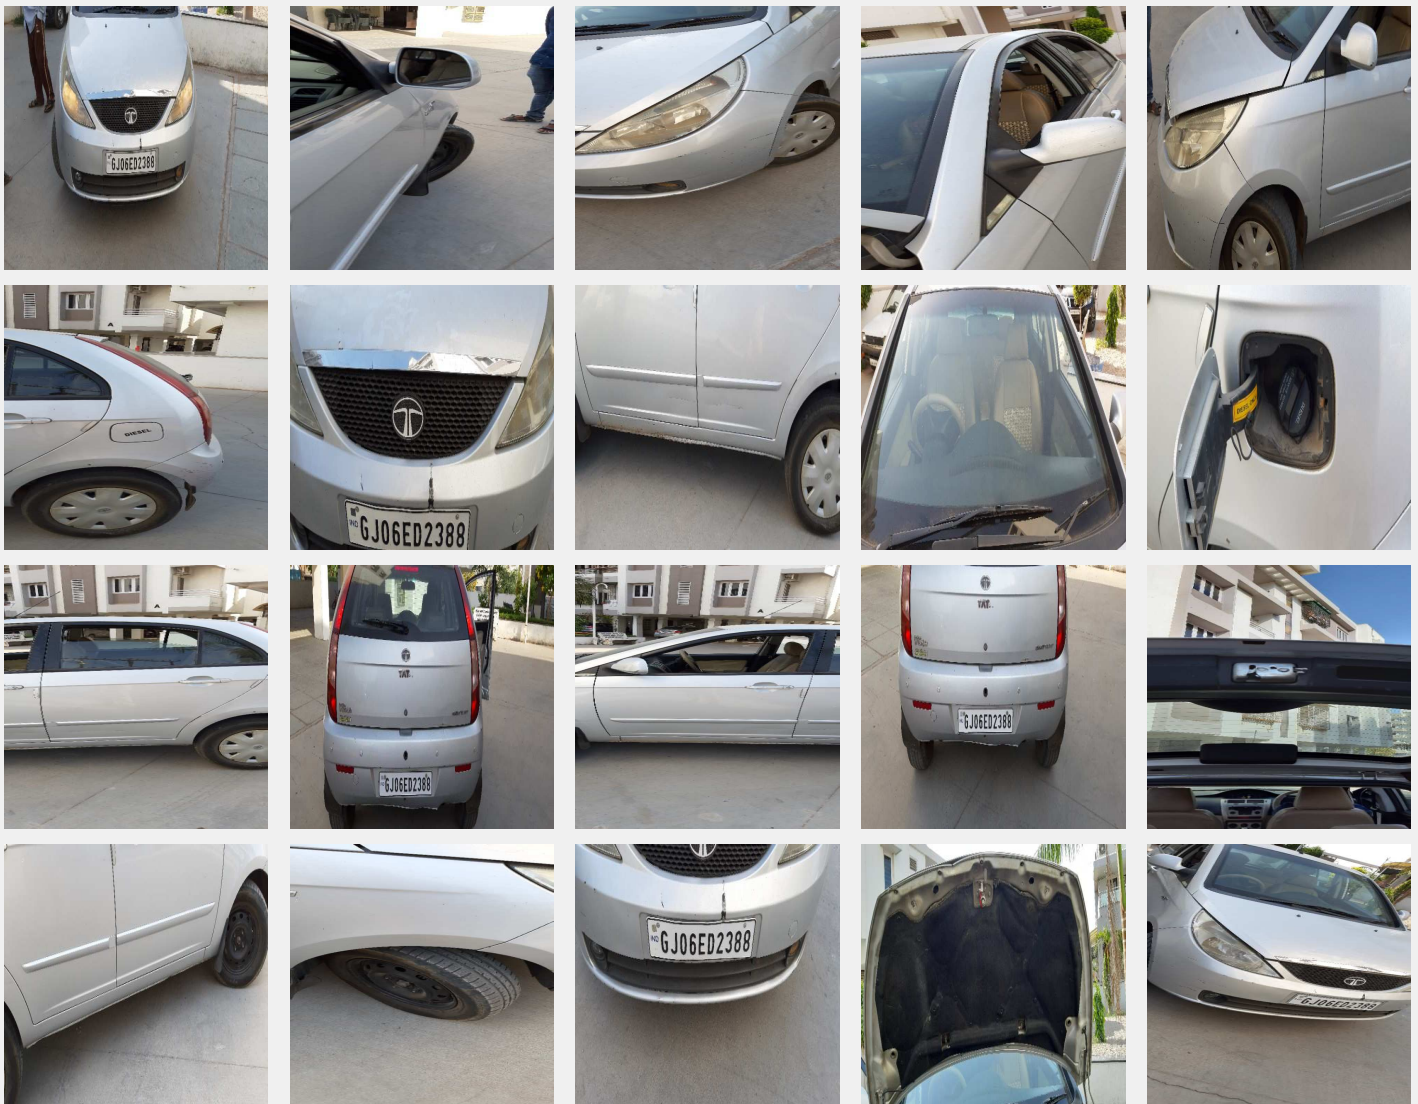
IMAGES

INSPECTION CHECKPOINTS	SCORE(X/10)	REMARKS/COMMENTS	OPTIONAL SPEND EST. (RS)
ROOF (REGULAR)	8		0
PAINT CONDITION	8	DENTED AND SCRTCH	15000
FRONT BUMPER	5	SCRATCH	2000
FOG LAMPS	3	NOT WORKING	5000
RH FRONT DOOR	4	DENTED AND SCRTCH	3000

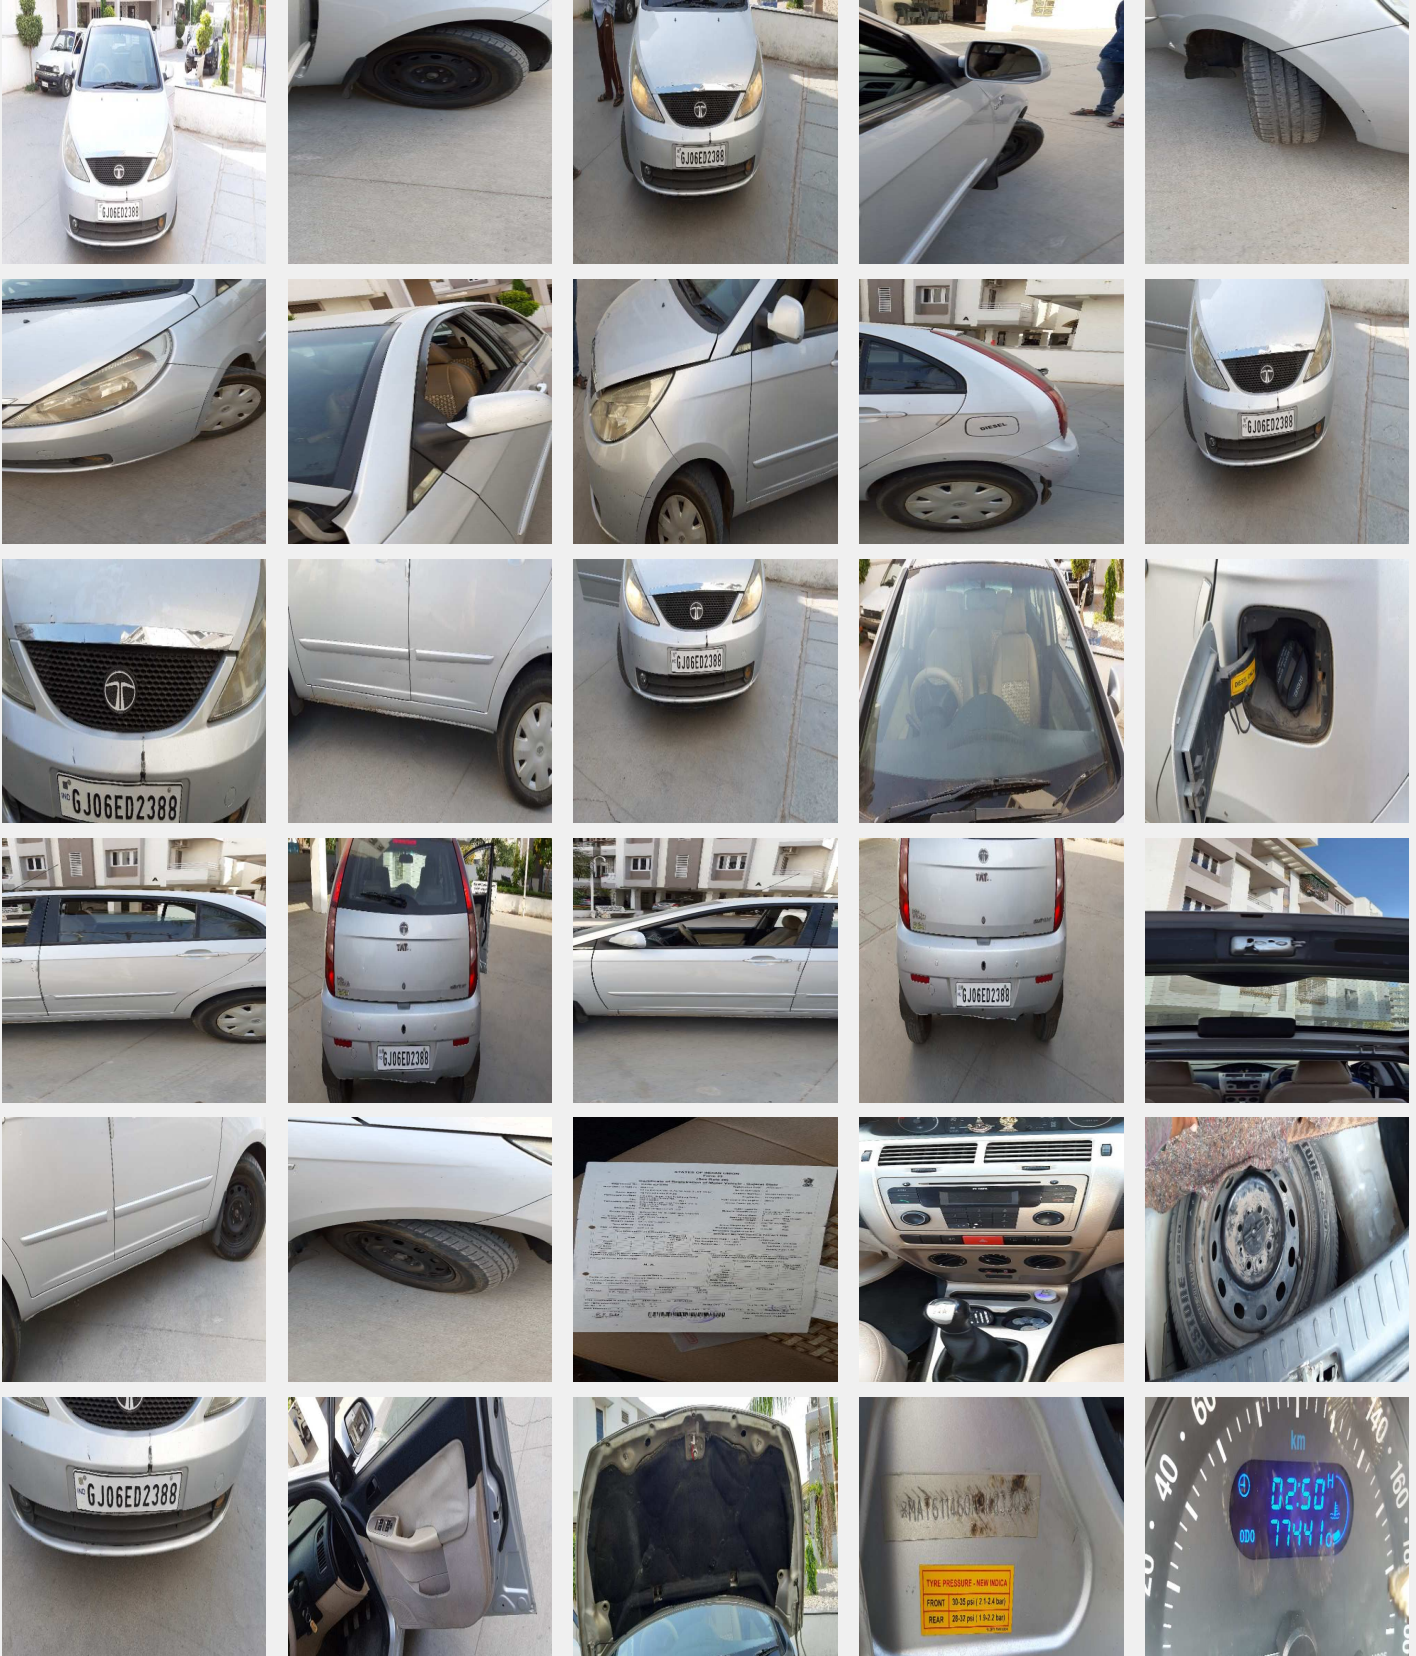
IMAGES

some body parys
