ECO INSPECTION CERTIFICATE

121 Points Vehicle Inspection Certificate

Inspection Date :
2019-05-07

Bajaj Avenger STREET 150, 2016

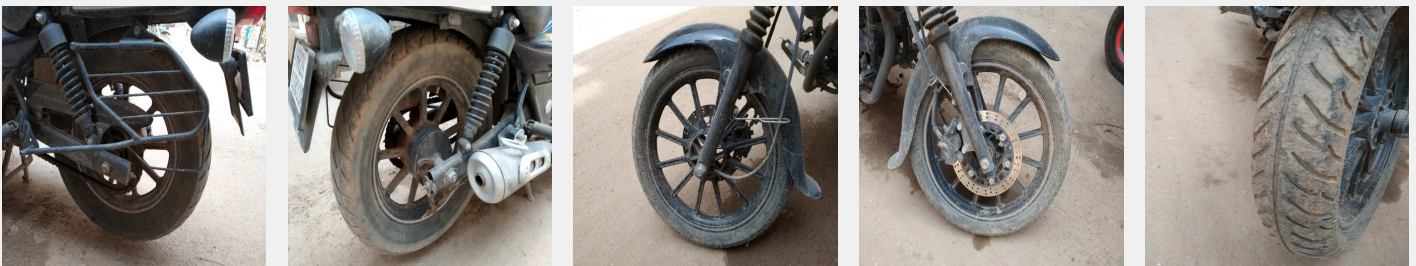
INSPECTION CHECKPOINTS	SCORE(X/10)	REMARKS/COMMENTS	OPTIONAL SPEND EST. (RS)
FRONT TYRE CONDITION & AIR PRESSURE	7		0
REAR TYRE CONDITION & AIR PRESSURE	7		0
WHEEL SPOKES FRONT	7		0
WHEEL SPOKES REAR	7		0
WHEEL RIM FRONT	8		0
WHEEL RIM REAR	8		0
WHEEL BEARINGS FRONT	8		0
WHEEL BEARINGS REAR	8		0
WHEEL SEALS FRONT	8		0
WHEEL SEALS REAR	8		0
BRAKE FUNCTION FRONT	8		0
BRAKE FUNCTION REAR	8		0
BRAKES CONDITION FRONT	8		0
BRAKES CONDITION REAR	8		0

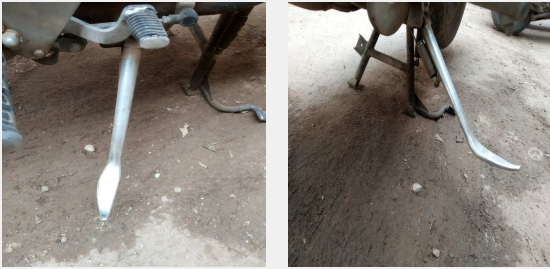
INSPECTION CHECKPOINTS	SCORE(X/10)	REMARKS/COMMENTS	OPTIONAL SPEND EST. (RS)
CENTRE STAND CONDITION	7		0
CENTRE STAND RETENTION	7		0
SIDE STAND CONDITION	7		0
SIDE STAND RETENTION	7		0

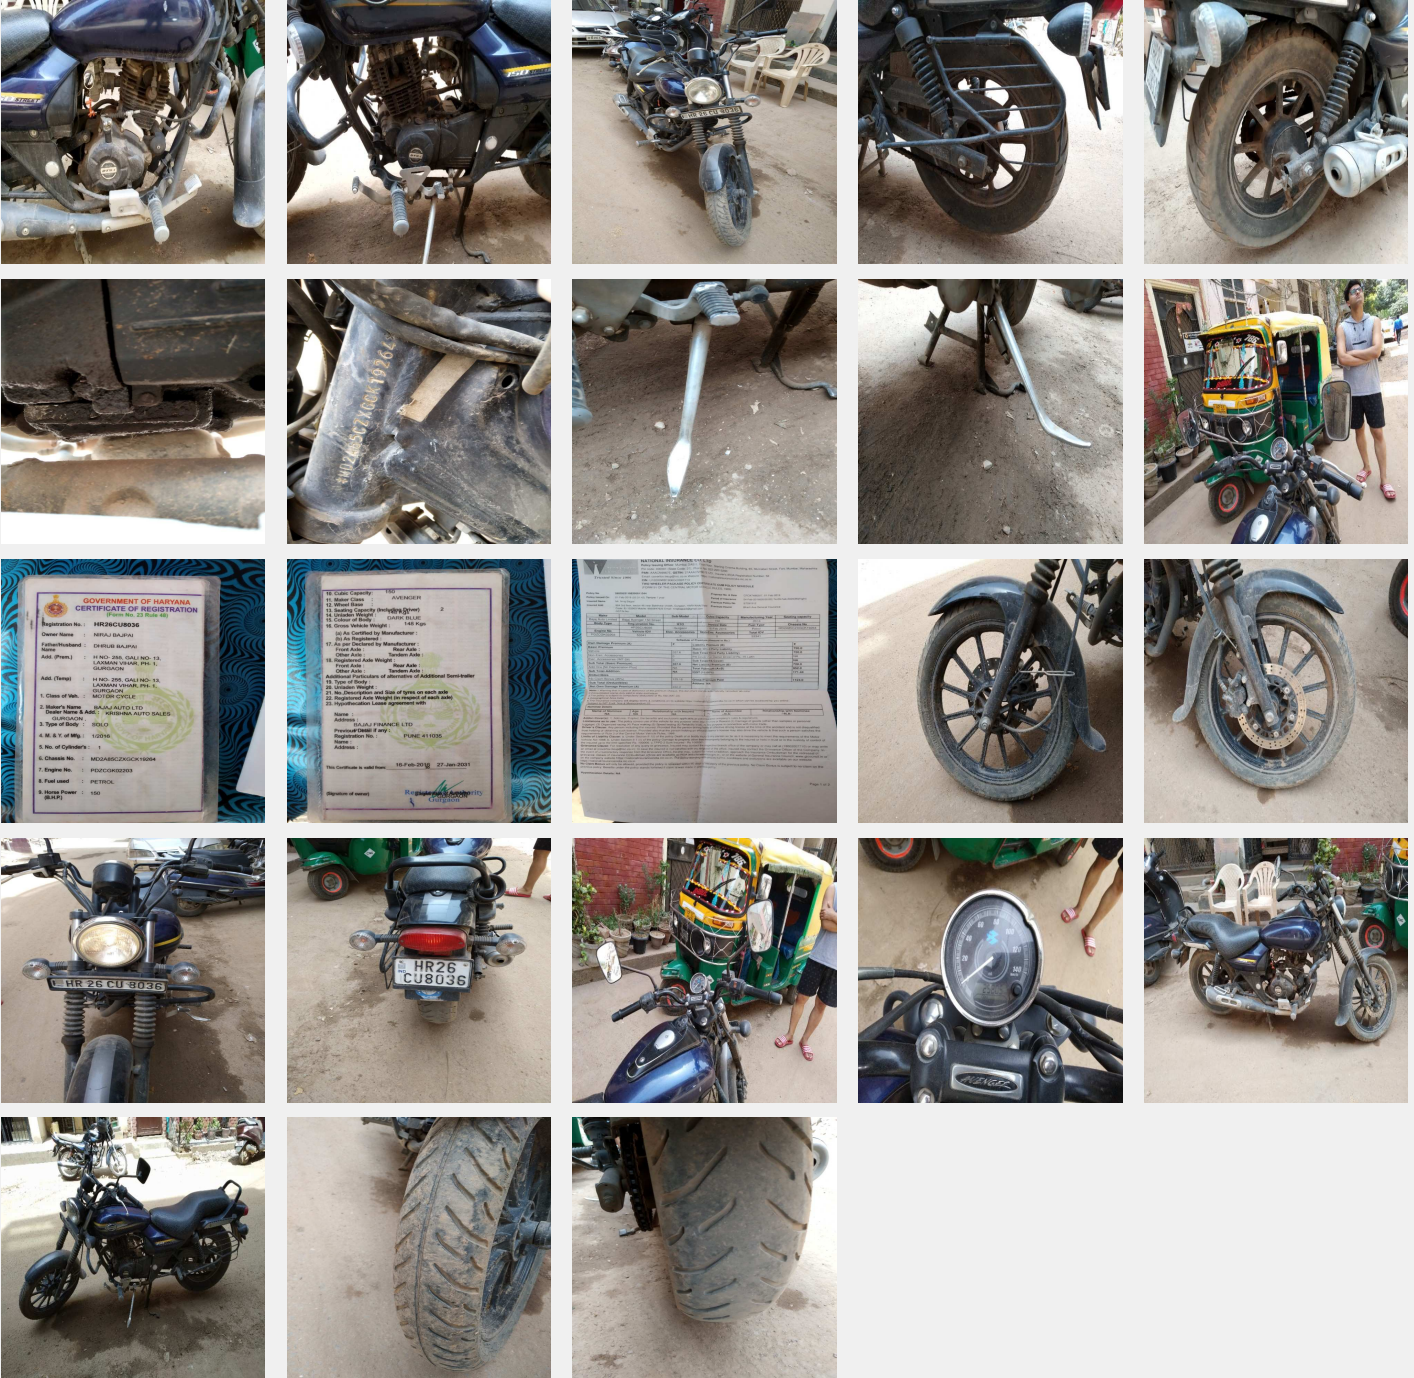
minor scratches service due
