# ECO INSPECTION CERTIFICATE

Order ID : 70645

121 Points Vehicle Inspection Certificate

## Honda Activa 5g 110CC DLX, 2018

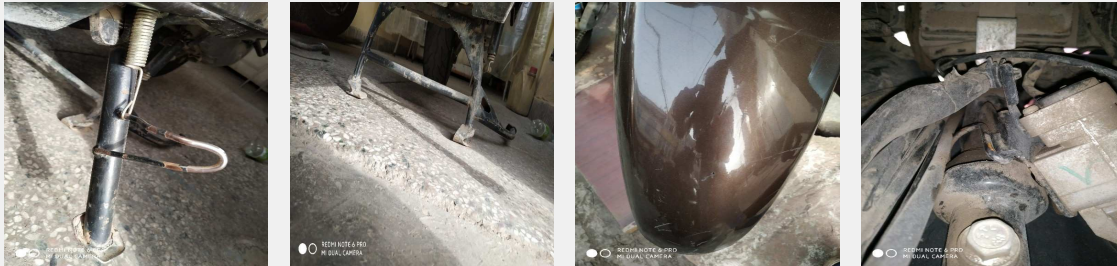
## IMAGES

INSPECTION CHECKPOINTS	SCORE(X/10)	REMARKS/COMMENTS	OPTIONAL SPEND EST. (RS)
CENTRE STAND CONDITION	8		0
CENTRE STAND RETENTION	8		0
SIDE STAND CONDITION	8		0
SIDE STAND RETENTION	8		0
