ECO INSPECTION CERTIFICATE

121 Points Vehicle Inspection Certificate

Um Renegade Commando 280CC, 2017

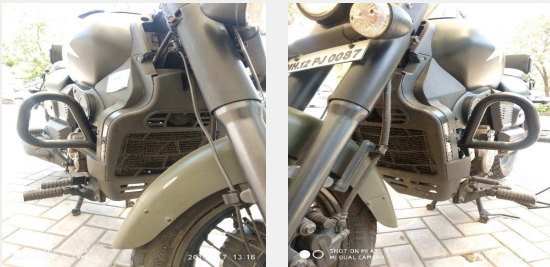
CHASSIS

INSPECTION CHECKPOINTS	SCORE(X/10)	REMARKS/COMMENTS	OPTIONAL SPEND EST. (RS)
FRAME CONDITION	7	GOOD CONDITION	0
FRAME STEERING-HEAD BEARINGS	7	GOOD CONDITION	0
FRAME SWINGARM BUSHINGS	7	GOOD CONDITION	0
SUSPENSION FRONT FORKS LEFT	7	GOOD CONDITION	0
SUSPENSION FRONT FORKS RIGHT	7	GOOD CONDITION	0
SUSPENSION REAR SHOCKS LEFT	7	MINIMUM SHOCK	0
SUSPENSION REAR SHOCKS RIGHT	7	MINIMUM SHOCK	0
CHAIN/BELT TENSION	7	CHAIN TENSION	0
CHAIN/BELT LUBRICATION	7	CHAIN LUBRICATION	0
CHAIN/BELT SPROCKETS	7	CHAIN SPROCKET	0
FASTENERS THREADED	7	GOOD CONDITION	0
FASTENERS CLIPS & COTTER PINS	7	GOOD CONDITION	0
ENGINE	7	NORMAL OPERATING NOISE	0
TRANSMISSION	7	PROPERLY ENGAGE	0
