ECO INSPECTION CERTIFICATE

Order ID : 70702

121 Points Vehicle Inspection Certificate

Hyundai Xcent S 1.1 CRDI OPT, 2014

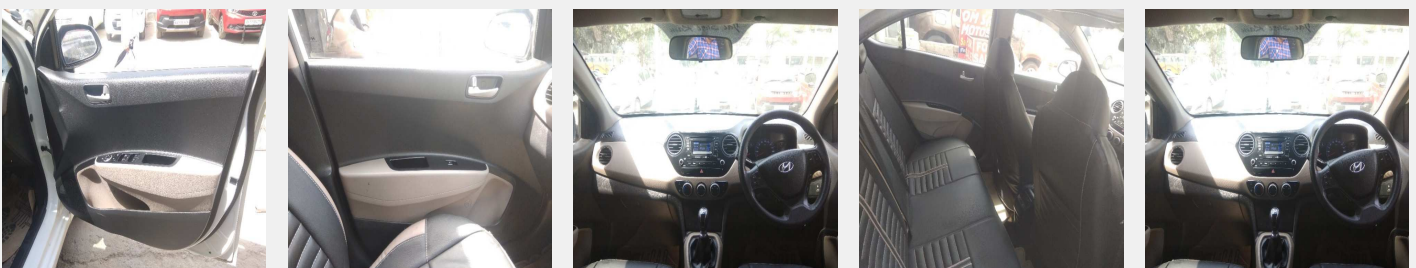
INTERIOR

INSPECTION CHECKPOINTS	SCORE(X/10)	REMARKS/COMMENTS	OPTIONAL SPEND EST. (RS)
DOOR PANEL	9	VERY GOOD CONDITION	0
DOOR HINGES	7	GOOD WORKING(CHECKED)	0
CARPET & FLOOR MAT	7	GOOD CONDITION	0
SEAT & SEAT BELT	7	GOOD WORKING(CHECKED)	0
DASHBOARD & INSTRUMENT PANEL	7	GOOD CONDITION	0
HORN	7	GOOD SOUND(CHECKED)	0
SPEAKERS & MUSIC SYSTEM	9	VERY GOOD CONDITION AND SOUNDS(CHECKED)	0
HANDBRAKE	7	GOOD WORKING(CHECKED)	0
STEERING-MOUNTED CONTROLS	7	GOOD CONDITION	0
PEDALS	7	GOOD WORKING(CHECKED)	0
CENTRAL LOCK	7	GOOD WORKING(CHECKED)	0
A/C VENTS & HEATER	7	GOOD CONDITION AND WORKS(CHECKED)	0
CUP HOLDERS	7	GOOD CONDITION	0
NAVIGATION (NO)	10		0
ODOMETER	7	GOOD WORKING(CHECKED)	0
POWER WINDOWS (YES)	7	BOTH ARE GOOD WORKING(CHECKED)	0
HAZARD LIGHT	7	GOOD(CHECKED)	0

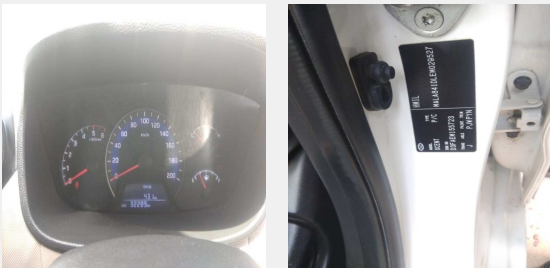
INSPECTION CHECKPOINTS	SCORE(X/10)	REMARKS/COMMENTS	OPTIONAL SPEND EST. (RS)
STEERING PERFORMANCE	7	GOOD CONDITION AND SMOOTHLY STEER BOTH SIDES	0
BRAKE PERFORMANCE	7	GOOD WORKING(CHECKED)	0
CLUTCH PERFORMANCE	7	GOOD WORKING(CHECKED)	0
ENGINE NOISE	7	GOOD CONDITION AND NOISE	0
IGNITION SYSTEM	7	GOOD WORKING(CHECKED)	0
SUSPENSION PERFORMANCE	6	AVERAGE WORKING(CHECKED)	0
SUSPENSION FRONT SHOCKS	6	AVERAGE CONDITION	0
SUSPENSION REAR SHOCKS	6	AVERAGE CONDITION	0
TRANSMISSION ENGAGE	7	GOOD WORKING(CHECKED)	0
CRUISE CONTROL (NO)	10		0
REAR PARKING SENSORS (YES)	7	GOOD WORKING(CHECKED)	0
REAR VIEW CAMERA (NO)	10		0

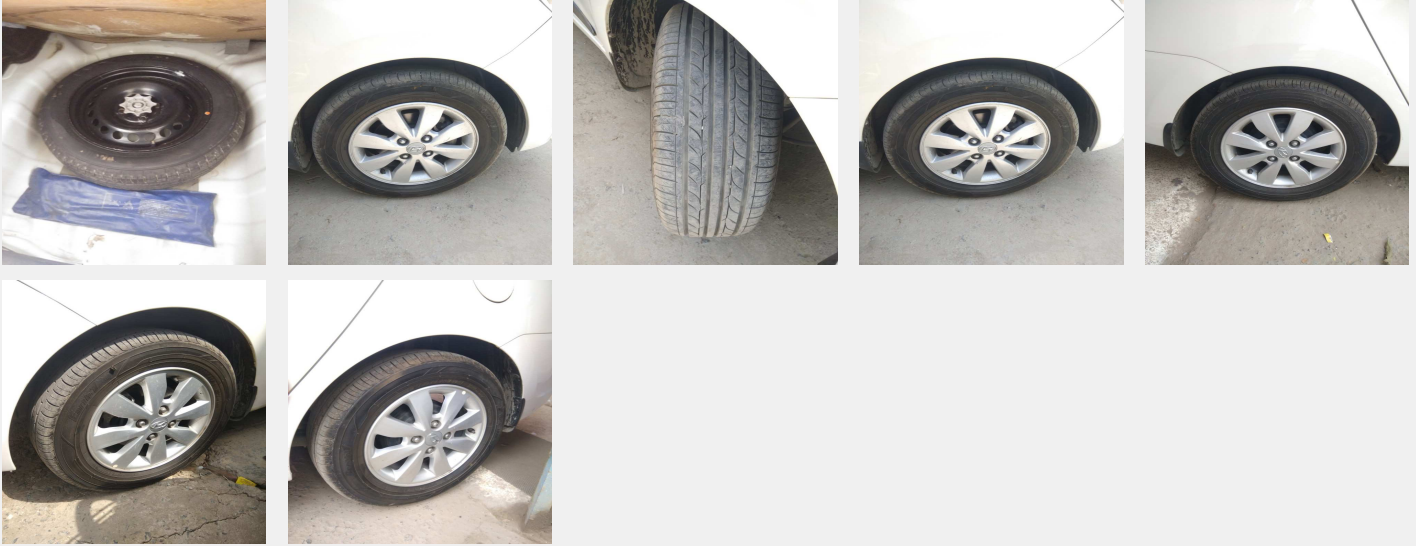
INSPECTION CHECKPOINTS	SCORE(X/10)	REMARKS/COMMENTS	OPTIONAL SPEND EST. (RS)
TYRES	7	GOOD CONDITION	0
SPARE TYRE (YES)	7	GOOD CONDITION	0
WHEEL ASSEMBLY (ALLOY RIM)	6	AVERAGE CONDITION	0

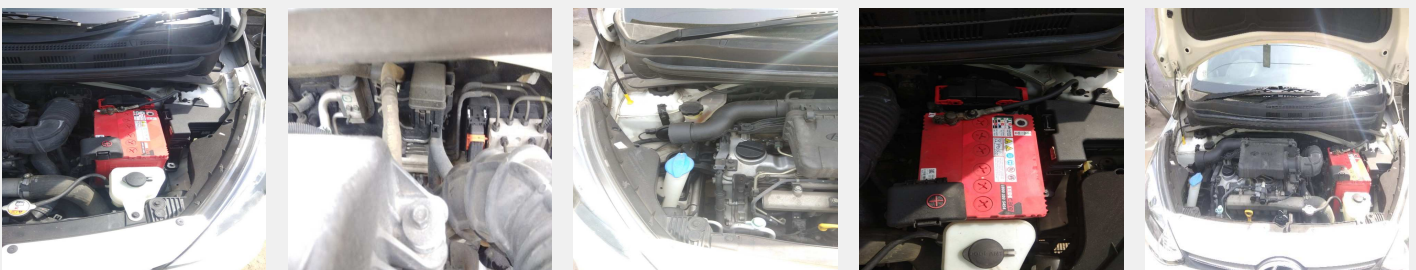
HOOD

INSPECTION CHECKPOINTS	SCORE(X/10)	REMARKS/COMMENTS	OPTIONAL SPEND EST. (RS)
LH APRON	7	GOOD CONDITION	0
RH APRON	7	GOOD CONDITION	0
RADIATOR	6	AVERAGE WORKING	0
WIRING	6	AVERAGE CONDITION	0
BATTERY	7	GOOD CONDITION AND WORKS(CHECKED)	0
BRAKE FLUID LEVEL	7	MAX LEVEL	0
ENGINE OIL	7	MAX LEVEL	0
COOLANT LEVEL	7	MAX LEVEL	0
BRAKE & COOLANT HOSE PIPES	6	AVERAGE CONDITION	0
UNDERCARRIAGE	6	AVERAGE CONDITION	0
EXHAUST SYSTEM	6	AVERAGE CONDITION	0

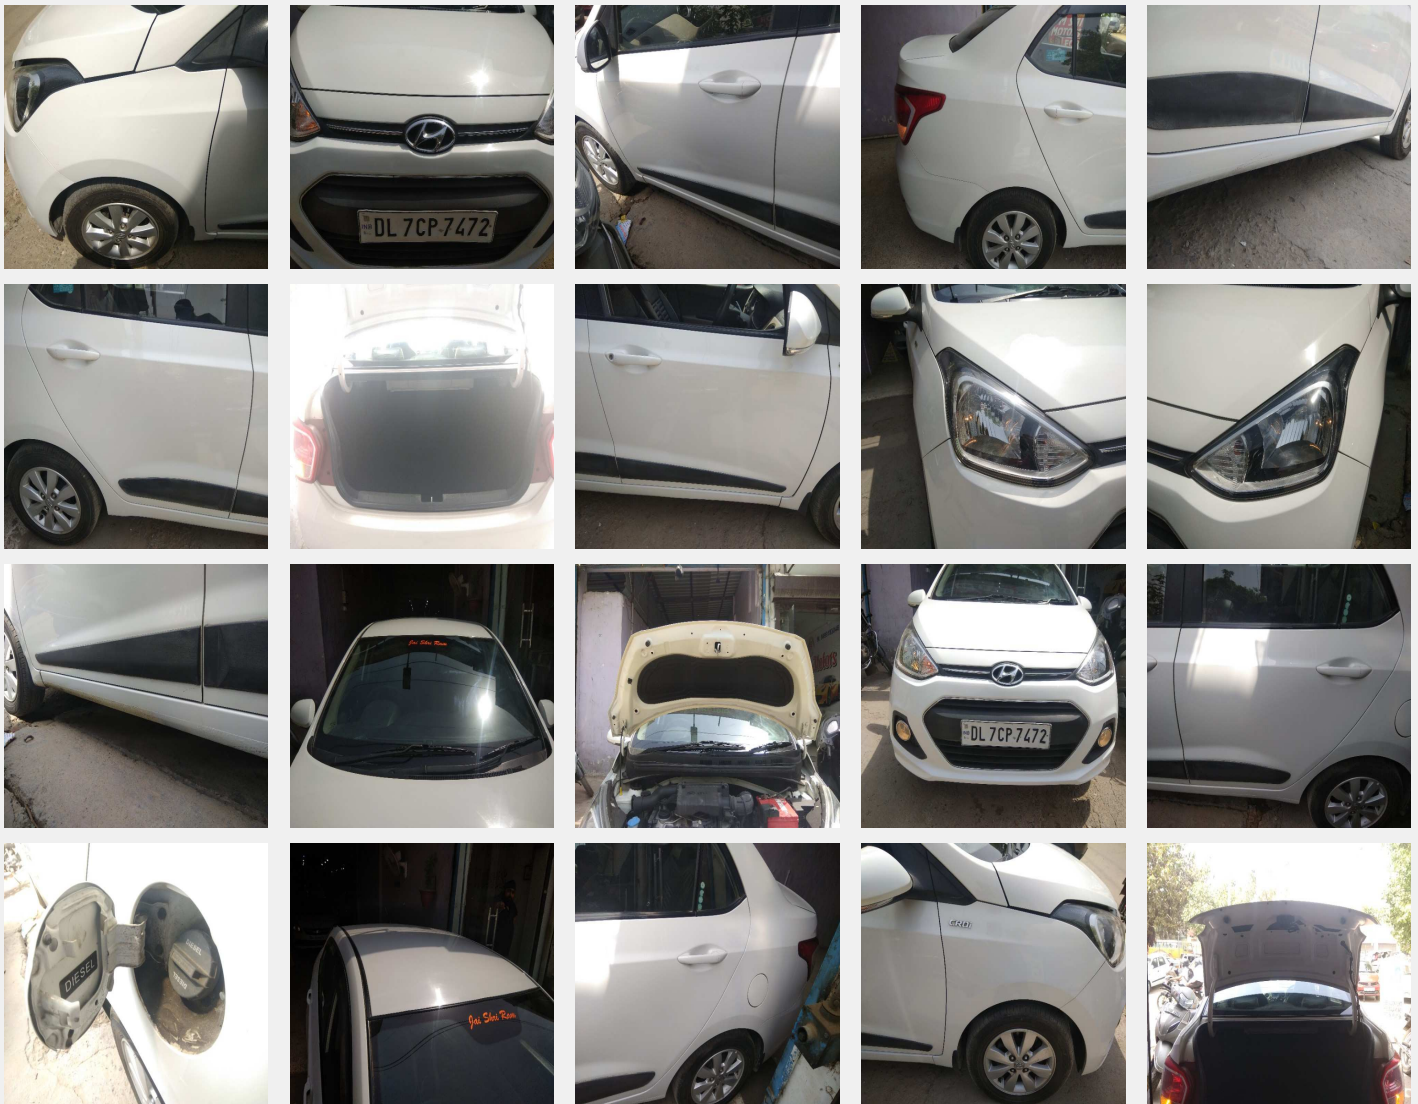
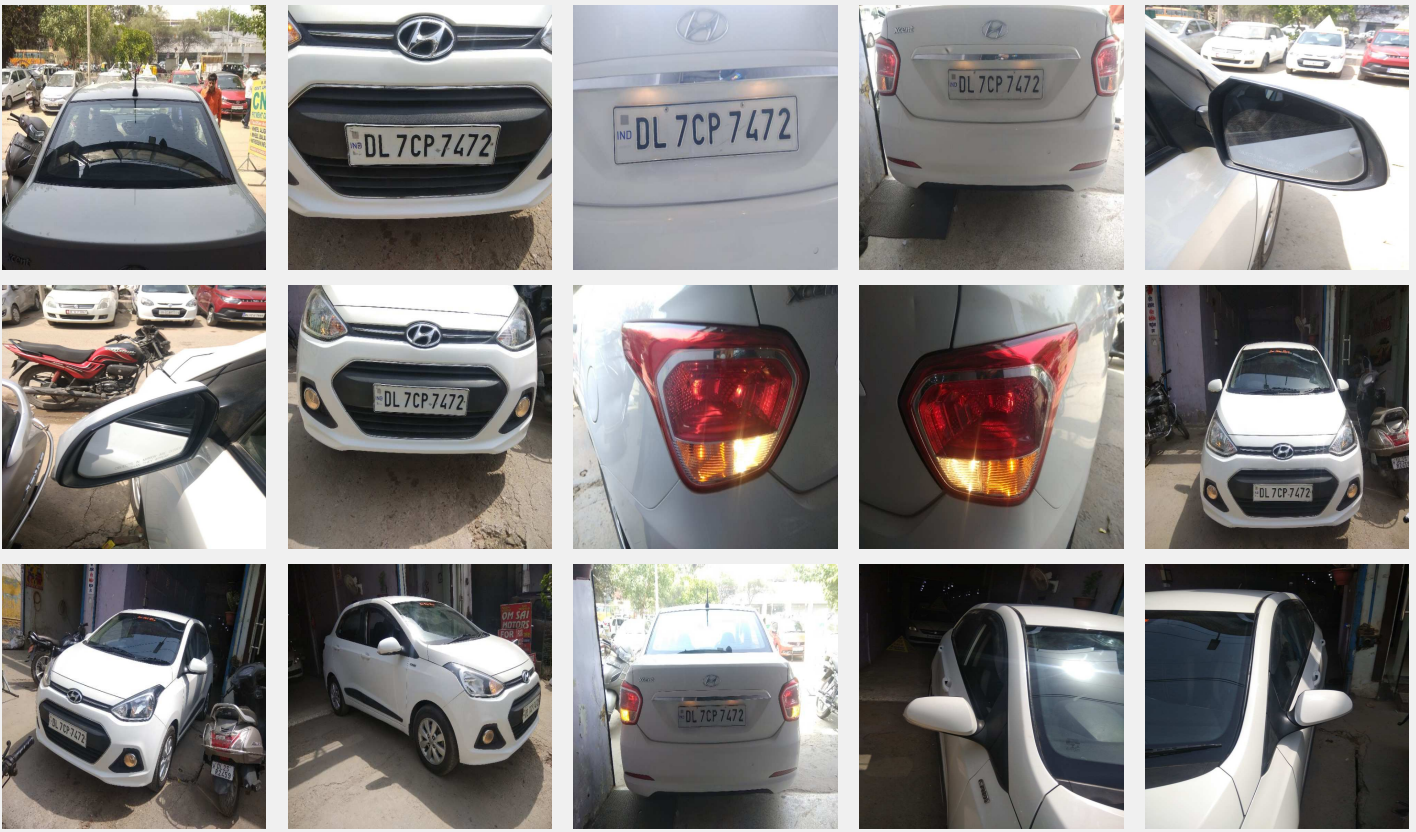
EXTERIOR (CONTINUED)

INSPECTION CHECKPOINTS	SCORE(X/10)	REMARKS/COMMENTS	OPTIONAL SPEND EST. (RS)
LICENSE PLATE	7	GOOD CONDITION	0
FRONT BUMPER	7	GOOD CONDITION	0
HEAD LIGHTS	7	GOOD CONDITION AND WORKS(CHECKED)	0
GRILLE	7	GOOD CONDITION	0
FOG LAMPS	7	GOOD WORKING(CHECKED)	0
HOOD	7	GOOD CONDITION	0
PILLAR	7	GOOD CONDITION	0
FRONT WINDSHIELD	7	GOOD CONDITION	0
SIDE VIEW MIRRORS	7	GOOD CONDITION	0
LH FENDER	7	GOOD CONDITION	0
LH FRONT DOOR	7	GOOD CONDITION	0
LH REAR DOOR	7	GOOD CONDITION	0
LH RUNNING BOARD	7	GOOD CONDITION	0
LH QUARTER PANEL	7	GOOD CONDITION	0
FUEL LID	7	GOOD WORKING(CHECKED)	0
REAR WINDSHIELD	7	GOOD CONDITION	0
REAR BUMPER	7	GOOD CONDITION	0
TAIL LIGHT	7	GOOD CONDITION AND WORKS(CHECKED)	0
TRUNK LID/TAIL GATE	7	GOOD CONDITION AND WORKS(CHECKED)	0
LUGGAGE COMPARTMENT LIGHT	7	GOOD CONDITION	0
RH QUARTER PANEL	7	GOOD CONDITION	0
RH RUNNING BOARD	7	GOOD CONDITION	0
RH REAR DOOR	7	GOOD CONDITION	0
RH FRONT DOOR	7	GOOD CONDITION	0

INSPECTION CHECKPOINTS	SCORE(X/10)	REMARKS/COMMENTS	OPTIONAL SPEND EST. (RS)
RH FENDER	7	GOOD CONDITION	0
BODY RUST	7	GOOD(CHECKED)	0
ROOF (REGULAR)	7	GOOD CONDITION	0
PAINT CONDITION	7	GOOD CONDITION	0
TURN SIGNAL	5	LHS LAMP ARE NOT WORKING	200

During the inspection time vehicle are good condition but some minor scratches and of all body frame
