# ECO INSPECTION CERTIFICATE

121 Points Vehicle Inspection Certificate

## Maruti Suzuki Swift LXI, 2015

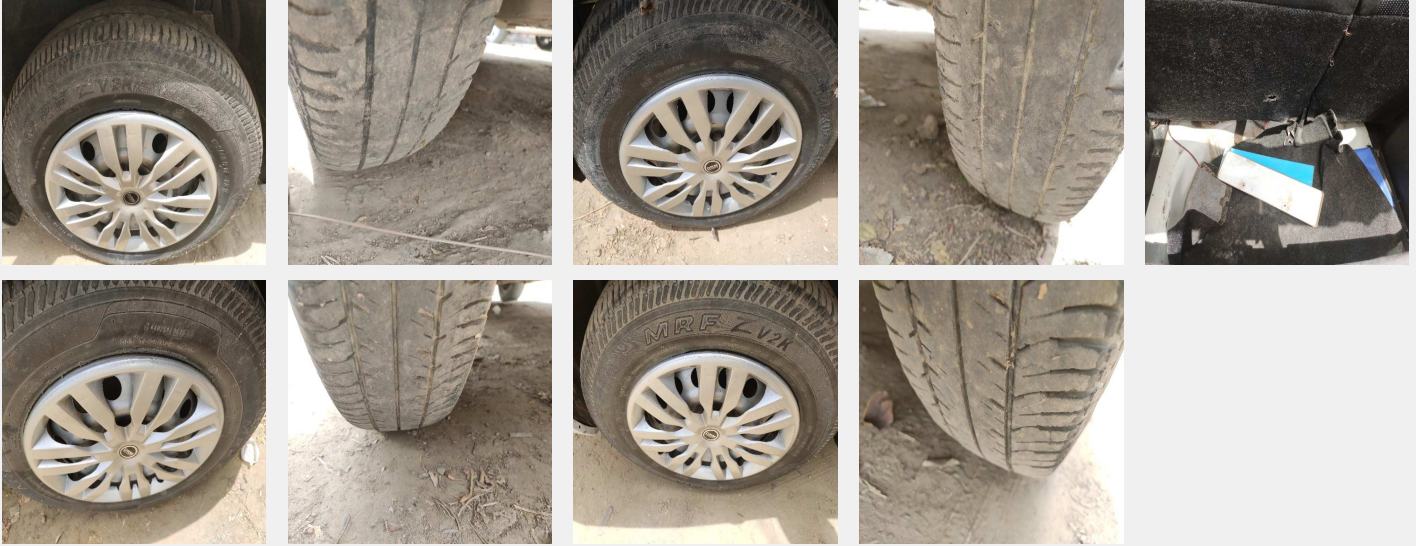
INSPECTION CHECKPOINTS	SCORE(X/10)	REMARKS/COMMENTS	OPTIONAL SPEND EST. (RS)
TYRES	6	FAIR CONDITION	0
SPARE TYRE (NO)	10		0
WHEEL ASSEMBLY (STEEL RIM)	7	GOOD CONDITION	0

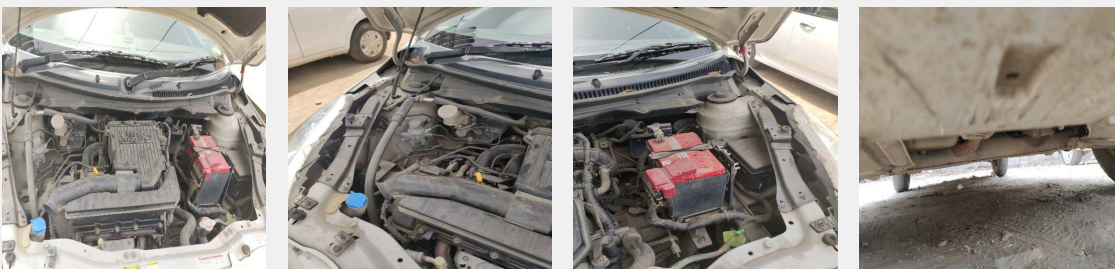
INSPECTION CHECKPOINTS	SCORE(X/10)	REMARKS/COMMENTS	OPTIONAL SPEND EST. (RS)
LH APRON	7	GOOD CONDITION	0
RH APRON	7	GOOD CONDITION	0
RADIATOR	7	GOOD CONDITION	0
WIRING	7	GOOD CONDITION	0
BATTERY	7	GOOD CONDITION	0
BRAKE FLUID LEVEL	7	MAX	0
ENGINE OIL	7	MAX	0
COOLANT LEVEL	7	MAX	0
BRAKE & COOLANT HOSE PIPES	7	GOOD CONDITION	0
UNDERCARRIAGE	7	GOOD CONDITION	0
EXHAUST SYSTEM	7	GOOD CONDITION	0

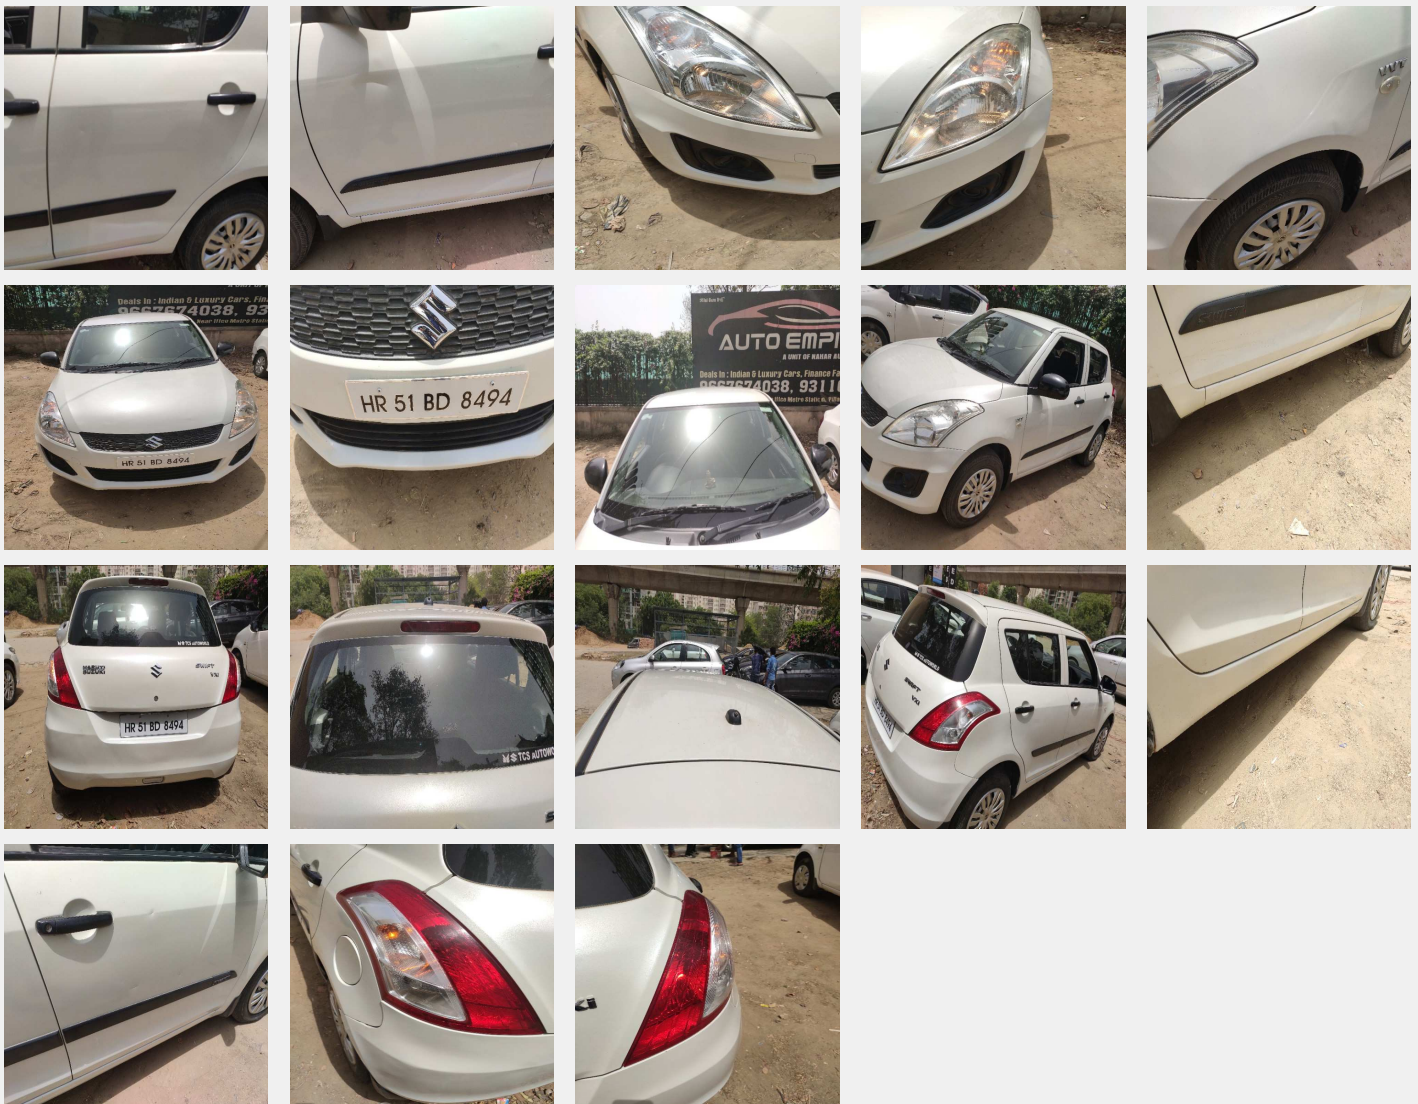
INSPECTION CHECKPOINTS	SCORE(X/10)	REMARKS/COMMENTS	OPTIONAL SPEND EST. (RS)
RH FENDER	7	GOOD CONDITION	0
BODY RUST	7	GOOD CONDITION	0
ROOF (REGULAR)	7	GOOD CONDITION	0
PAINT CONDITION	7	GOOD CONDITION	0
FOG LAMPS	0	NOT AVAILABLE	0

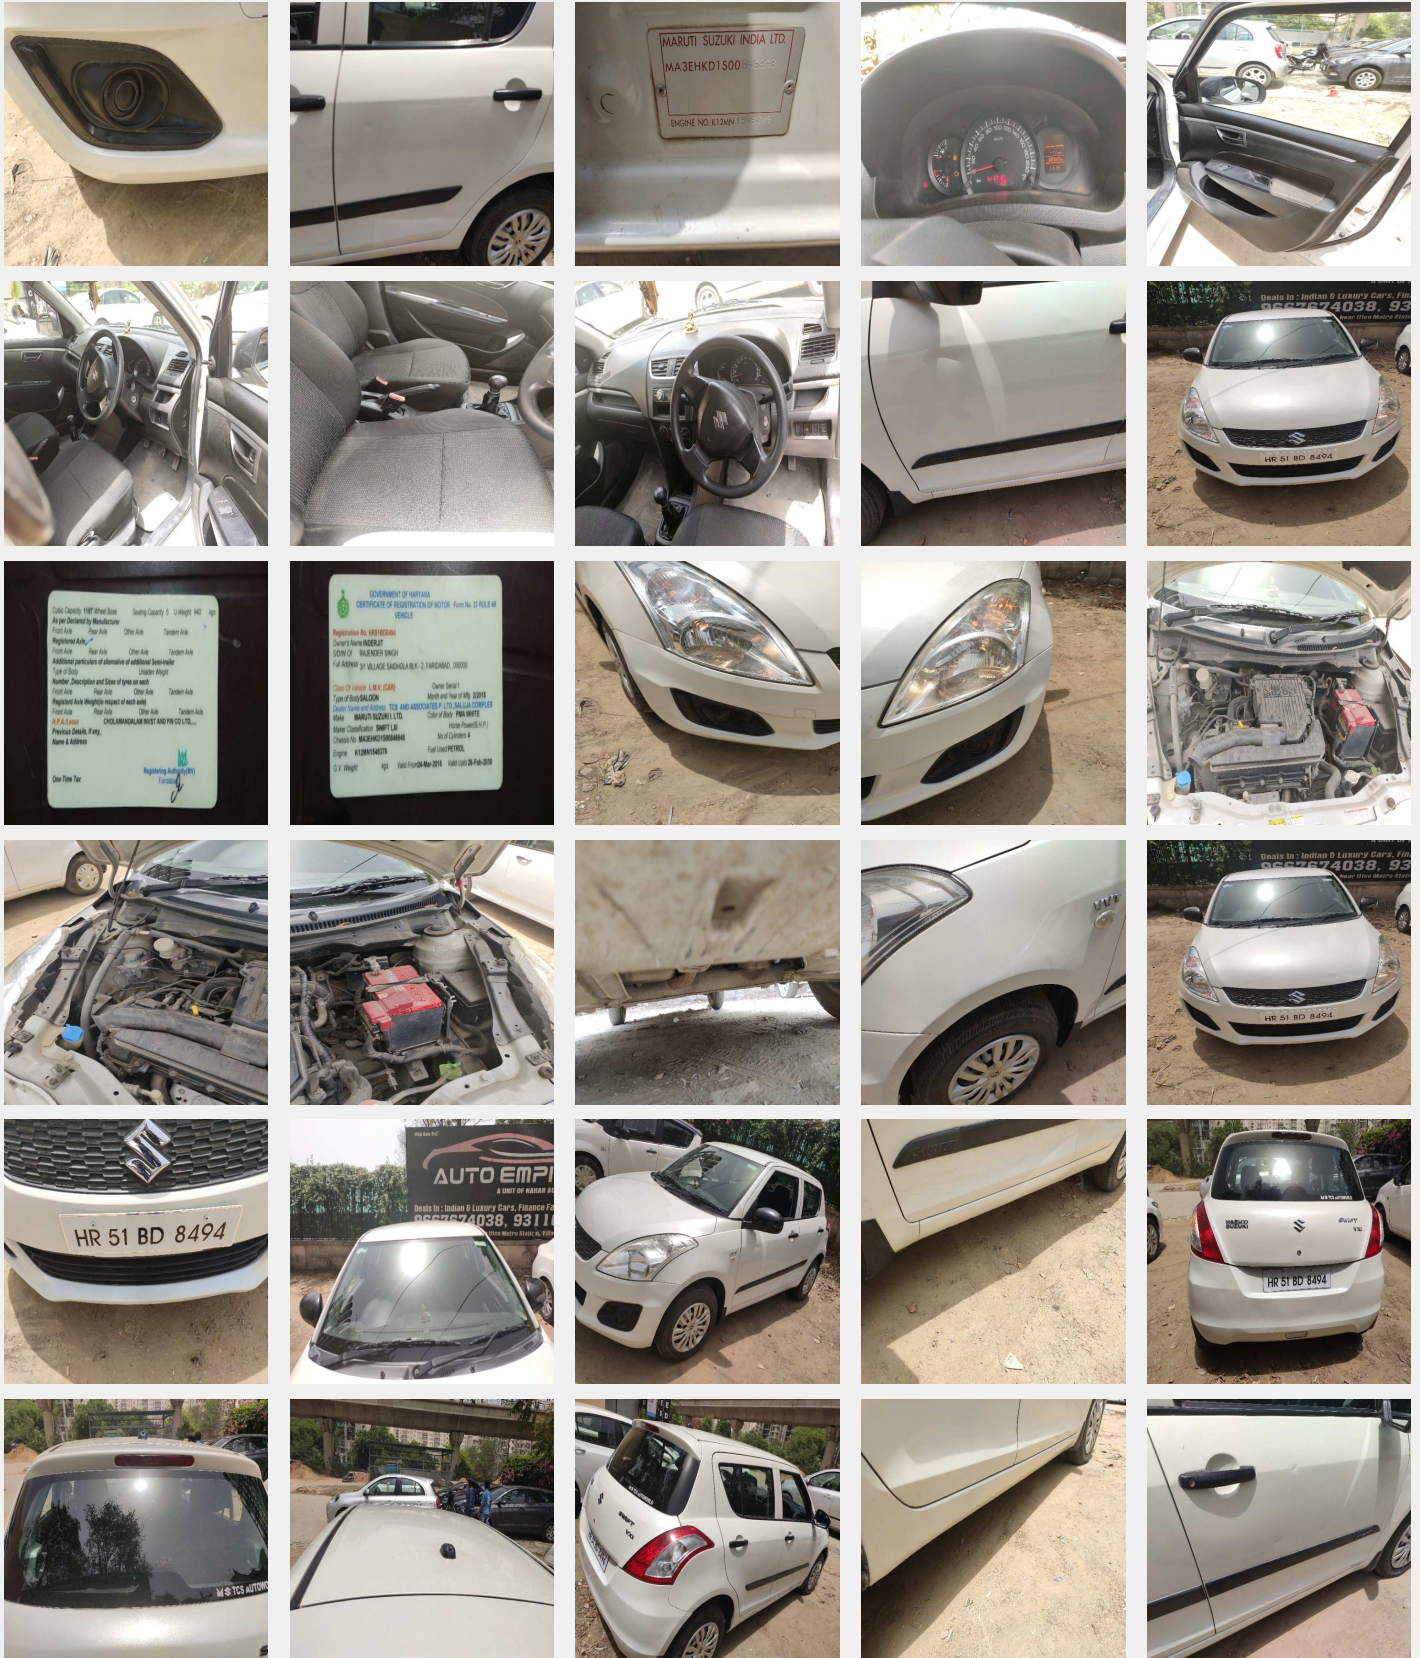
minor scratches and dent car already painted
