ECO INSPECTION CERTIFICATE

Order ID : 68837

121 Points Vehicle Inspection Certificate

Tata Nano LX, 2013

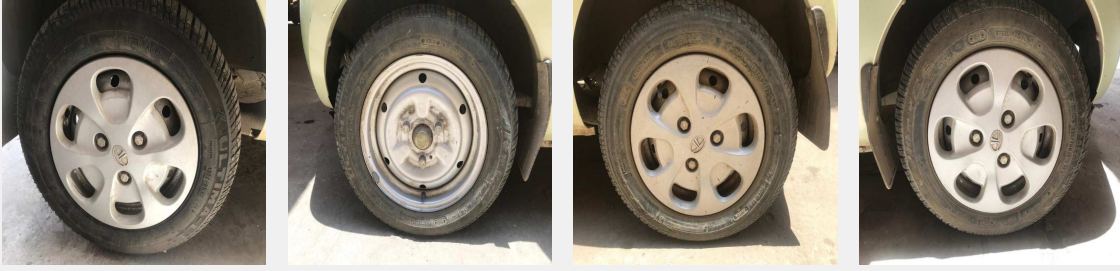
INSPECTION CHECKPOINTS	SCORE(X/10)	REMARKS/COMMENTS	OPTIONAL SPEND EST. (RS)
TYRES	6		0
SPARE TYRE (YES)	6		0
WHEEL ASSEMBLY (STEEL RIM)	6		0

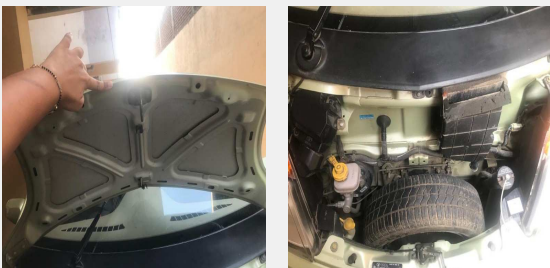
HOOD

INSPECTION CHECKPOINTS	SCORE(X/10)	REMARKS/COMMENTS	OPTIONAL SPEND EST. (RS)
LH APRON	6		0
RH APRON	6		0
RADIATOR	6		0
WIRING	6		0
BATTERY	6		0
BRAKE FLUID LEVEL	6		0
ENGINE OIL	6		0
COOLANT LEVEL	6		0
BRAKE & COOLANT HOSE PIPES	6		0
UNDERCARRIAGE	6		0
EXHAUST SYSTEM	6		0
