ECO INSPECTION CERTIFICATE

121 Points Vehicle Inspection Certificate

Ordered By : Ajay Radadiya	Inspection Date : 2019-05-09	Location : SURAT

Honda Amaze 1.5 S I-DTEC, 2015

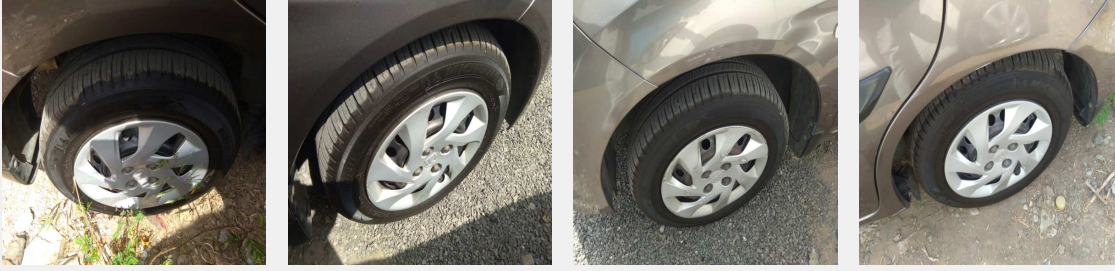
IMAGES

INSPECTION CHECKPOINTS	SCORE(X/10)	REMARKS/COMMENTS	OPTIONAL SPEND EST. (RS)
TYRES	6		0
WHEEL ASSEMBLY (STEEL RIM)	6		0
SPARE TYRE (YES)	3	DAMEGE	3000

NEED ATTENTION
