ECO INSPECTION CERTIFICATE

121 Points Vehicle Inspection Certificate

Ordered By : Satnam Kaur	Inspection Date : 2019-05-09	Location : SEC29 GGN	Inspected By

Mahindra Scorpio S10, 2015

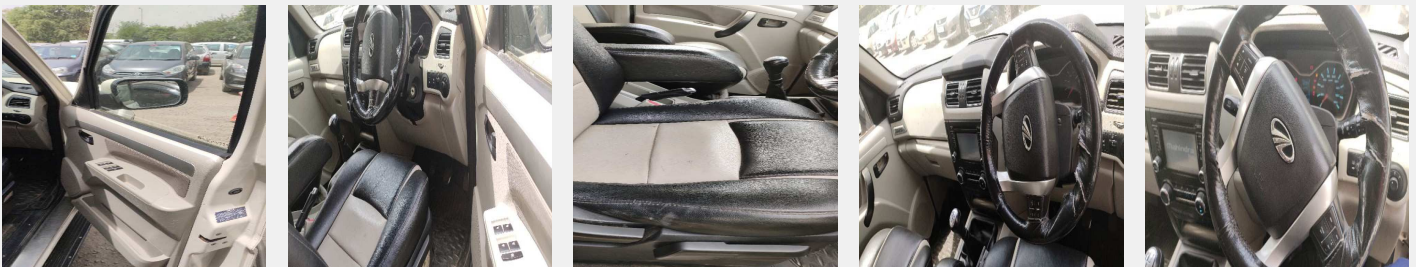
INTERIOR

INSPECTION CHECKPOINTS	SCORE(X/10)	REMARKS/COMMENTS	OPTIONAL SPEND EST. (RS)
DOOR PANEL	7	GOOD CONDITION	0
DOOR HINGES	7	GOOD CONDITION	0
CARPET & FLOOR MAT	7	GOOD CONDITION	0
SEAT & SEAT BELT	7	GOOD CONDITION	0
DASHBOARD & INSTRUMENT PANEL	7	GOOD CONDITION	0
HORN	7	GOOD CONDITION	0
SPEAKERS & MUSIC SYSTEM	7	GOOD CONDITION	0
HANDBRAKE	7	GOOD CONDITION	0
STEERING-MOUNTED CONTROLS	7	GOOD CONDITION	0
PEDALS	7	GOOD CONDITION	0
CENTRAL LOCK	7	GOOD CONDITION	0
A/C VENTS & HEATER	7	GOOD CONDITION	0
CUP HOLDERS	7	GOOD CONDITION	0
NAVIGATION (NO)	10		0
ODOMETER	7	GOOD CONDITION	0
POWER WINDOWS (YES)	7	GOOD CONDITION	0
HAZARD LIGHT	7	GOOD CONDITION	0

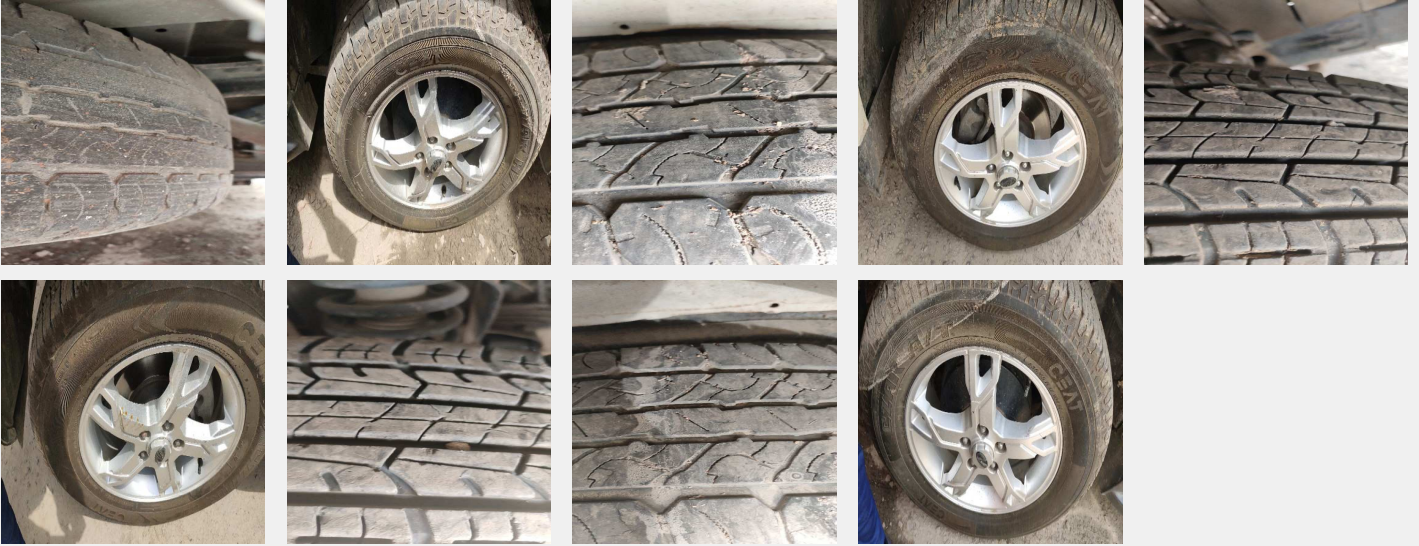
INSPECTION CHECKPOINTS	SCORE(X/10)	REMARKS/COMMENTS	OPTIONAL SPEND EST. (RS)
TYRES	7	GOOD CONDITION	0
SPARE TYRE (YES)	7	GOOD CONDITION	0
WHEEL ASSEMBLY (ALLOY RIM)	7	GOOD CONDITION	0

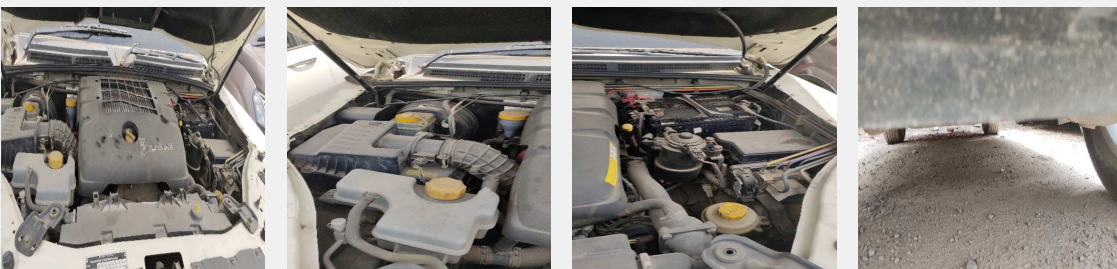
HOOD

INSPECTION CHECKPOINTS	SCORE(X/10)	REMARKS/COMMENTS	OPTIONAL SPEND EST. (RS)
LH APRON	7	GOOD CONDITION	0
RH APRON	7	GOOD CONDITION	0
RADIATOR	7	GOOD CONDITION	0
WIRING	7	GOOD CONDITION	0
BATTERY	7	GOOD CONDITION	0
BRAKE FLUID LEVEL	7	MAX	0
ENGINE OIL	7	MAX	0
COOLANT LEVEL	7	MAX	0
BRAKE & COOLANT HOSE PIPES	7	GOOD CONDITION	0
UNDERCARRIAGE	7	GOOD CONDITION	0
EXHAUST SYSTEM	7	GOOD CONDITION	0

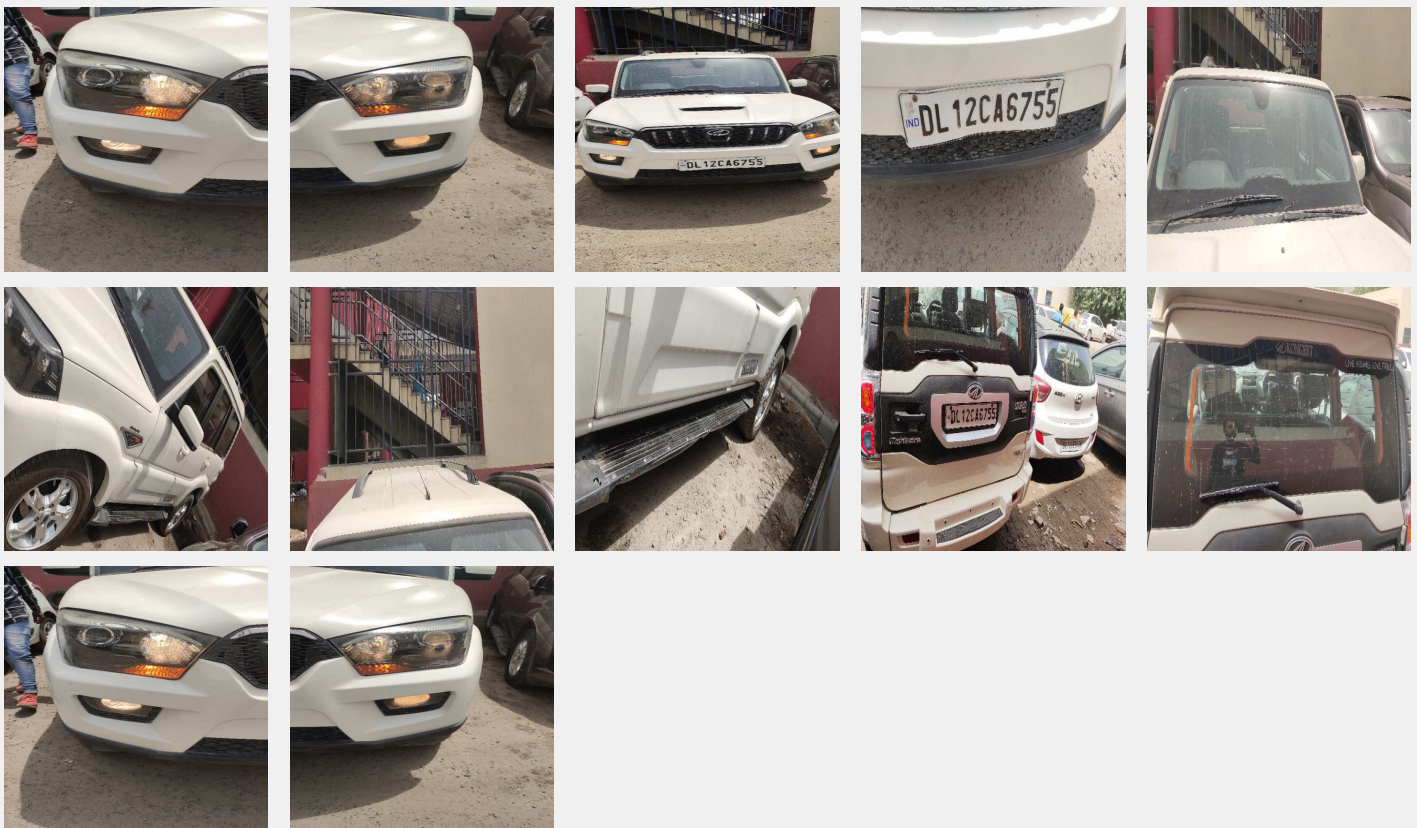
EXTERIOR (CONTINUED)

INSPECTION CHECKPOINTS	SCORE(X/10)	REMARKS/COMMENTS	OPTIONAL SPEND EST. (RS)
RH FRONT DOOR	7	GOOD CONDITION	0
RH FENDER	7	GOOD CONDITION	0
BODY RUST	7	GOOD CONDITION	0
ROOF (REGULAR)	7	GOOD CONDITION	0
PAINT CONDITION	7	GOOD CONDITION	0

car fully painted
