ECO INSPECTION CERTIFICATE

Order ID : 71117

121 Points Vehicle Inspection Certificate

Maruti Suzuki Wagon R LXI CNG, 2011

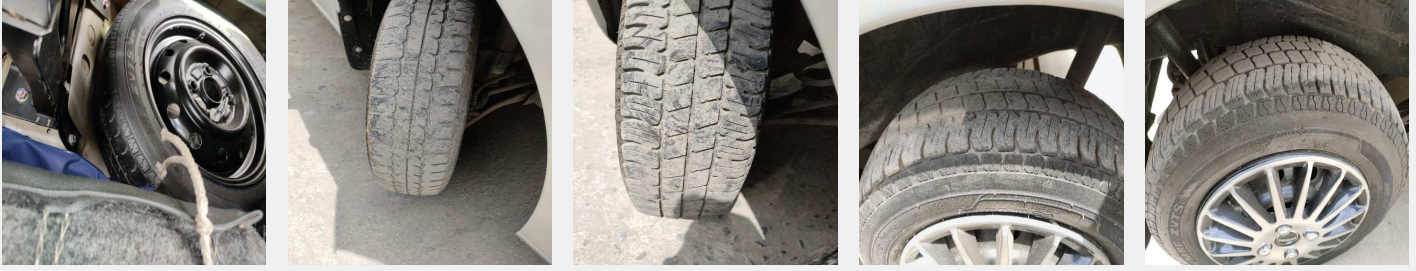
INSPECTION CHECKPOINTS	SCORE(X/10)	REMARKS/COMMENTS	OPTIONAL SPEND EST. (RS)
TYRES	7		0
SPARE TYRE (YES)	6	AVERAGE CONDITION	0
WHEEL ASSEMBLY (STEEL RIM)	7		0

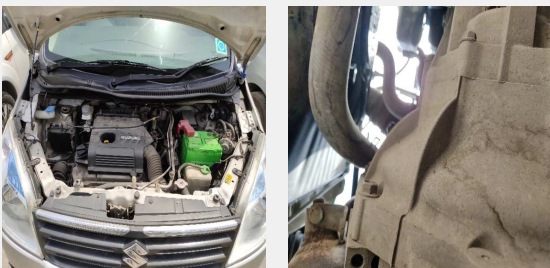
INSPECTION CHECKPOINTS	SCORE(X/10)	REMARKS/COMMENTS	OPTIONAL SPEND EST. (RS)
LH APRON	7		0
RH APRON	7		0
RADIATOR	6	AVERAGE CONDITION	0
WIRING	6	AVERAGE CONDITION	0
BATTERY	7		0
BRAKE FLUID LEVEL	7		0
ENGINE OIL	7		0
COOLANT LEVEL	7		0
BRAKE & COOLANT HOSE PIPES	6	AVERAGE CONDITION	0
UNDERCARRIAGE	6	AVERAGE CONDITION	0
EXHAUST SYSTEM	6	AVERAGE CONDITION	0

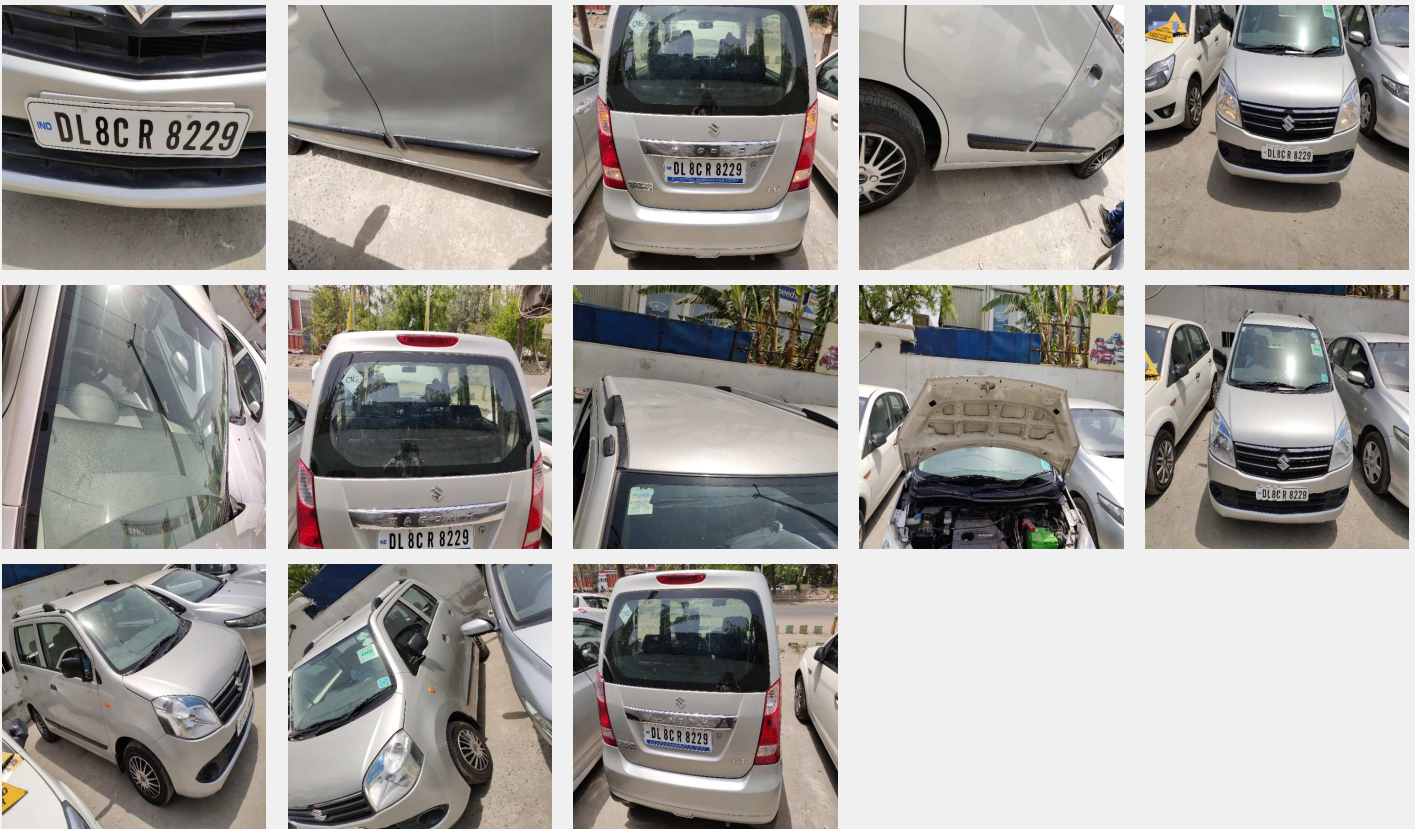
INSPECTION CHECKPOINTS	SCORE(X/10)	REMARKS/COMMENTS	OPTIONAL SPEND EST. (RS)
RH FENDER	7		0
BODY RUST	7		0
ROOF (REGULAR)	7		0
PAINT CONDITION	6	AVERAGE CONDITION	0
FOG LAMPS	0	NA	0

all body minor scratches
